## BUILDING DEFECT DIAGNOSIS REPORT

Reported Cracking — Principally the Front Bay Windows; also Outrigger & Rear Floor

24 Example Road, London E5 0AA

Date of inspection: 16 July 2026 | Date of report: 16 July 2026 | Report ref: EXAMPLE

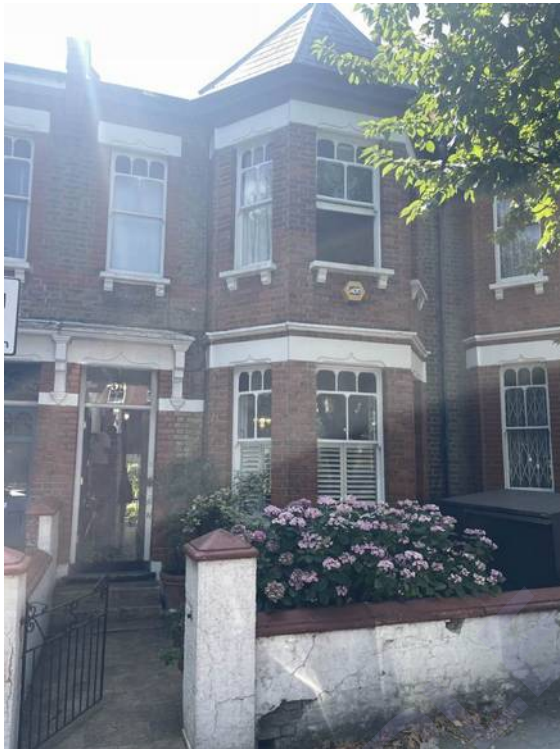
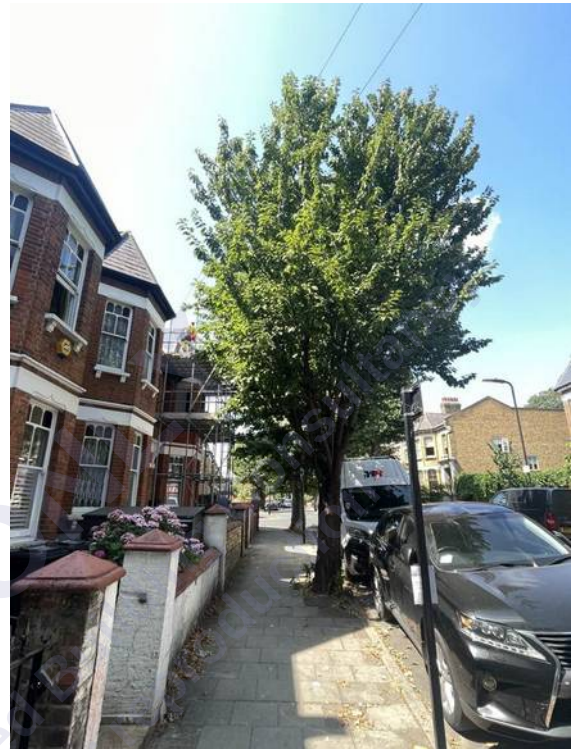
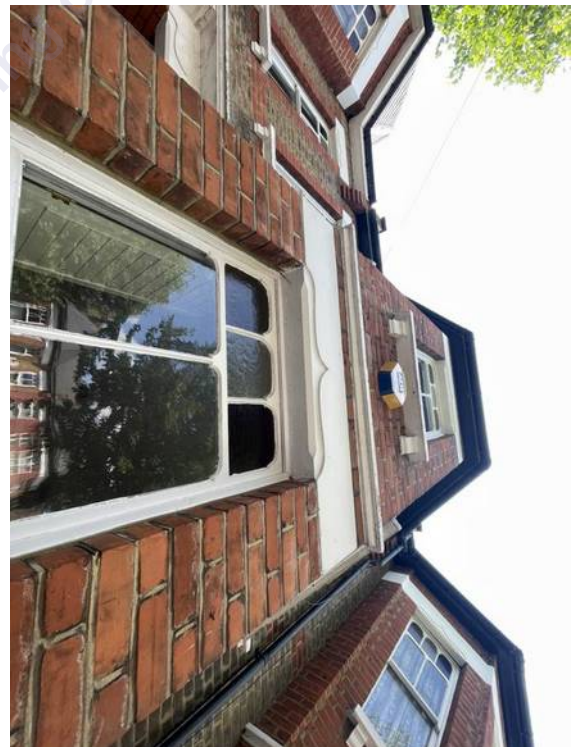
## A1 — General Front Elevation

The property viewed from Example Road: a late-Victorian mid-terrace with a two-storey canted bay window, of solid brick in lime mortar. The mature London Plane street tree stands immediately to the front, and cracking is visible to the rendered front boundary wall.

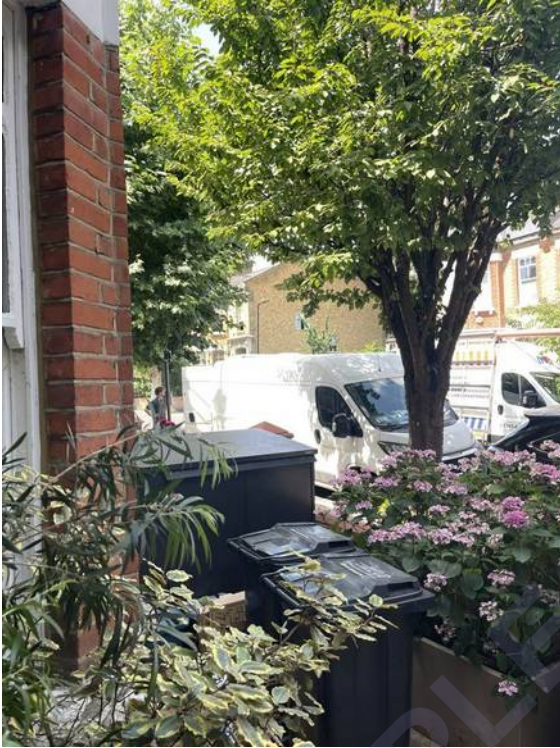
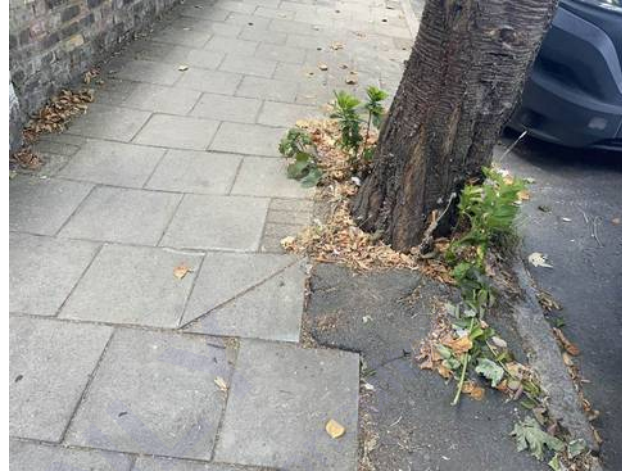
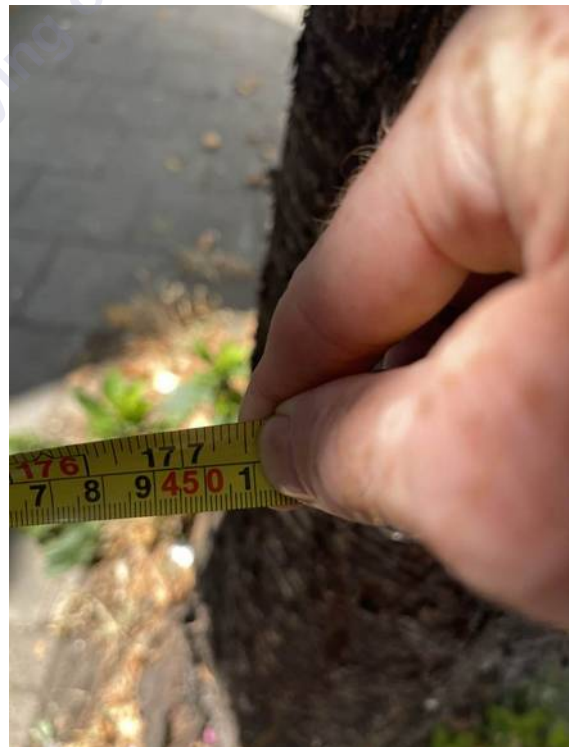
## A2 — Roadside London Plane Tree to Front of Property

A mature London Plane street tree stands directly in front of the property, approximately 8 metres high and approximately 4.5 metres from the front bay window (to the right when viewed from the street). The owners report that it is pruned annually by the local authority. The London Plane is a high water-demand, broad-leaved species; at 4.5m distance the foundations lie well within its zone of influence (NHBC Chapter 4.2 / BRE Digest 240 treat foundations within one mature tree height as inside the zone of influence, and the species can reach 25–30m at maturity).

The London Plane street tree, approximately 8 metres high and approximately 4.5 metres from the front bay window, pruned annually by the local authority. Note the lifted/bulging paving slabs in its vicinity, indicative of root activity, and the left-hand side crack to the bay visible from this viewpoint.

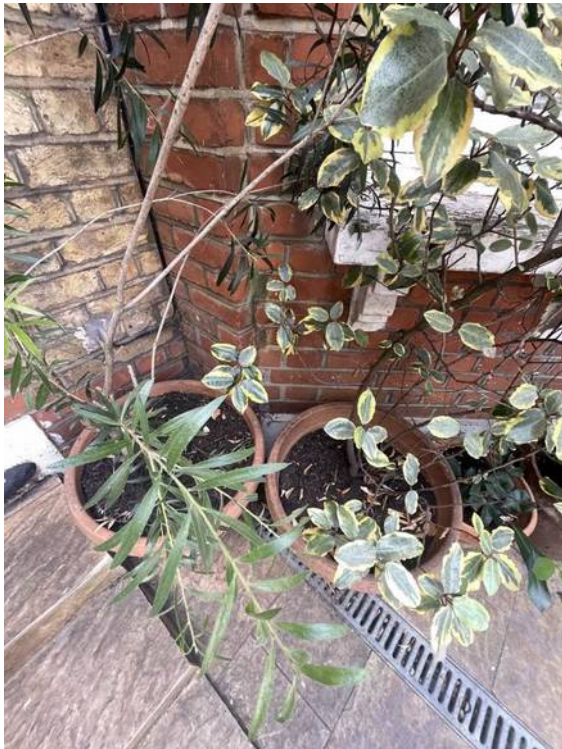
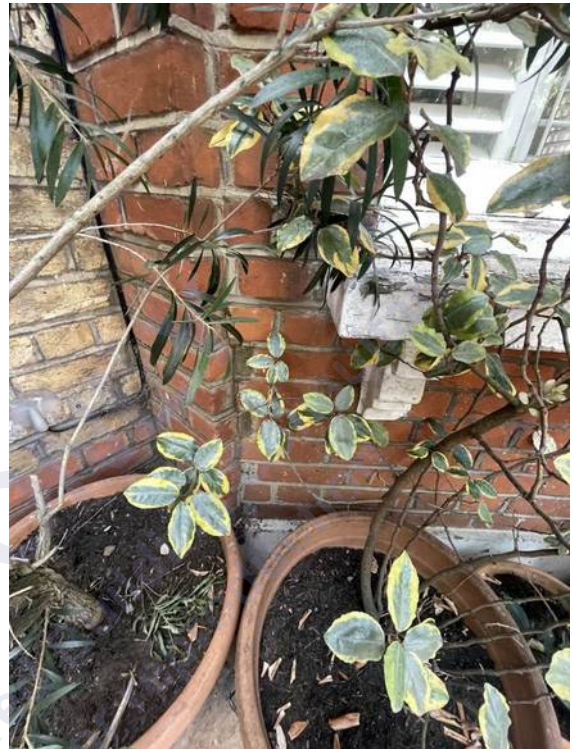
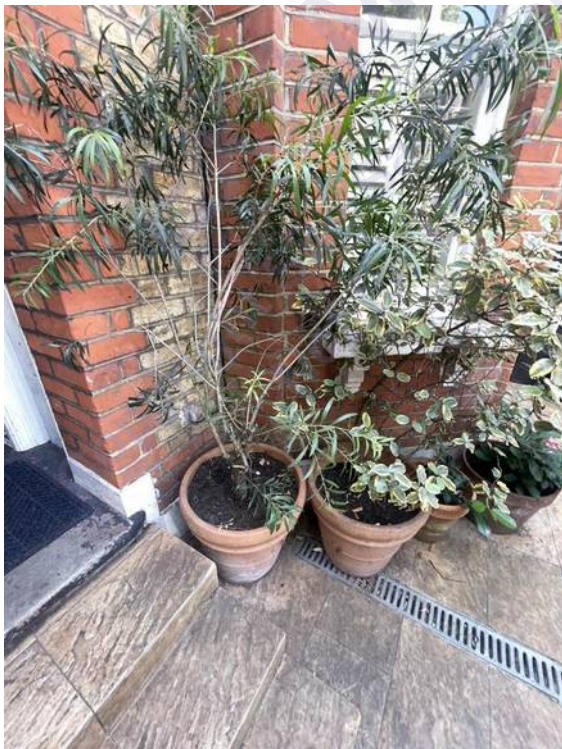
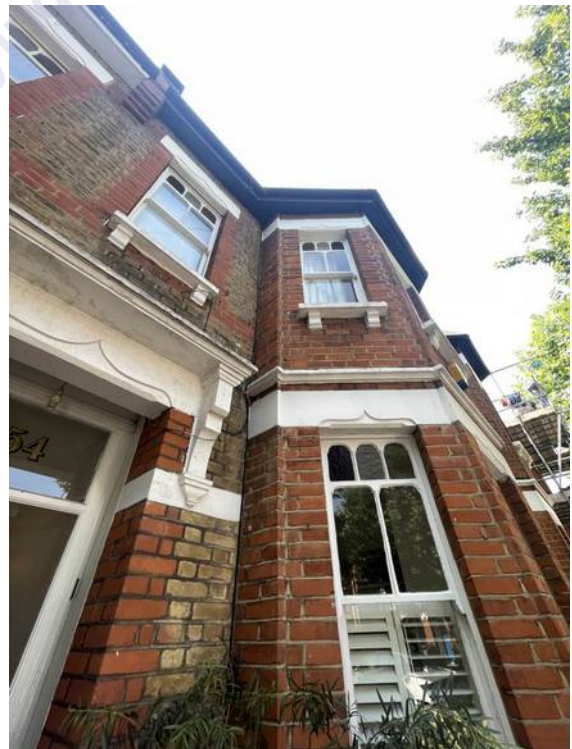
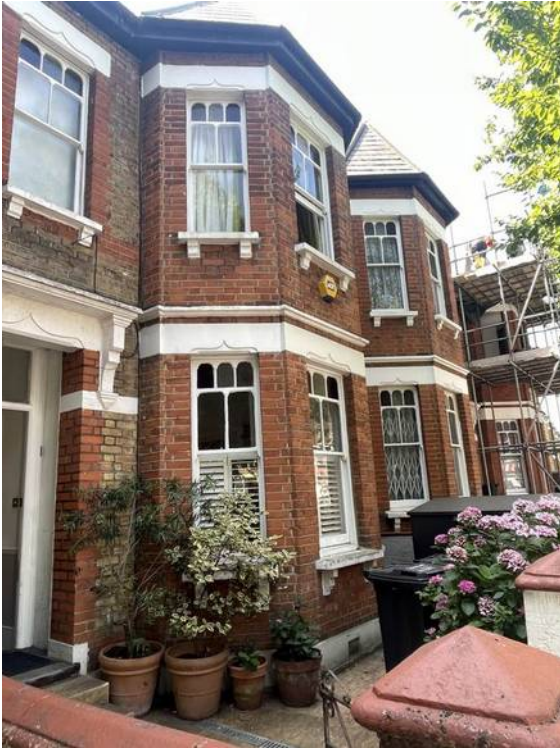
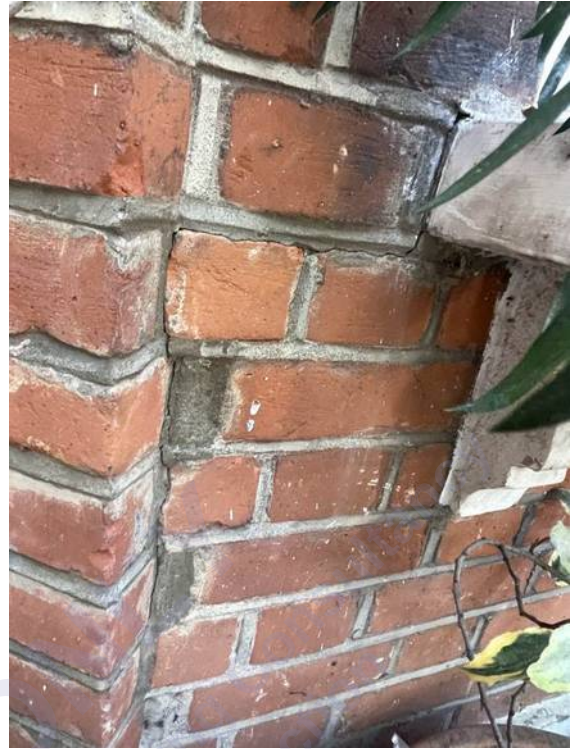
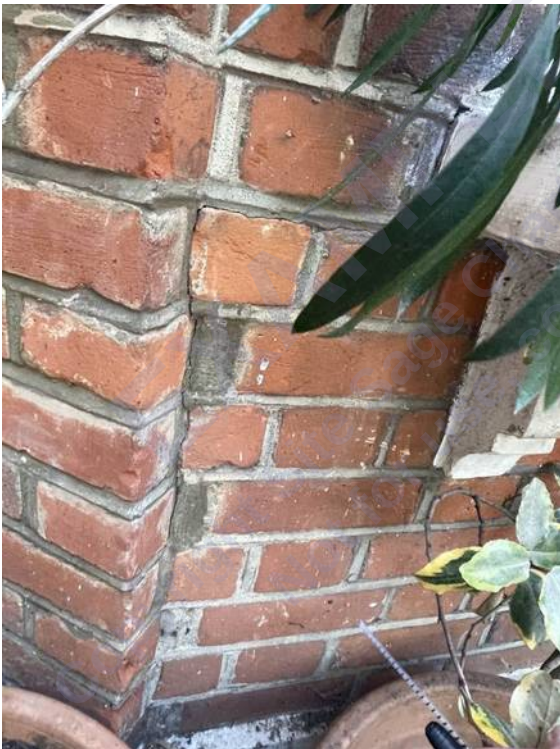
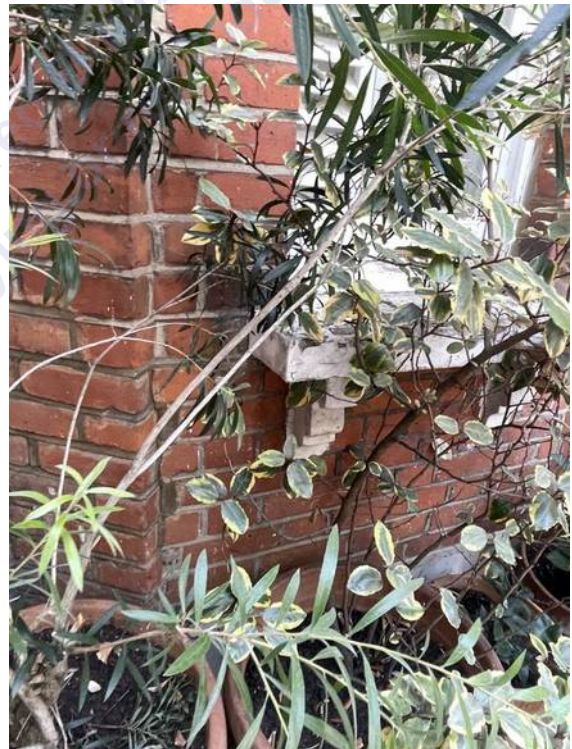
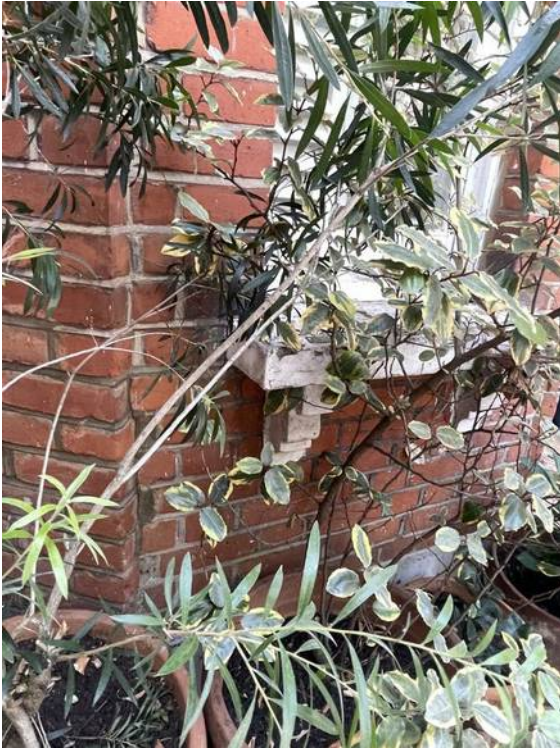
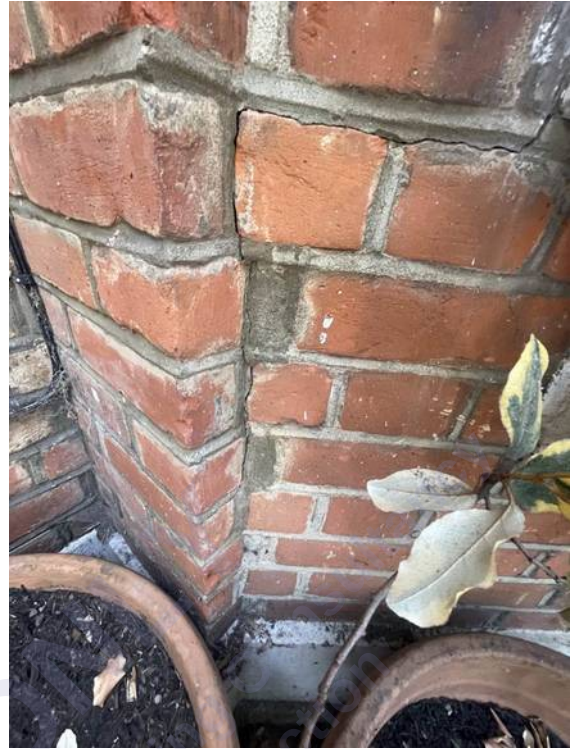
### A3 — External: Front, Left-Hand Side of Bay Window

| No. | Location & description | Int/Ext | Direction/character | Width | BRE Cat. | At opening? |
|---|---|---|---|---|---|---|
| 1 | External — ground floor front, left of the left-hand bay window light, low level (with corresponding internal crack on the opposite face of the same wall, radiating from the corner of the window cill) | Ext +<br>Int | Tapered | 1.5–2mm tapering to hairline | 2 | Yes — off cill corner |

On the balance of probabilities, the most likely cause of the cracking to the front bay is clay-shrinkage subsidence causing rotational/differential movement of the shallow-founded bay relative to the main house. The observed pattern — diagonal, tapered cracks radiating from the corners of window openings (the weakest points), mirrored high-level cracking either side of the bay returning to the party wall, and the ground floor crack visible on both faces of the solid wall — is characteristic of downward/rotational movement of the bay. The movement is not currently excessive: the recorded damage falls within BRE Digest 251 Category 2 (aesthetic to slight).

Three factors, in combination, are the probable drivers: (i) the mature London Plane approximately 4.5m from the bay, extracting moisture from the shrinkable London Clay — an effect intensified during prolonged dry weather as roots extend in search of water; (ii) the exceptional 2025–26 dry spells and accumulated soil moisture deficit, which correlate with the reported acceleration of the cracking; and (iii) the possible soakaway adjacent to the right-hand side of the bay, which if confirmed would alternately soften and shrink the supporting ground. The bay's shallow footing makes it the most vulnerable element to all three. It is further noted that the first floor cracking is wider on the right-hand side of the bay — the opposite side to the ground floor crack — a distribution consistent with root-related differential movement beneath the bay acting in combination with the factors above.

External, left-hand side of the bay: Crack 1 — low level, left of the left-hand bay light, measured at 1.5–2mm tapering to hairline (BRE Category 2; see crack gauge photographs for measured widths). Minor cracking is also present around the window surrounds. The ACO channel to this side collects and takes surface water away from the bay.

(a) CCTV drainage survey — first priority — to establish whether the gully to the right-hand side of the bay discharges to a soakaway and to confirm the integrity of drainage runs near the bay. (b) Crack monitoring over 6 to 12 months (through a full seasonal cycle), using calibrated tell-tales read periodically. Specialist crack monitoring firms serving London include, for example, Construction Testing Services (CTS) and SML Subsidence — neither has been used by Site Sage and no endorsement is given; the clients should check reviews and satisfy themselves as to suitability before engaging any firm. In practice the insurer will normally arrange monitoring within a claim, so commissioning it independently is advisable but not obligatory at this stage. (c) Arboricultural report on the London Plane — the clients may request this directly from the local authority, which prunes the tree annually. (d) BGS GeoSure shrink–swell susceptibility data for E5 0AA — a postcode-level dataset published by the British Geological Survey grading the shrink–swell hazard of the mapped soils; obtaining this would corroborate the ground conditions assumed in this report. (e) Property and neighbouring claims history via the insurer (CUE database).

Structural repair should follow, not precede, the monitoring and investigation. If monitoring shows movement has stabilised (for example following drainage repair and/or tree management by the council), repair is likely to comprise crack stitching/repair and redecoration rather than underpinning. The outrigger junction crack and minor cracking may simply be filled and decorated, accepting that fine seasonal cracks may reappear. Repointing is required in isolated areas around the rear bay, and the minor external defects observed around the front bay (cracking to the window surrounds and minor pointing defects) should be made good at the same time as the crack repairs. The works should be undertaken by a suitably competent contractor experienced in this type of repair. The contractor should inspect the property, verify dimensions and site conditions, and provide a fixed quotation before works commence.

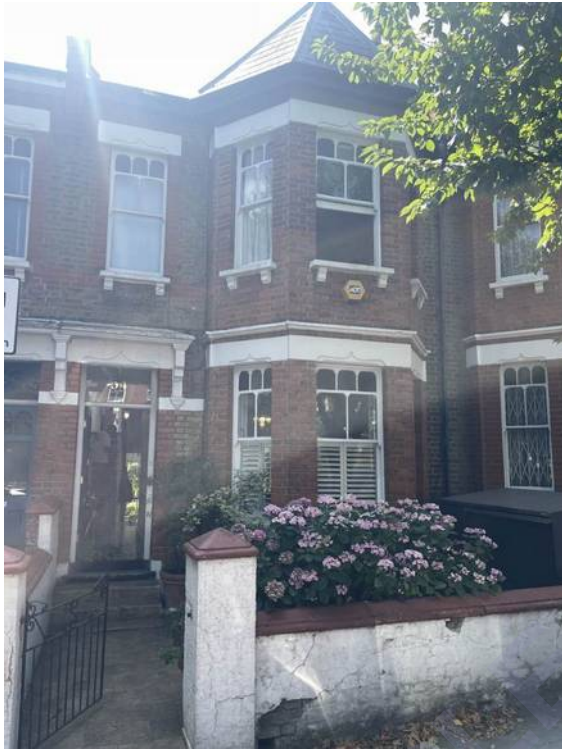
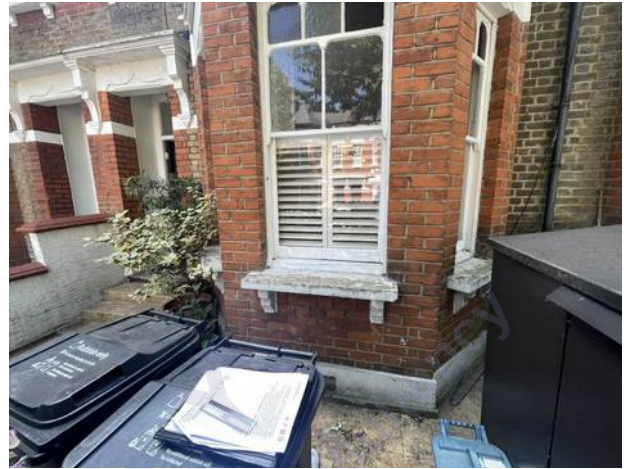
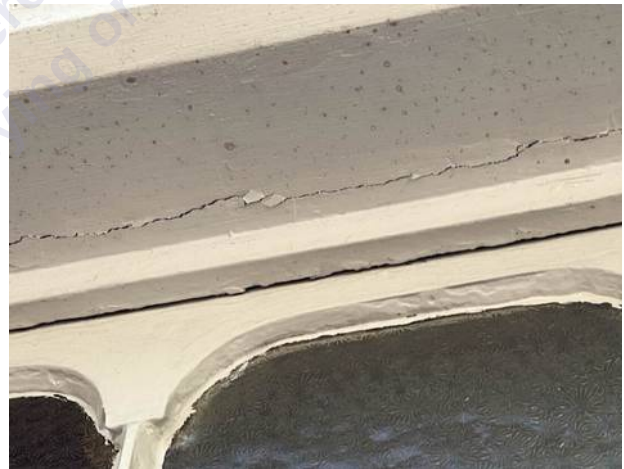
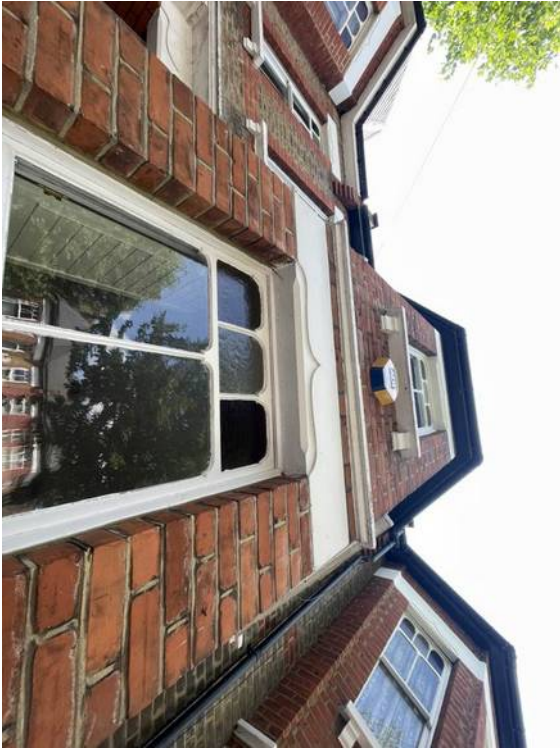
## A4 — External: Middle of Bay Window

External, middle of the bay: general condition, with minor defects around the window surrounds; no significant structural cracking to this face.

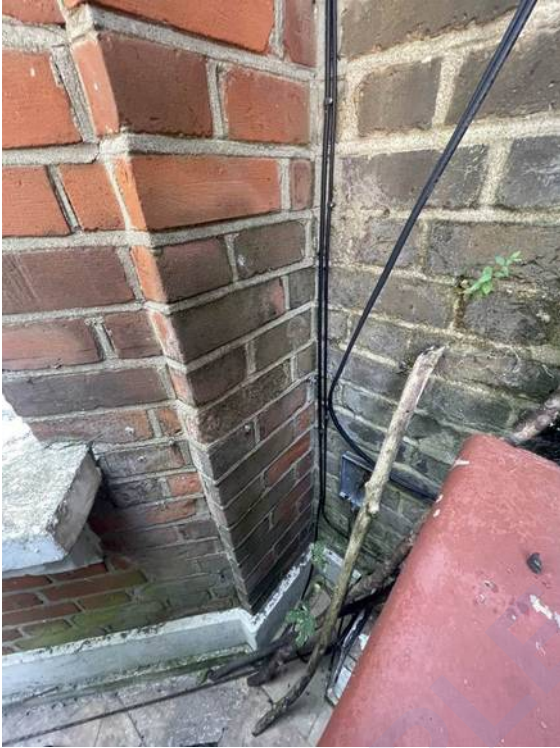
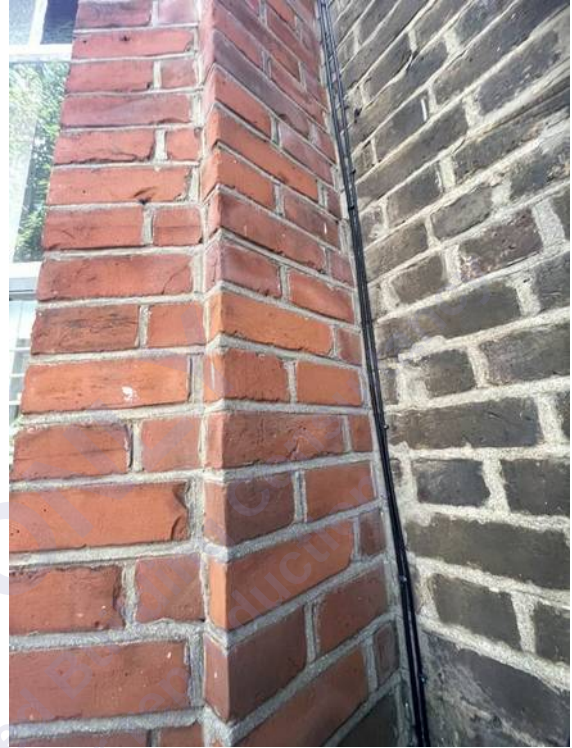
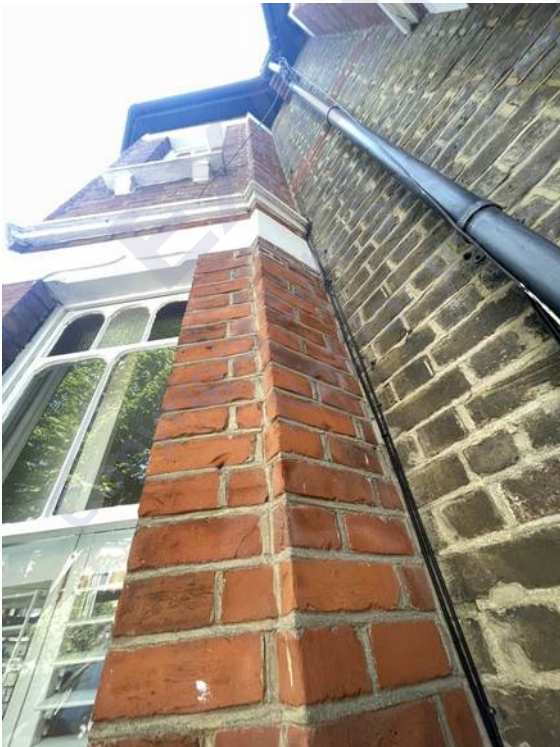
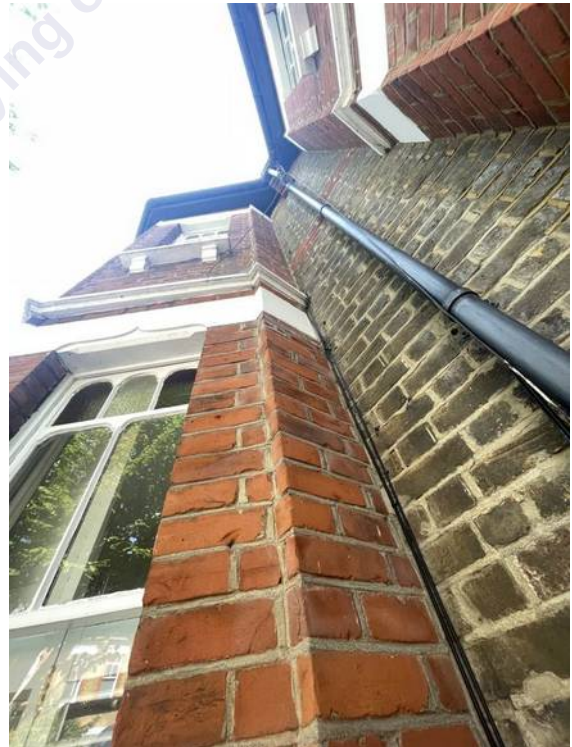
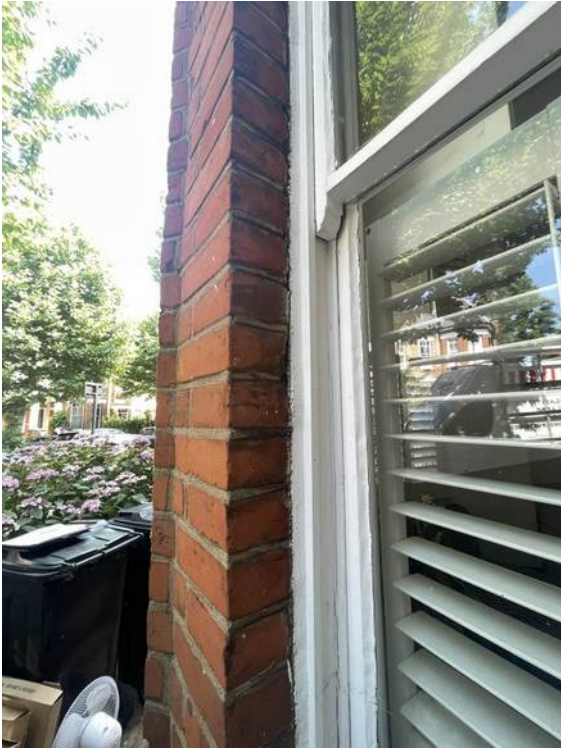
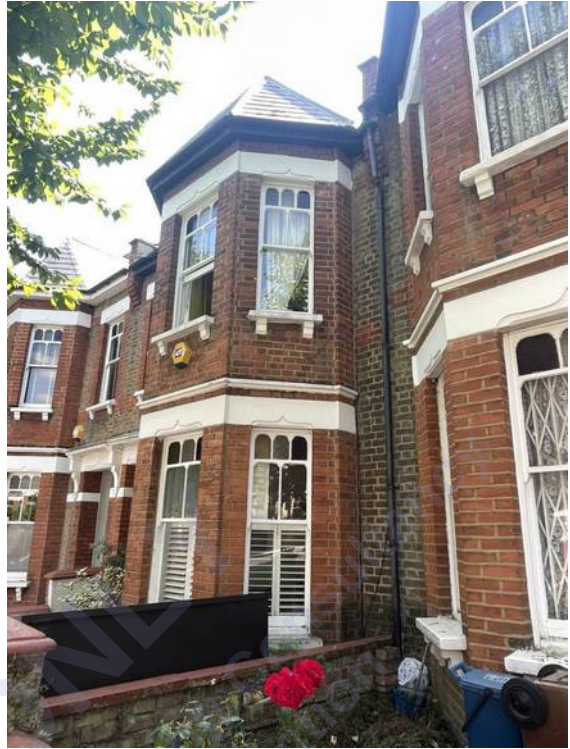
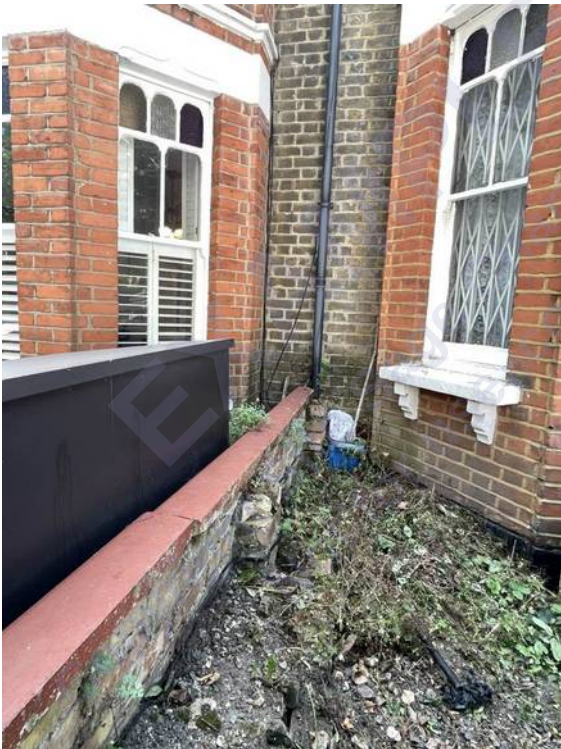
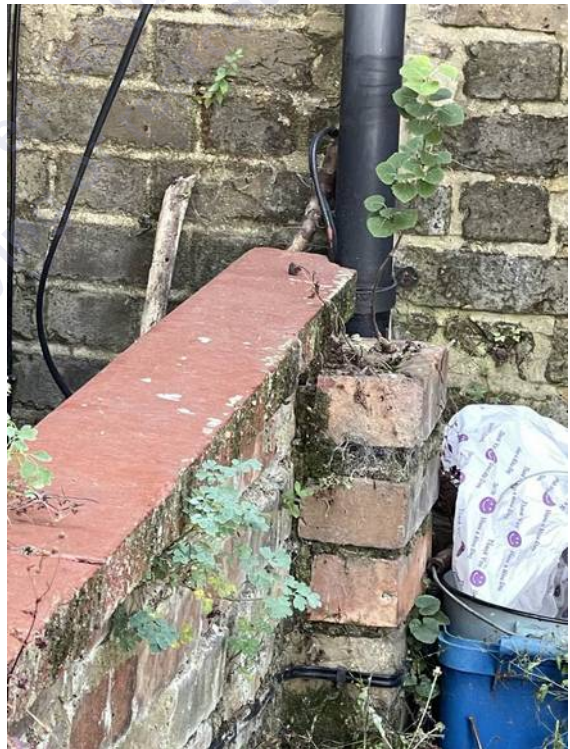
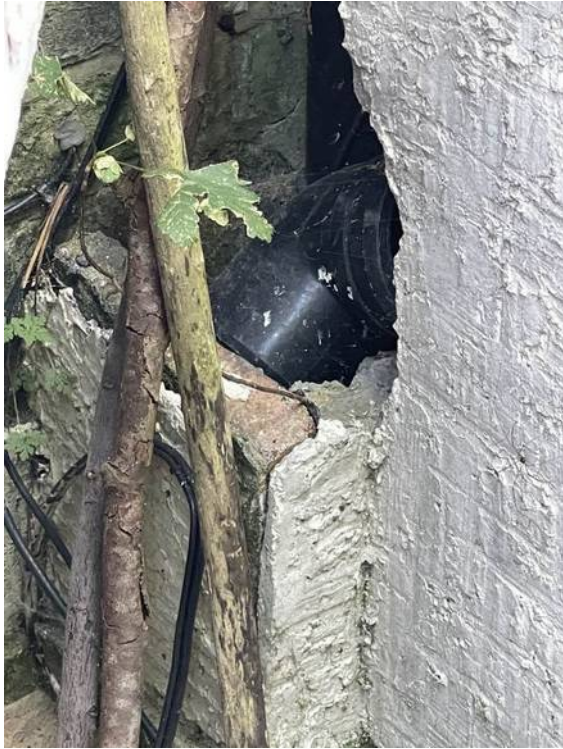
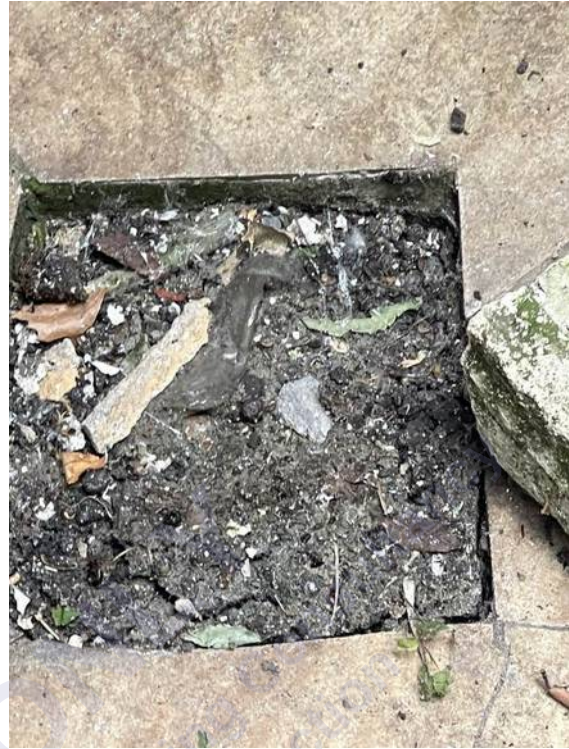
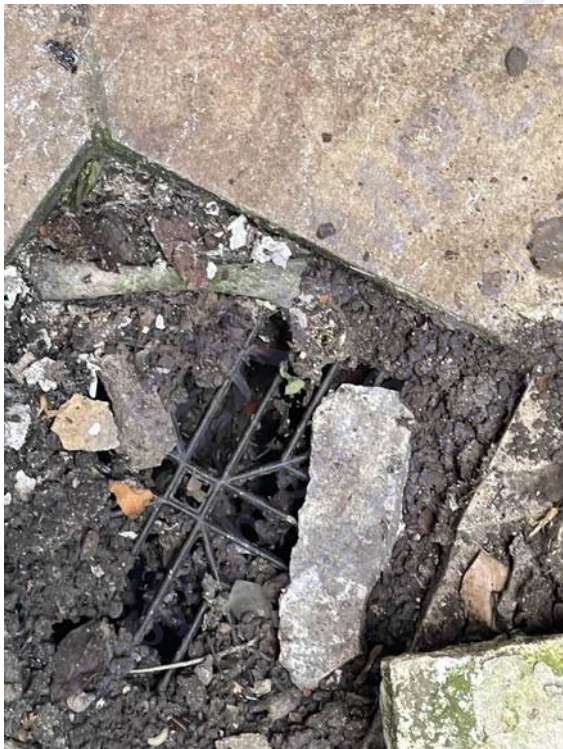
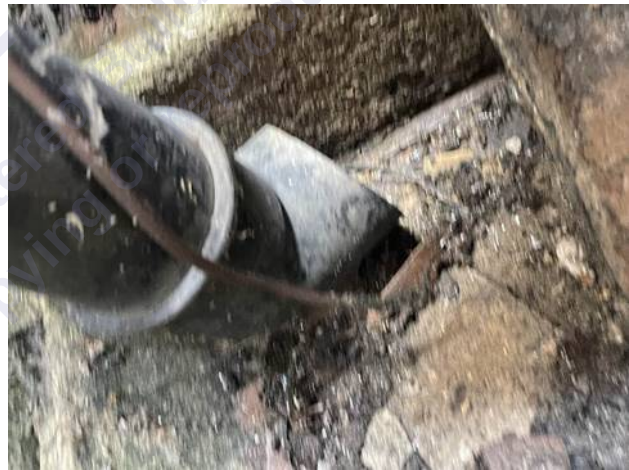
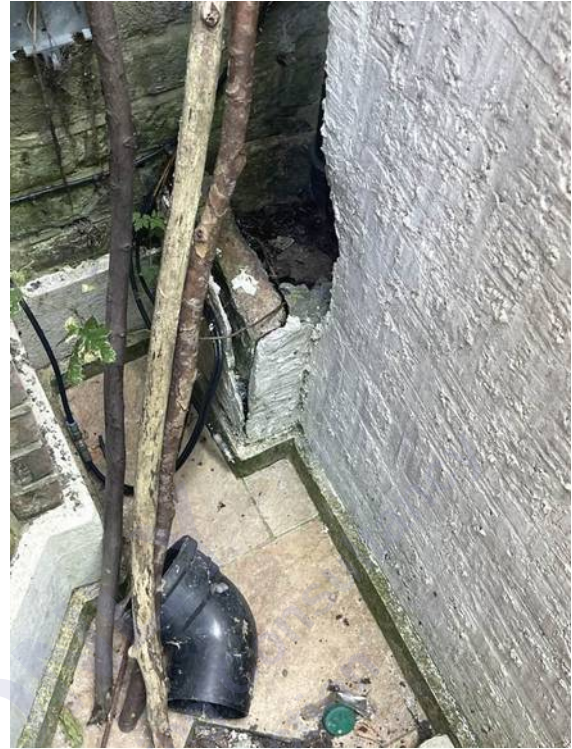
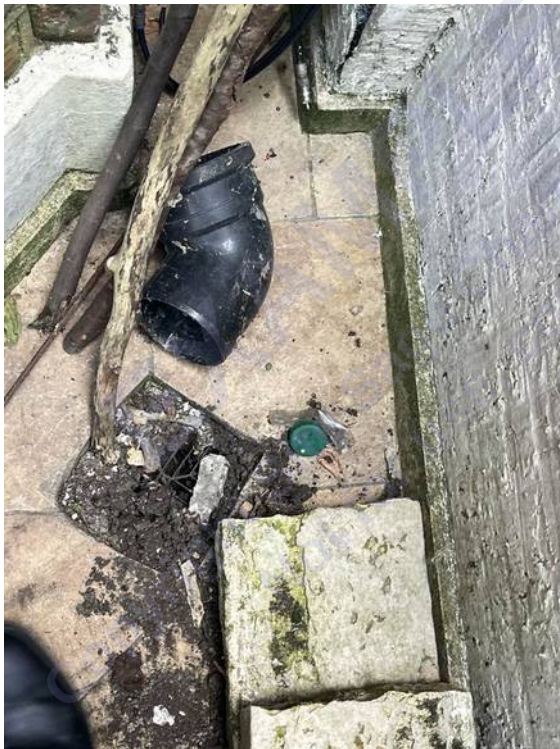
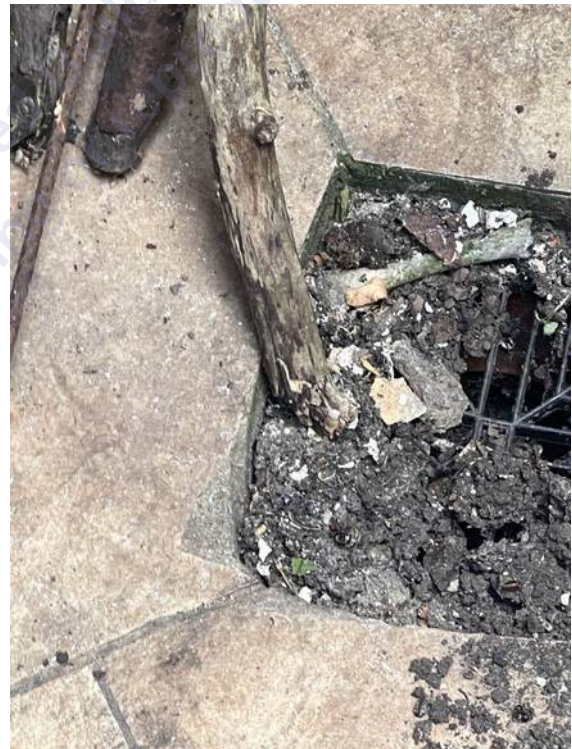
## A5 — External: Front, Right-Hand Side of Bay Window

No drainage problems or blockages are known to the owners. To the right-hand side of the bay window a rainwater pipe discharges to a gully which, on the balance of the visible evidence, may serve a soakaway rather than the main drainage system. If so, discharge close to the bay foundations would cyclically soften the supporting ground when charged and shrink it during hot, dry weather. A CCTV drainage survey is recommended to establish the position (Section 10). To the left-hand side of the bay an ACO channel already collects and takes surface water away from the area.

External, right-hand side of the bay: the rainwater pipe discharging to a gully suspected to serve a soakaway (subject to the recommended CCTV drainage survey), together with minor external defects around the bay.

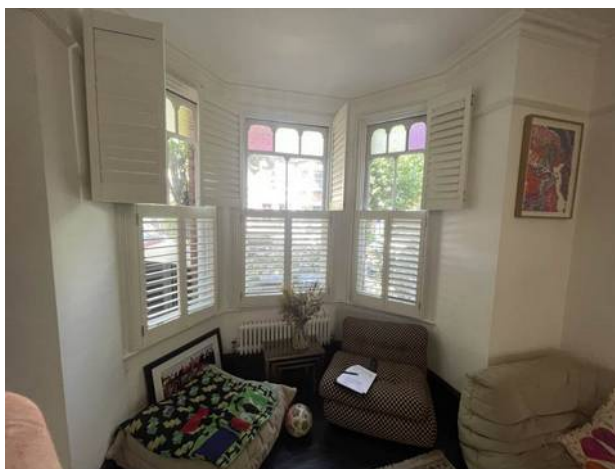
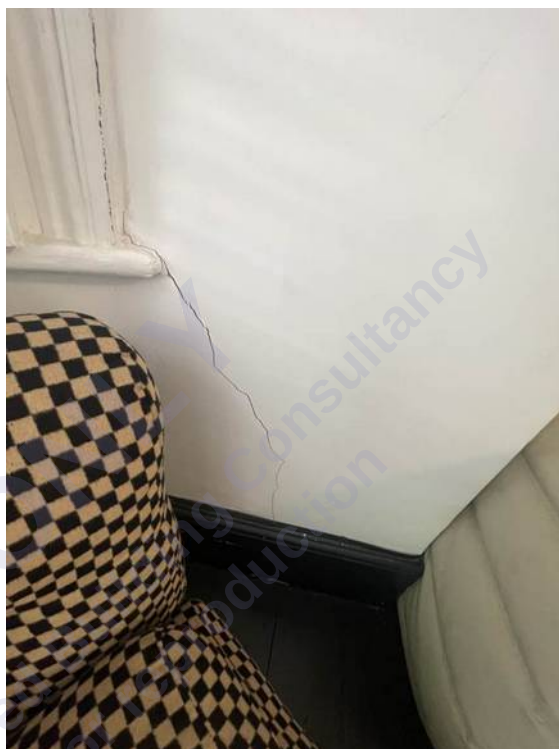
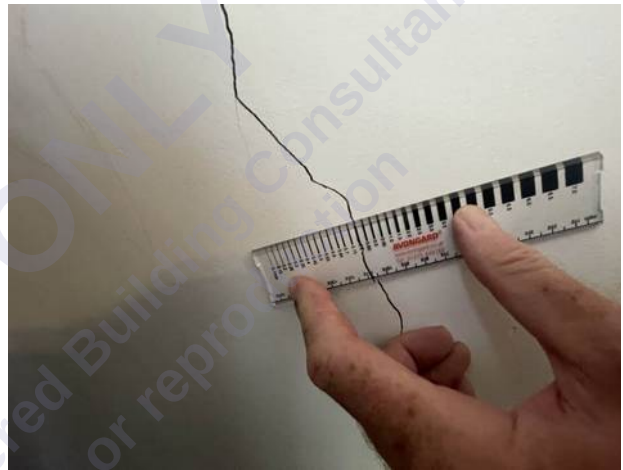
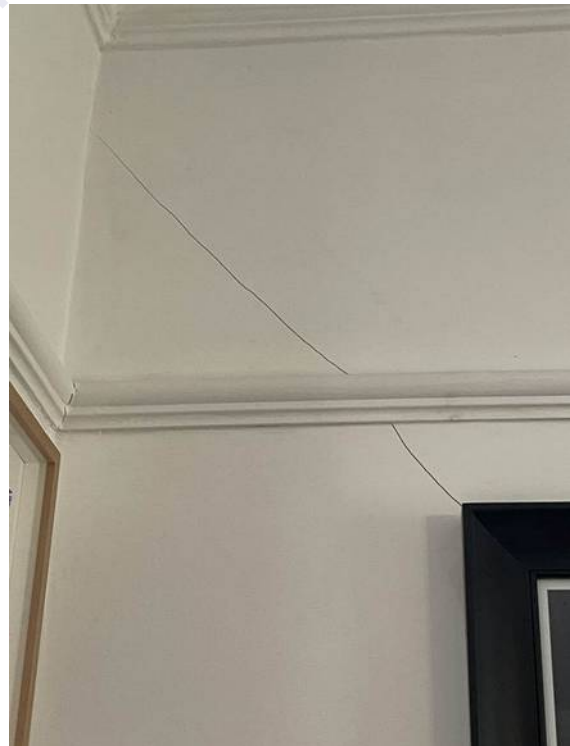
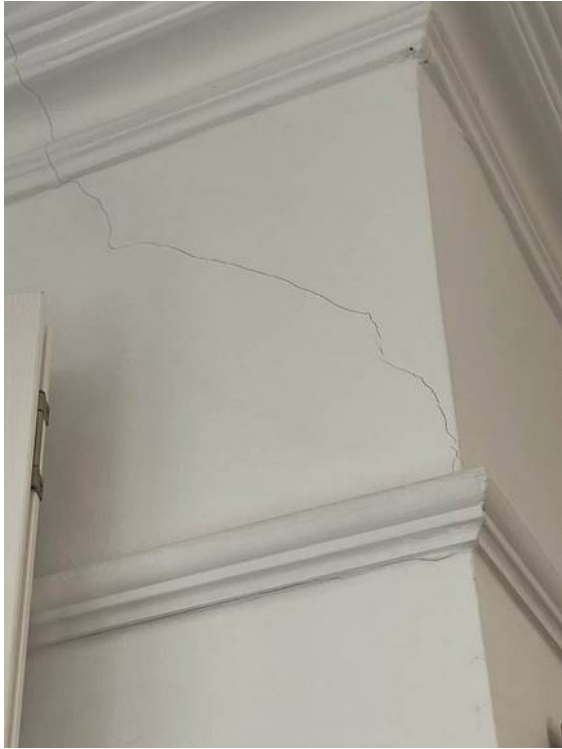
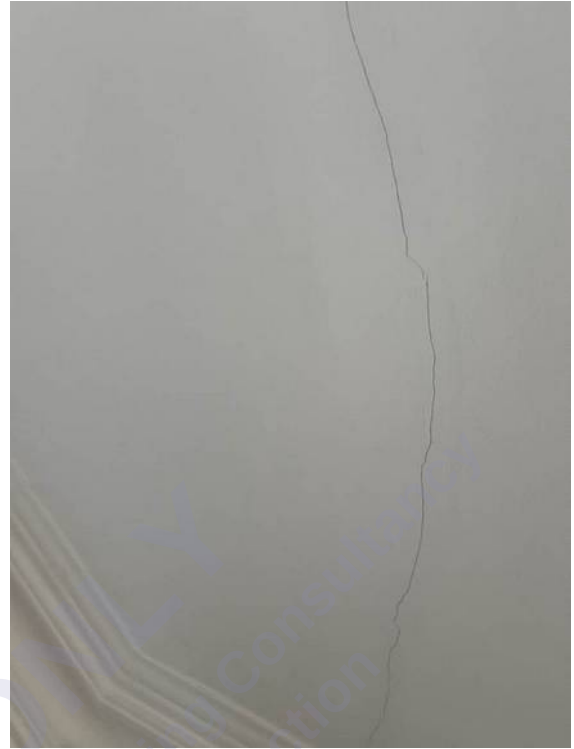
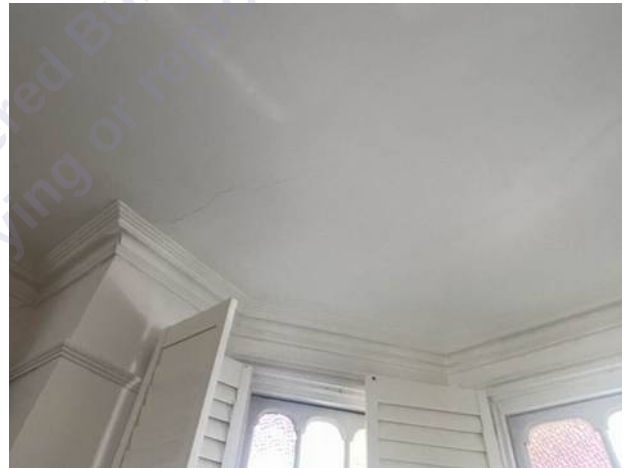
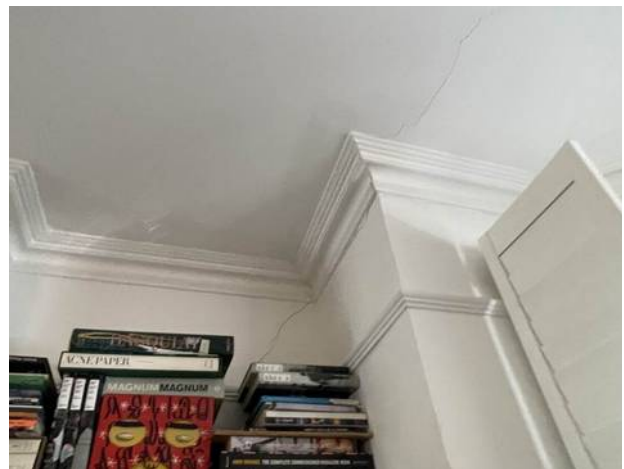
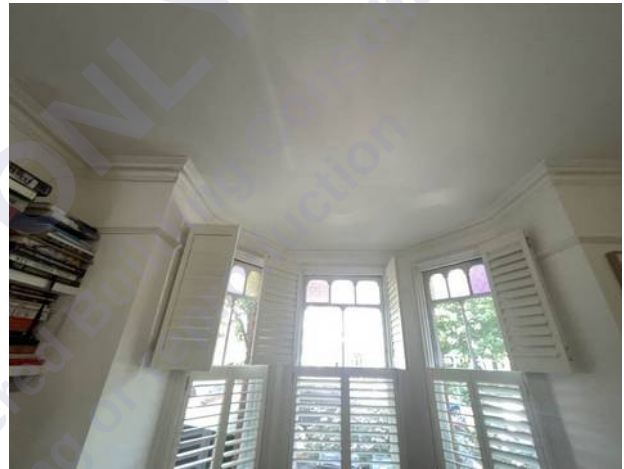
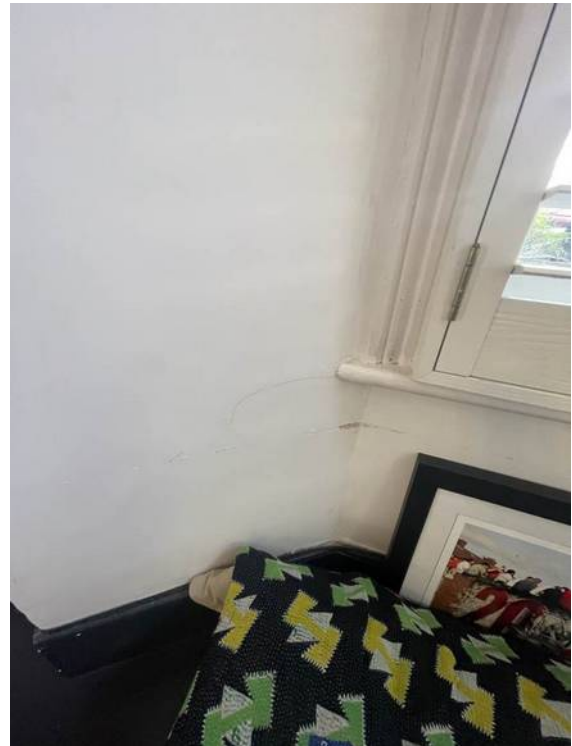
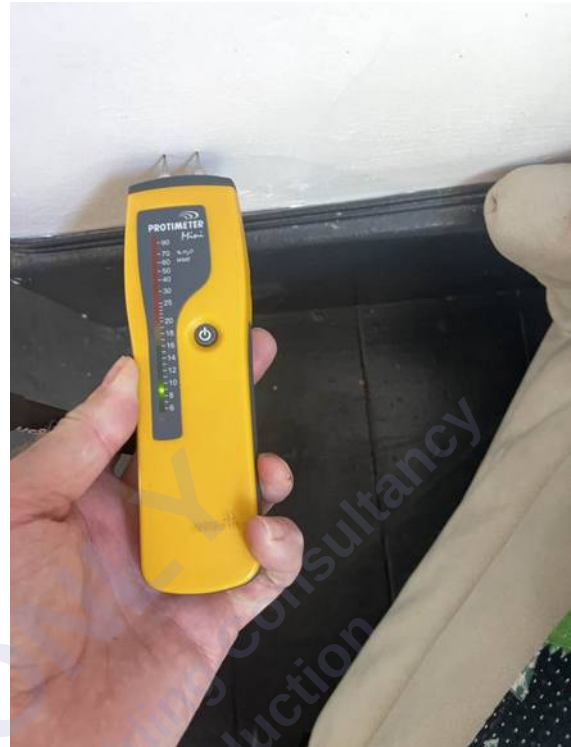
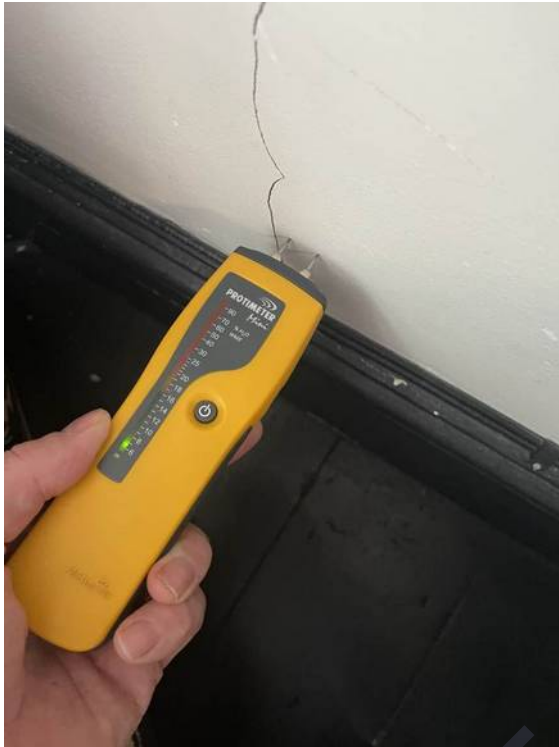
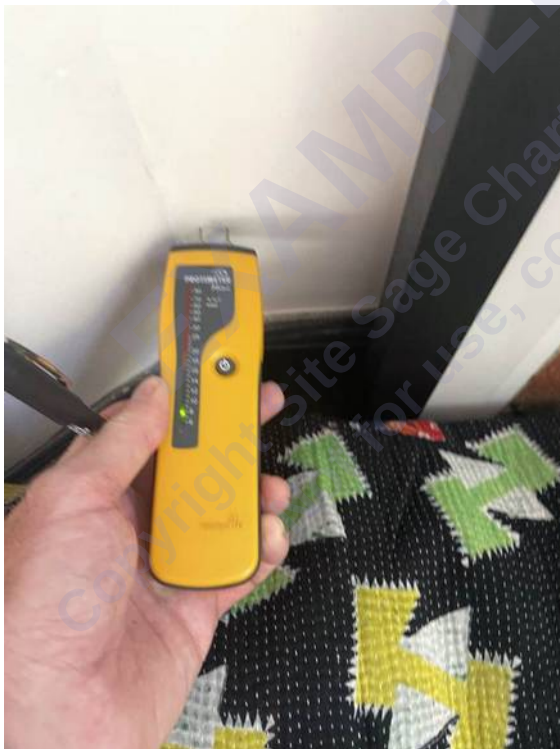
## A6 — Internal: Ground Floor Bay Window to Lounge

| No. | Location & description | Int/Ext | Direction/character | Width | BRE Cat. | At opening? |
|---|---|---|---|---|---|---|
| 2 | Internal — ground floor lounge bay, bottom right-hand corner of window (viewed from inside) | Int | Tapered | 1.5–3mm | 2 | Yes — off cill corner |

Internal, ground floor lounge bay: Cracks 1 and 2 radiating from the corners of the window cill — the weakest points — with widths of 1.5–3mm (BRE Category 2; the crack gauge photographs record the measured widths in millimetres). Damp meter readings taken at the base of the bay were dry (readings of zero).
