## BUILDING DEFECT DIAGNOSIS REPORT

Reported Cracking — Principally the Front Bay Windows; also Outrigger & Rear Floor

24 Example Road, London E5 0AA

Date of inspection: 16 July 2026 | Date of report: 16 July 2026 | Report ref: EXAMPLE

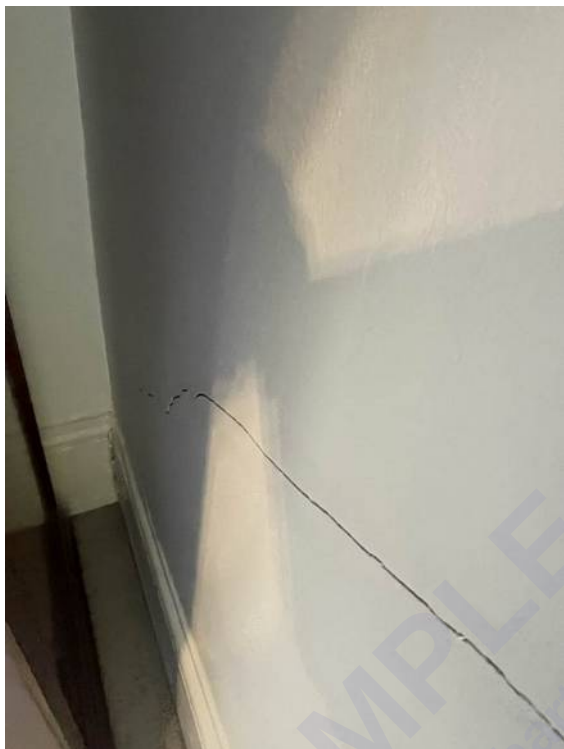
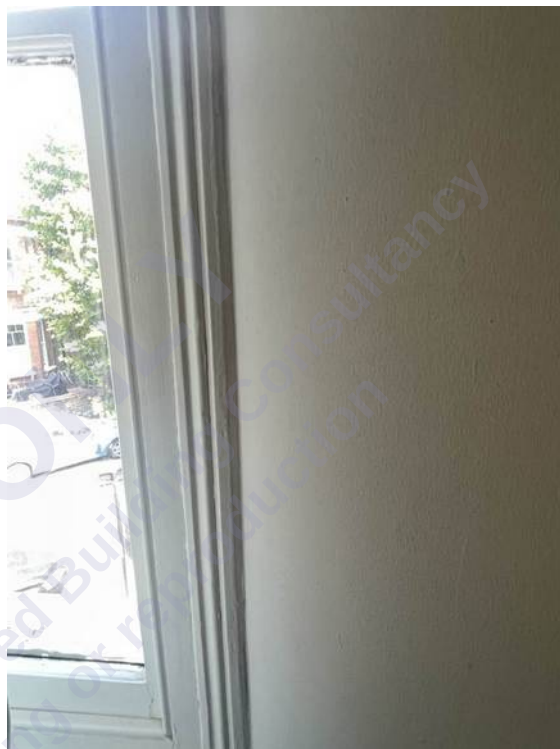
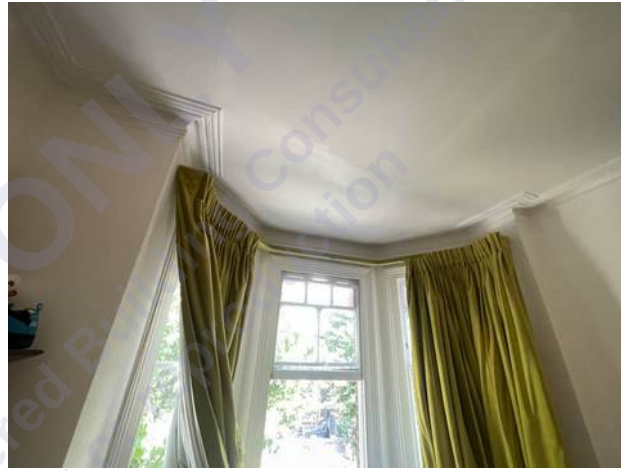
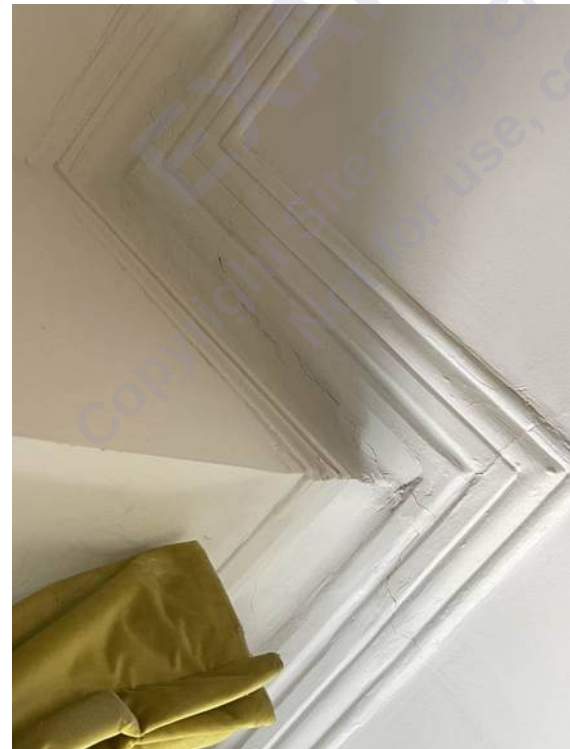
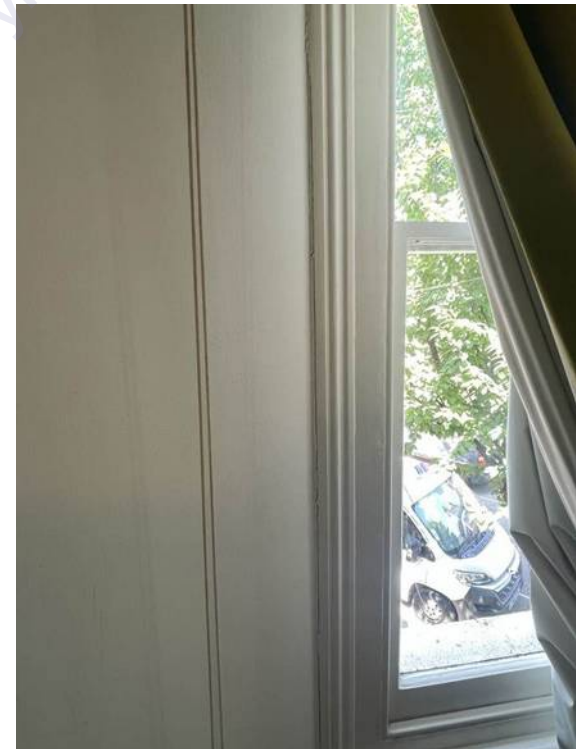
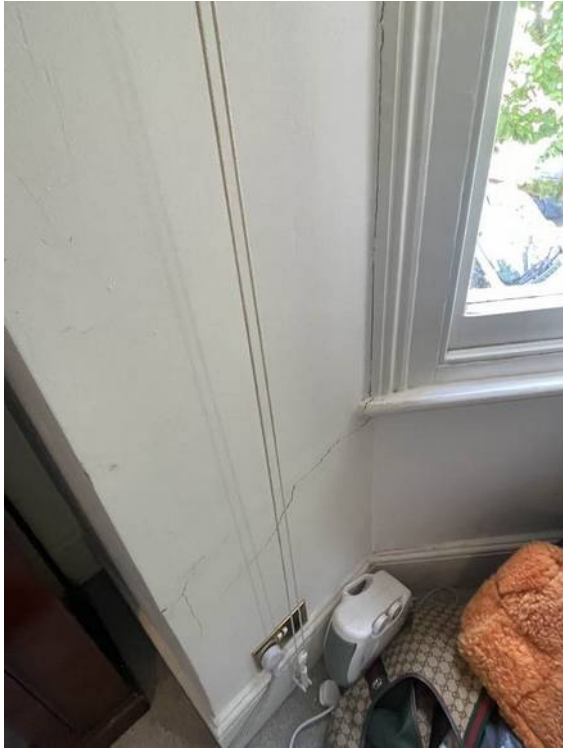
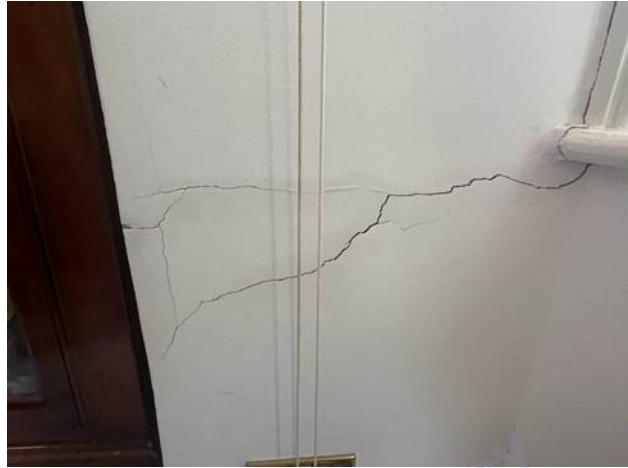
## A7 — Internal: First Floor Bay Window to Master Bedroom

| No. | Location & description | Int/Ext | Direction/character | Width | BRE Cat. | At opening? |
|---|---|---|---|---|---|---|
| 3 | First floor front — across the ceiling by the bay window, diagonal in character | Int | Diagonal, tapered | Hairline–1mm | 1–2 | Near opening |
| 4 | First floor — top right-hand side of bay to main wall, running to the party wall and returning along the party wall | Int | Tapered | Hairline–1mm | 1–2 | No |
| 5 | First floor — top left-hand side above bay, main wall to party wall through the cornice; horizontal across the bay, diagonal at the party wall | Int | Horizontal/diagonal, tapered | Hairline–2mm | 2 | No |
| 6 | First floor front bedroom — hairline crack across ceiling at bay window, extending through the corners | Int | Hairline | Hairline | 0–1 | Corners of bay |
| 7 | First floor front bedroom — nib at bottom left-hand side of bay: cracks rising diagonally to the left-hand side and returning to the party wall; horizontal and diagonal in character | Int | Horizontal/diagonal, tapered | Up to 1.5mm | 2 | Bay nib |

Internal, first floor master bedroom bay: Cracks 3–7, including the hairline ceiling crack extending through the corners of the bay, the tapered cracks to the top left- and right-hand sides returning to the party wall (hairline to 2mm), and the diagonal cracking at the bay nib (up to 1.5mm). The cracking at this level is wider on the right-hand side — the opposite side to the ground floor crack — which may indicate tree-root related differential movement acting in combination with the other factors identified in this report.

Structural repair should follow, not precede, the monitoring and investigation. If monitoring shows movement has stabilised (for example following drainage repair and/or tree management by the council), repair is likely to comprise crack stitching/repair and redecoration rather than underpinning. The outrigger junction crack and minor cracking may simply be filled and decorated, accepting that fine seasonal cracks may reappear. Repointing is required in isolated areas around the rear bay, and the minor external defects observed around the front bay (cracking to the window surrounds and minor pointing defects) should be made good at the same time as the crack repairs. The works should be undertaken by a suitably competent contractor experienced in this type of repair. The contractor should inspect the property, verify dimensions and site conditions, and provide a fixed quotation before works commence.

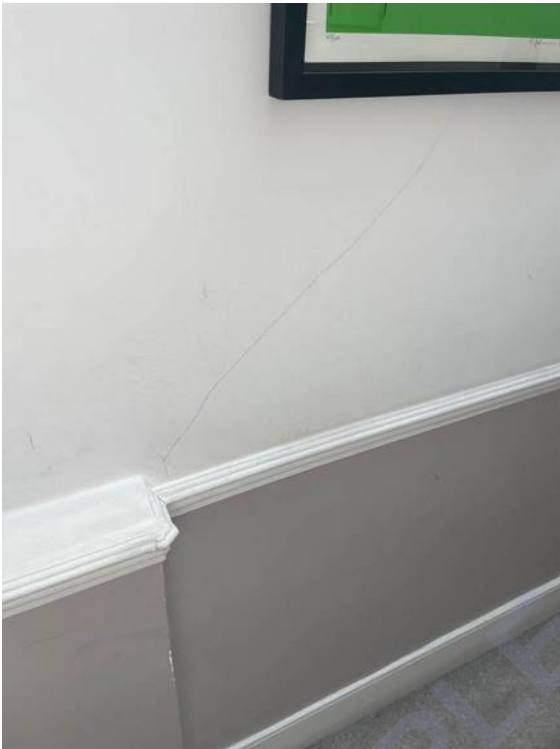
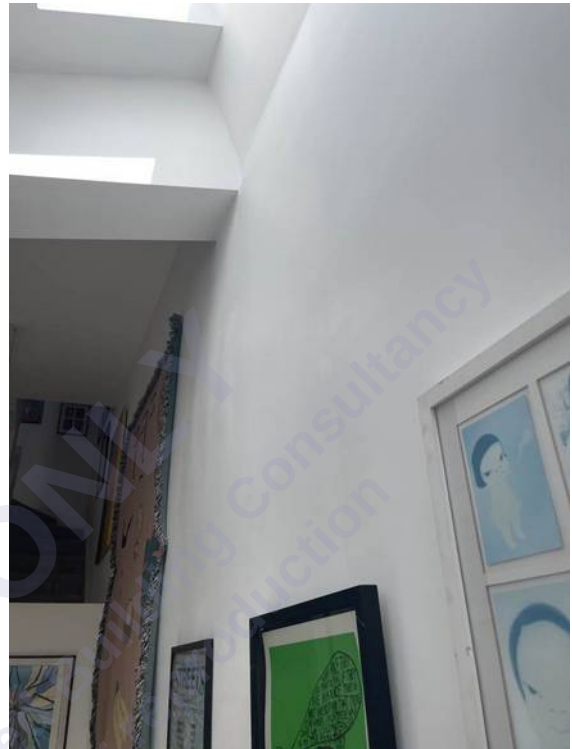
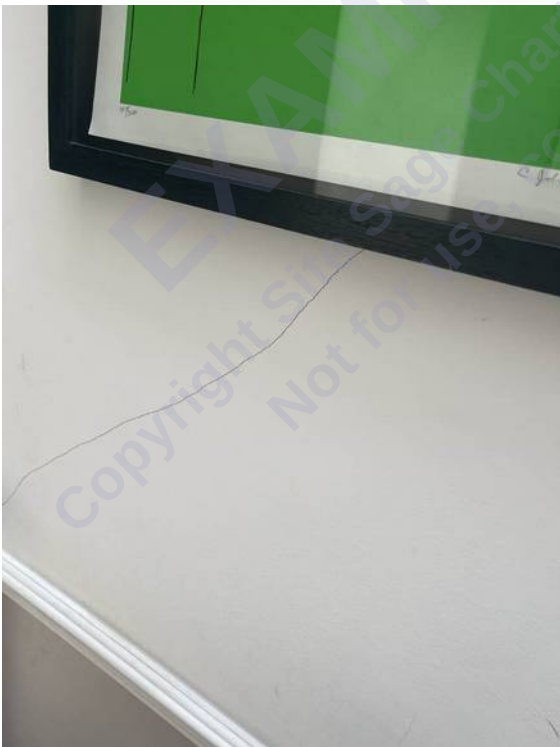
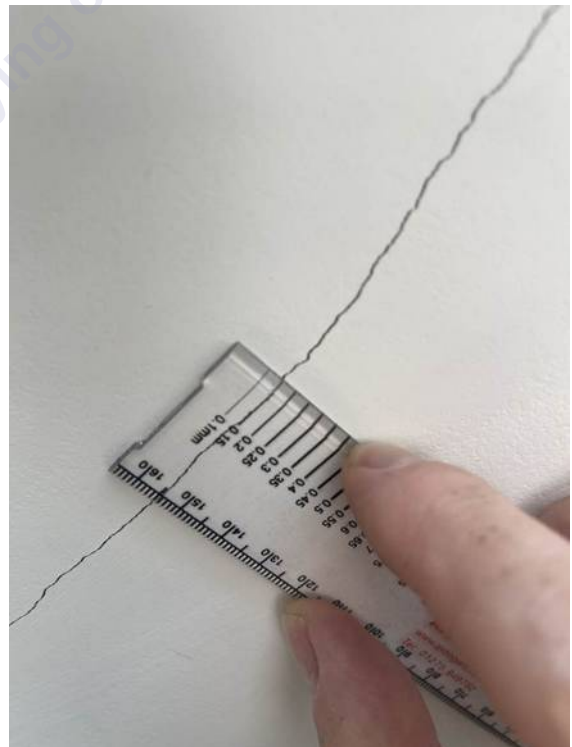
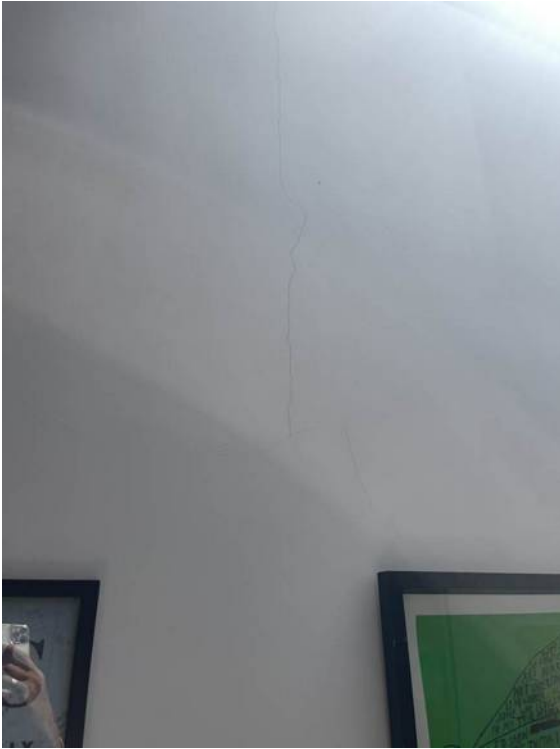
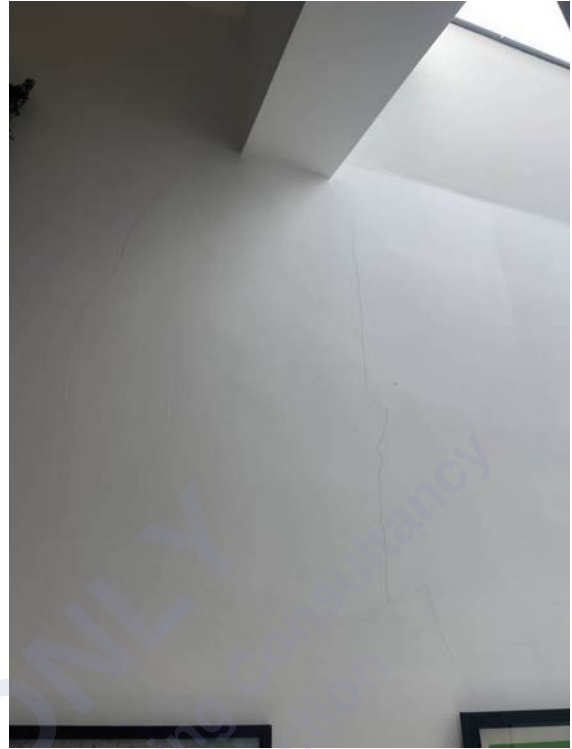
## A8 — Internal: First Floor Junction of Outrigger and Main House

| No. | Location & description | Int/Ext | Direction/character | Width | BRE Cat. | At opening? |
|---|---|---|---|---|---|---|
| 8 | Middle of house — junction of outrigger and main building (split-level landing) | Int | Vertical | Hairline | 0–1 | No — junction crack |

The hairline vertical crack at the junction of the outrigger and the main house is a common and well-understood feature of Victorian terraces. The rear outrigger is typically built off shallower footings than the taller main house, and the junction acts as a natural stress-relief line between two elements of differing height, stiffness and foundation depth, which move at slightly different rates with seasonal thermal and moisture cycles. This crack is superficial and aesthetic only: it can be filled and decorated over if it bothers the owners, and it is likely to reappear between seasons. It does not represent a structural problem requiring attention.

Internal, first floor landing: Crack 8 — a hairline vertical crack at the junction of the outrigger and the main house; a superficial, seasonal feature typical of this form of construction, requiring decoration only.

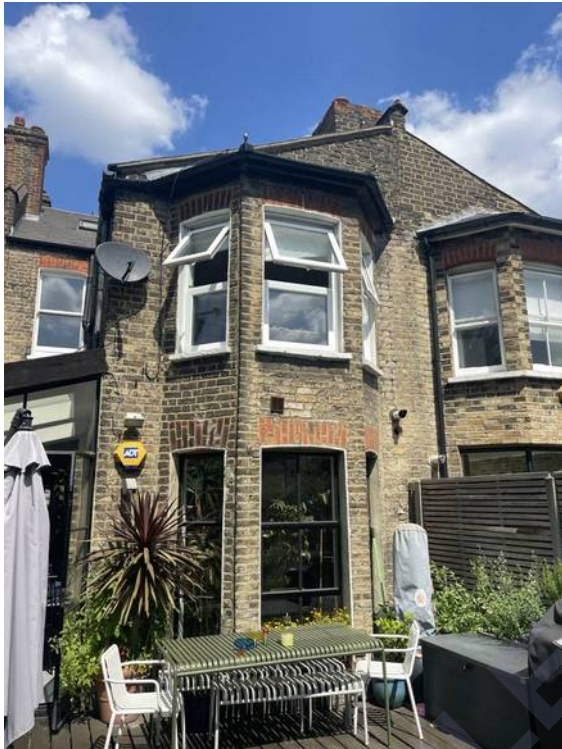
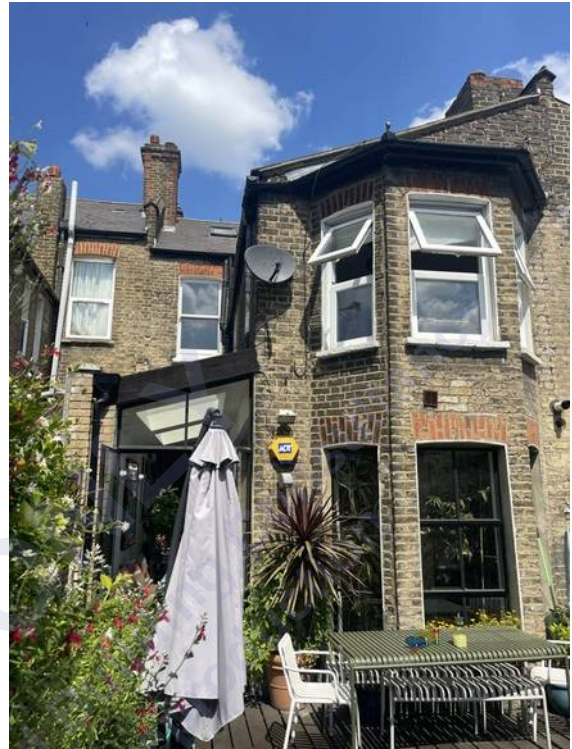
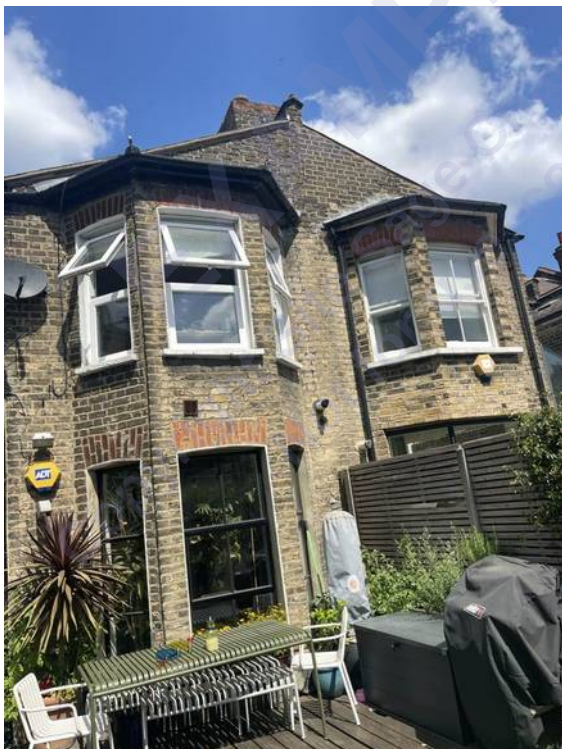
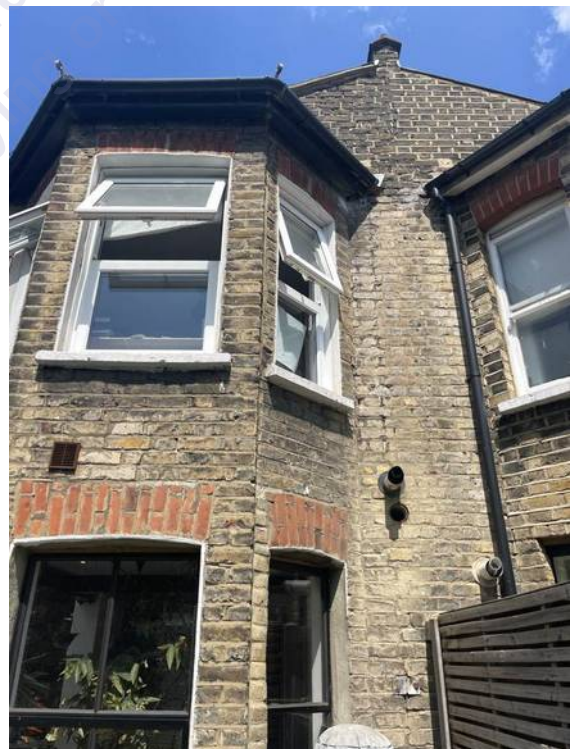
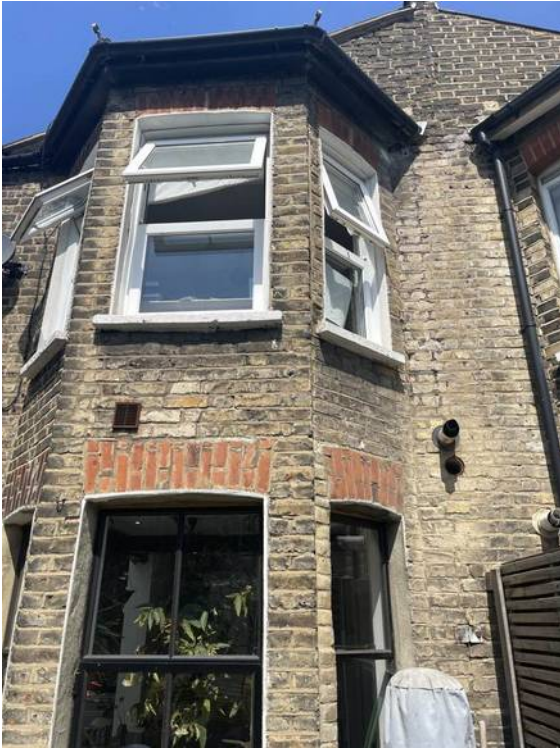
## A9 — External: Rear Bay Window

The rear bay window shows no significant cracking internally or externally, save for very fine historic hairline marks; repointing is required in isolated areas around the rear bay. The junction crack between the outrigger and main house (crack 8) is a hairline, vertical crack of superficial character.

External, rear bay: no significant cracking internally or externally, save for very fine historic hairline marks. Repointing is required in isolated areas around the rear bay.

| Item | Description | Indicative budget (£) |
|---|---|---|
| 4 | Repointing in isolated areas around rear bay | £300 – £600 |

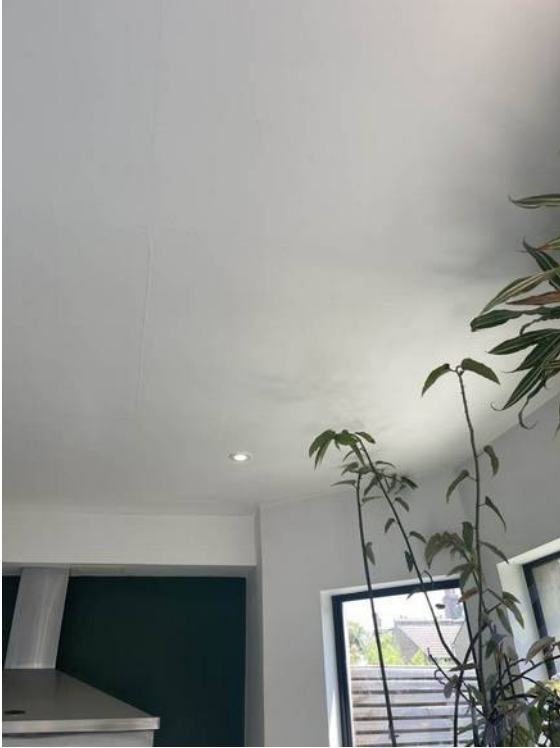
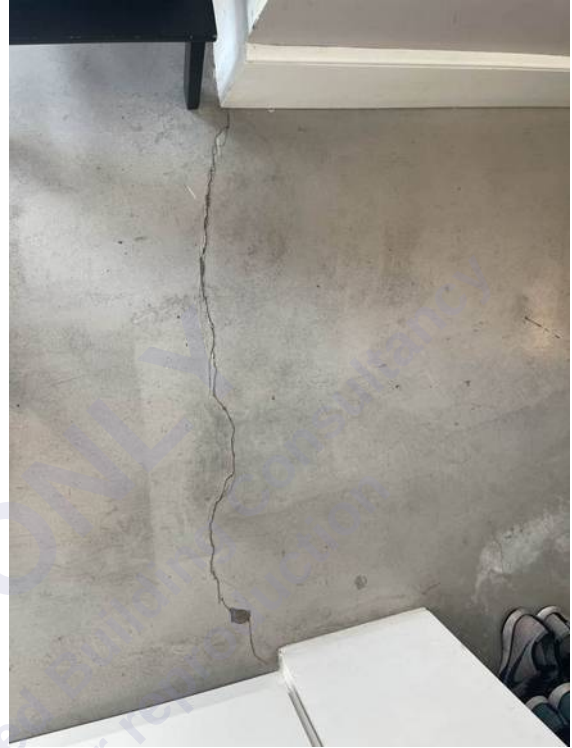
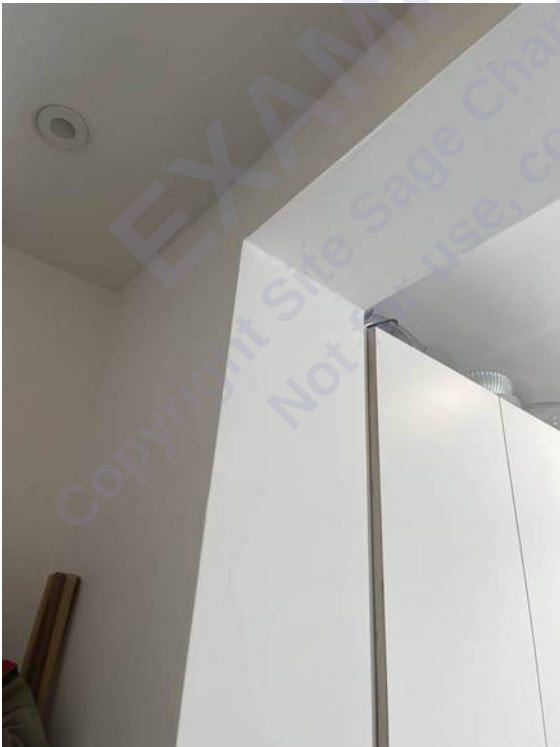
## A10 — Ground Floor Hall / Kitchen Floor Junction

The slight differential movement at the ground floor threshold between the original suspended timber floor and the solid floor of the rear extension reflects normal differential behaviour between the two floor constructions and is unrelated to the movement at the front bay.

The ground floor threshold between the hall/kitchen (original suspended timber floor) and the rear extension (solid floor): slight differential movement between the two floor constructions, unrelated to the movement at the front bay.
