## COMMERCIAL BUILDING SURVEY

1 & 2 Sample Parade  
Sampleton  
Sampletown  
Essex  
XX1 1XX

Prepared by  
Dennis Brett MCIOB FFPWS LCGI MPTS  
Site Sage Chartered Building Consultancy

Inspection Date  
5 March 2026

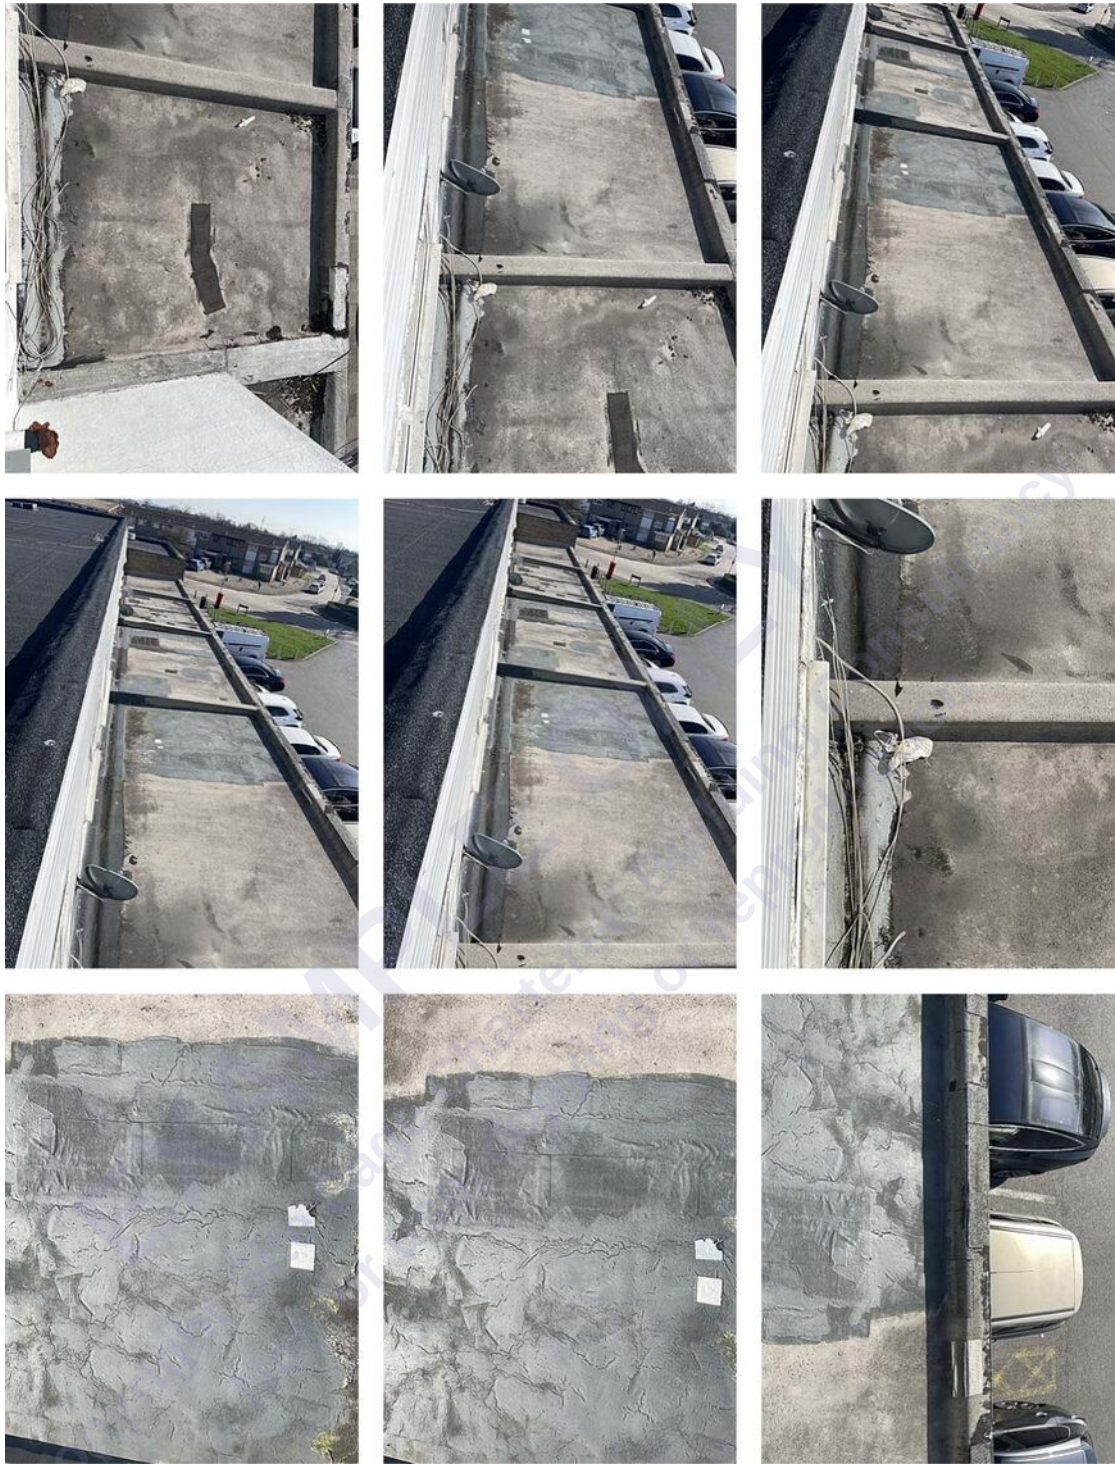
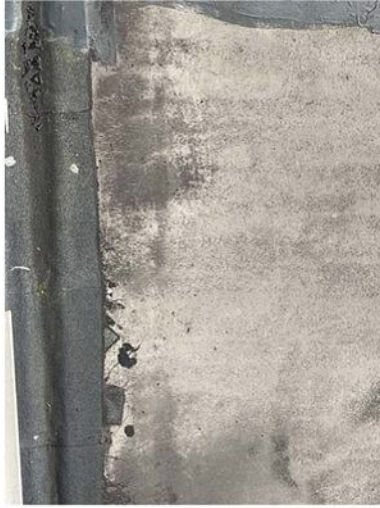
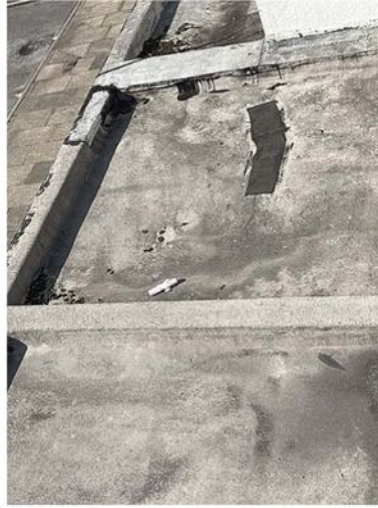
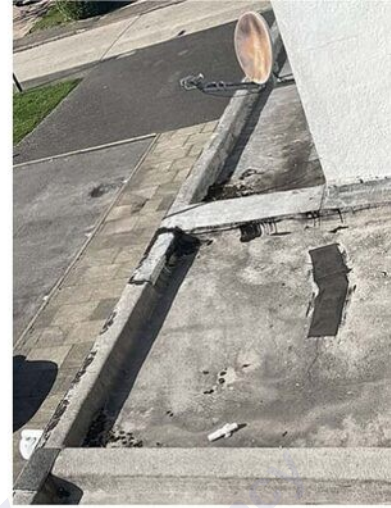
# Appendix B – Flat Roof Over Entrance to Ground Floor Commercial Unit

The asphalt roof forming the canopy above the front entrance is **in poor condition and leaking at the junction with the shop signage.**

Minor leakage occurs during heavy rainfall due to defects to the canopy roof covering.

Replacement of the roof covering is recommended.

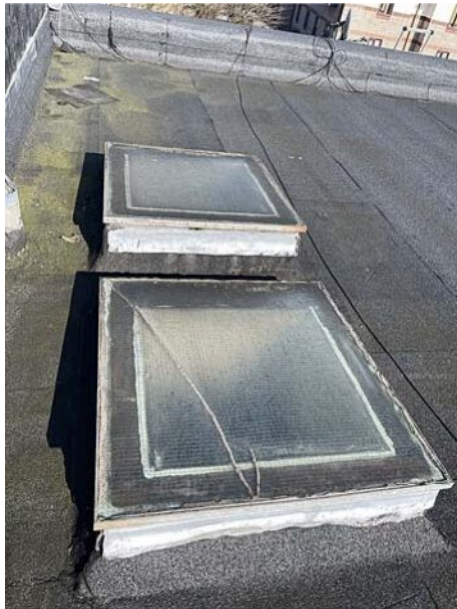
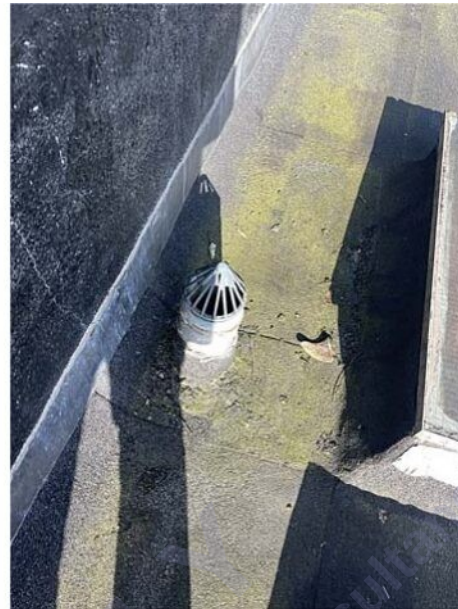
# Appendix E – Main Flat Roof Over HMO

The main roof covering serving the HMO accommodation comprises a **flat felt roof covering**.

The roof appears to have been **recently renewed** and was reported by the seller to be subject to a warranty.

No significant defects were observed.

The client's solicitor should request **confirmation of any roof warranty documentation**.

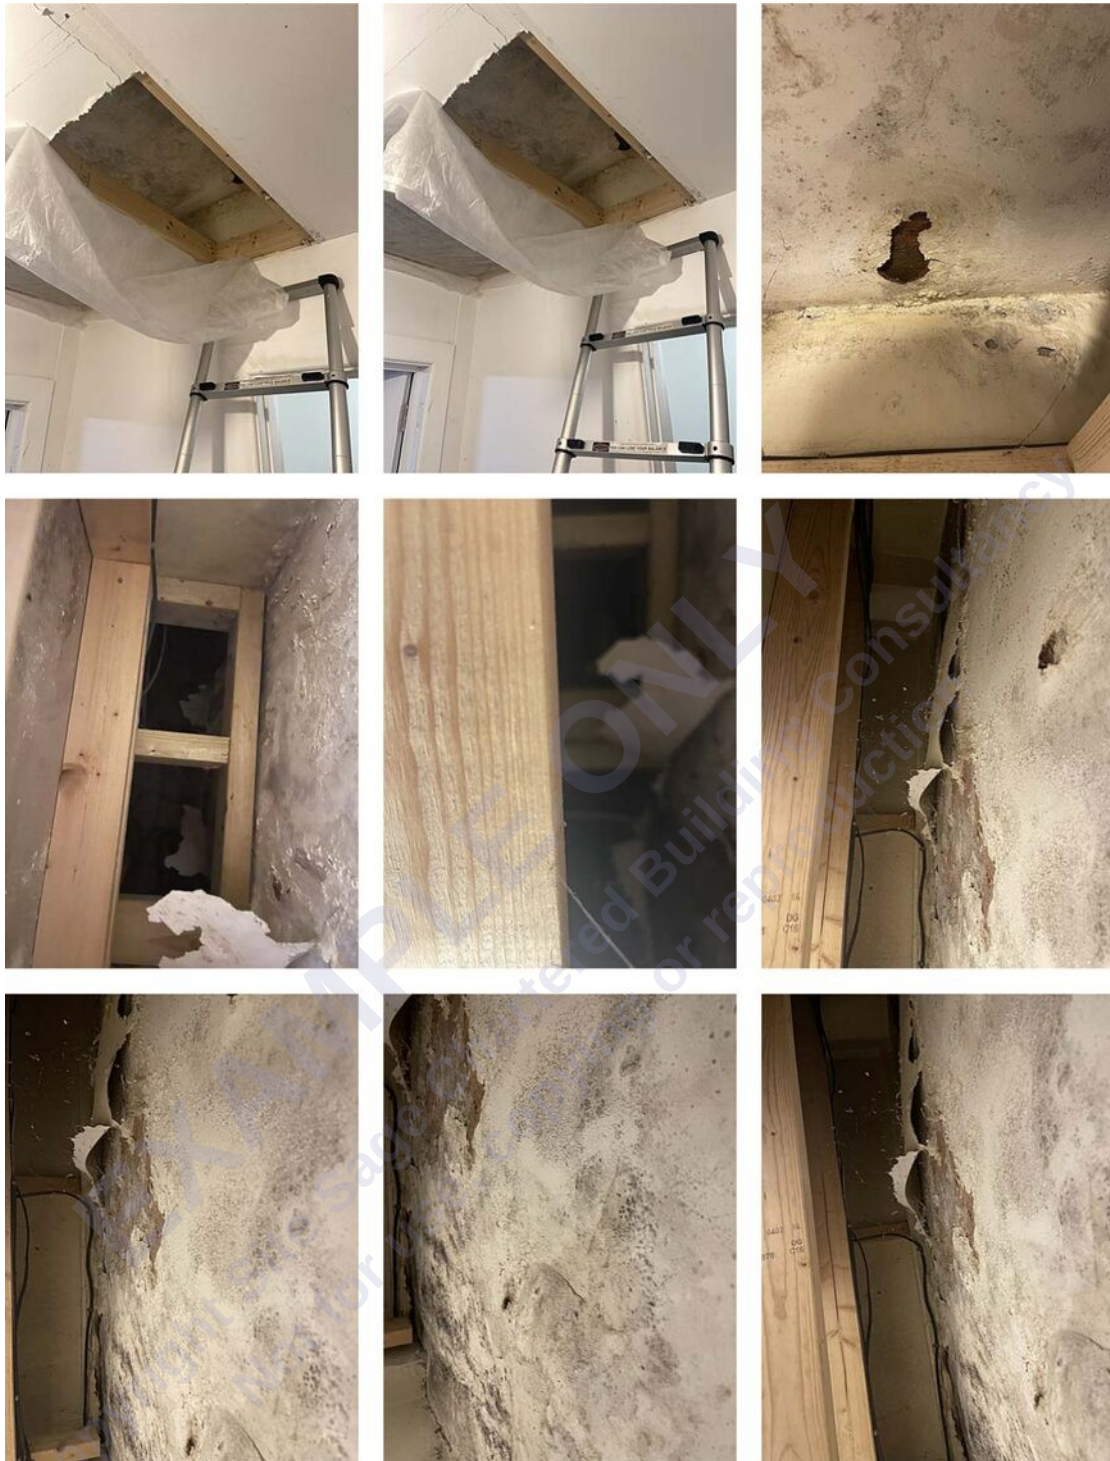
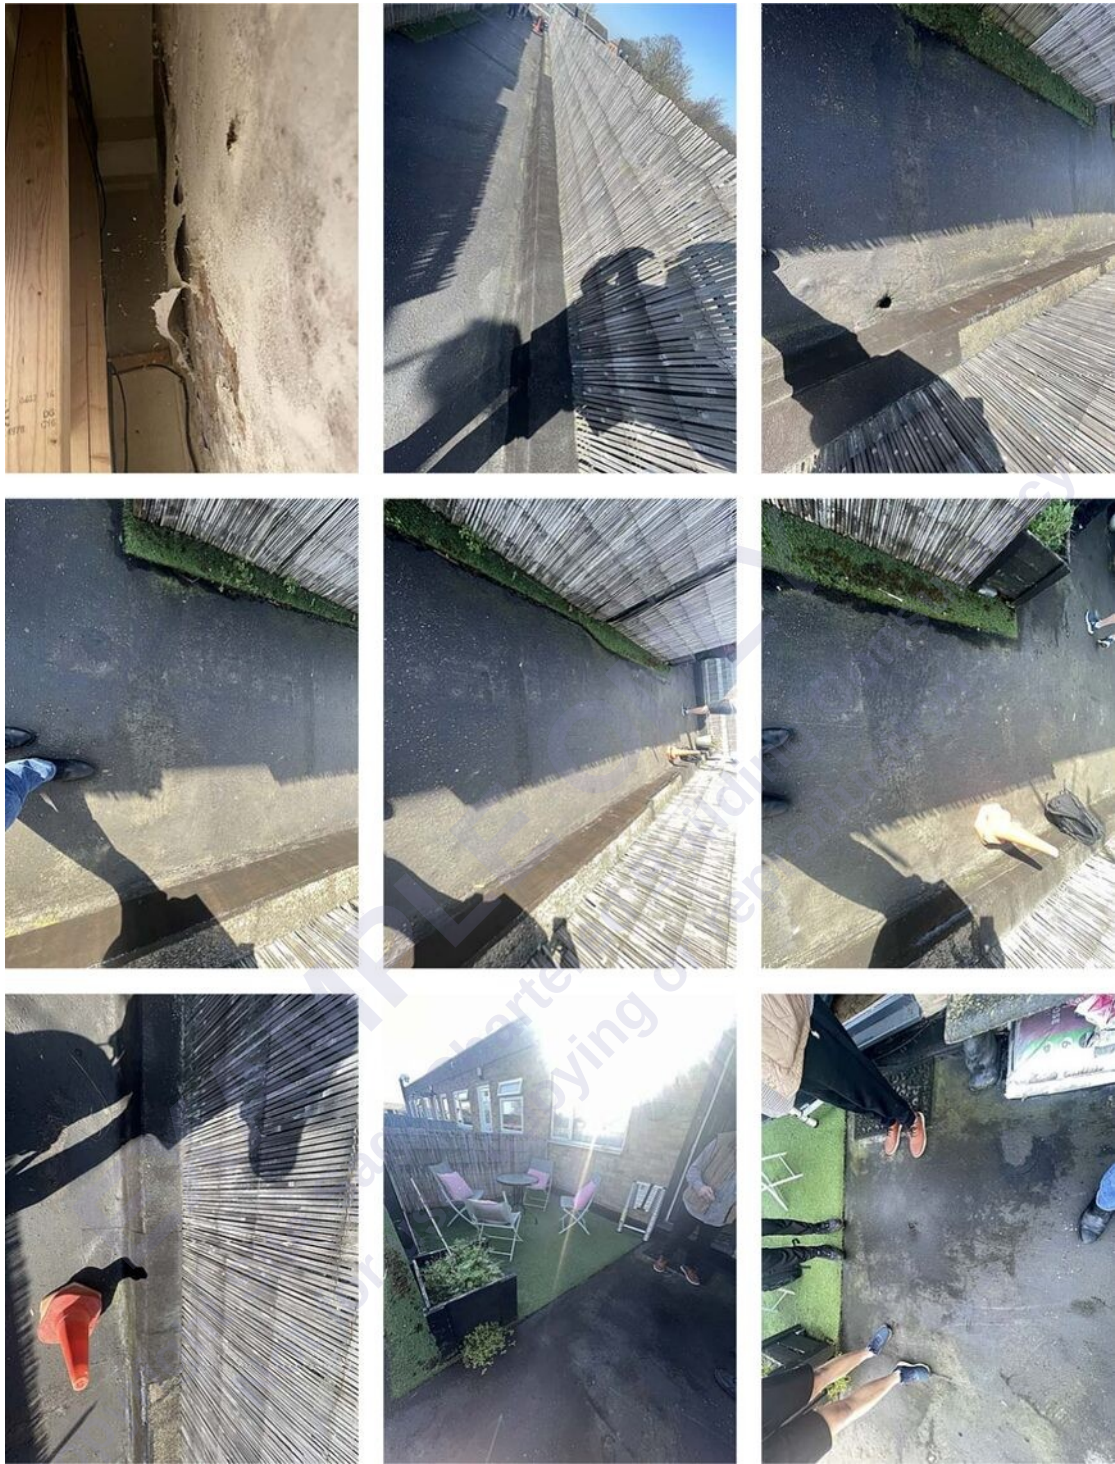
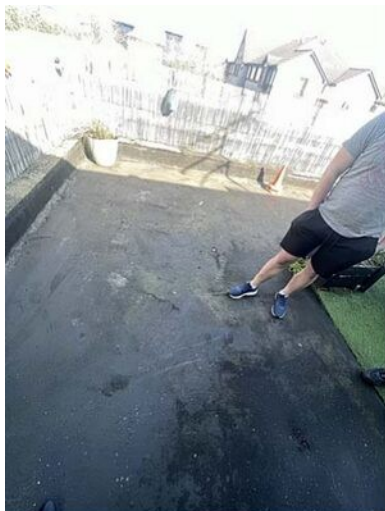
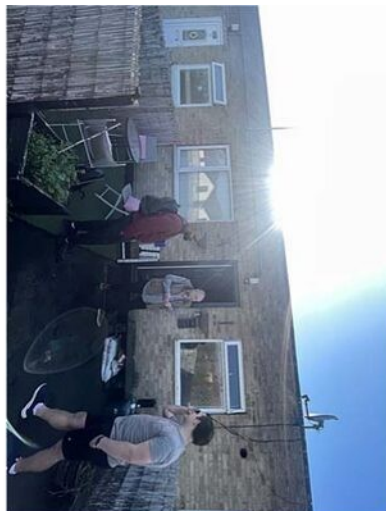
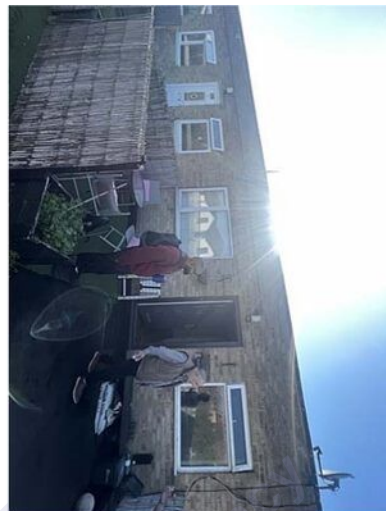
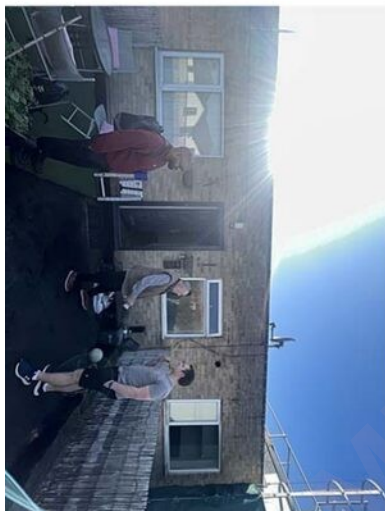
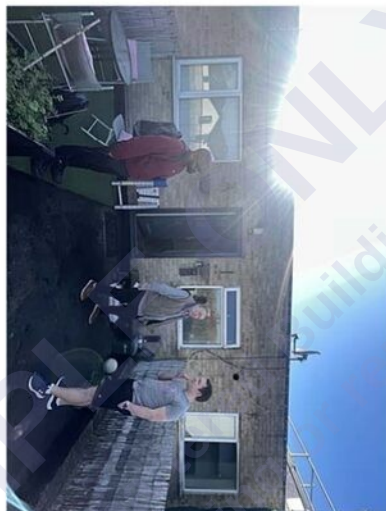
# Appendix I – Rear Flat Roof Covering Ground Floor Rear Hall and Pathway

The asphalt roof above the rear hallway is **defective and leaking**.

The ceiling below is **saturated with mould growth present**.

The asphalt pathway providing access to the HMO also forms a **roof structure below and is leaking**, cross-referenced with Section 19.

Water ingress was observed to the hallway ceiling caused by the defective roof covering above.

In my opinion the roof requires **complete replacement**.
