## SCHEDULE OF CONDITION

**Sample Industrial Estate**  
**Units 2F, 2G & 2H**  
**1 Sample Way, Sampleton, Essex XX1 1XX**

**Client:** Sample Trading Limited (Mr A Sample)  
**Surveyor:** Dennis Brett MCIQB FFPWS LCGI MPTS  
**Date of Inspection:** 16 January 2026  
**Time:** 10:30am

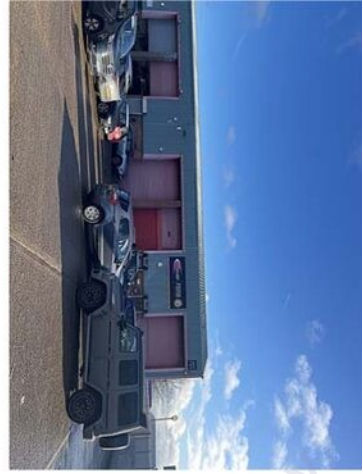
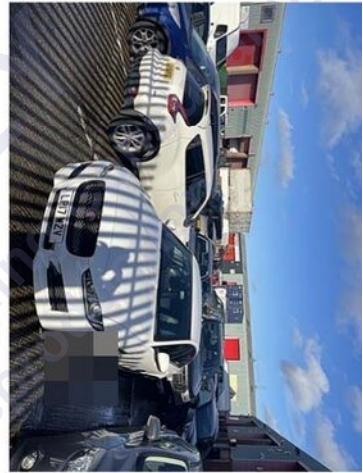
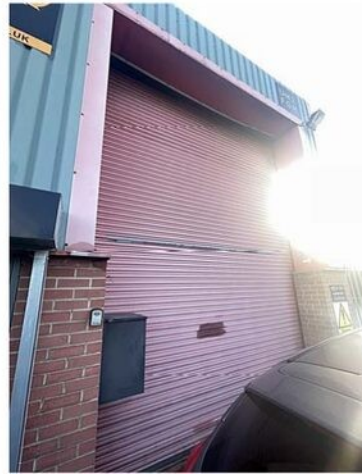
## Appendix B – External Front Elevation

Brickwork to lower level with metal cladding above. General wear and tear noted with localised discolouration and paint loss.

Redundant fixing holes noted. Diagonal crack through approximately five courses of brickwork to brick pier dividing Unit G.

Generally serviceable. Localised paint loss and wear consistent with use.

Photographs showing front elevation including brickwork, metal cladding, roller shutter doors, signage, and forecourt parking.

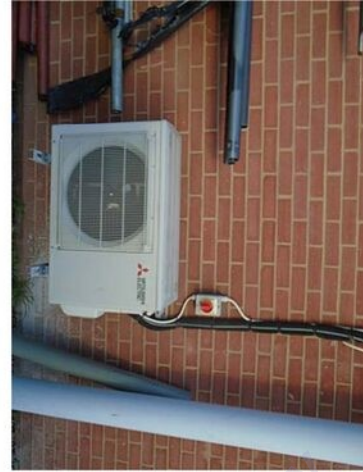
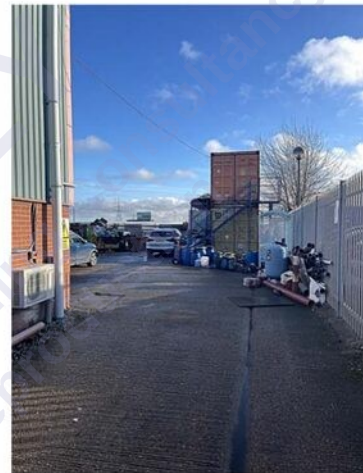
## Appendix C – External Side Elevation

Metal cladding in fair condition with general weathering.

Vehicle access gate present and operational with minor resistance noted.

Concrete surfacing showing general wear and isolated hairline cracking.

Photographs showing side elevation including metal cladding, vehicle access gate, concrete hardstanding, and external services.

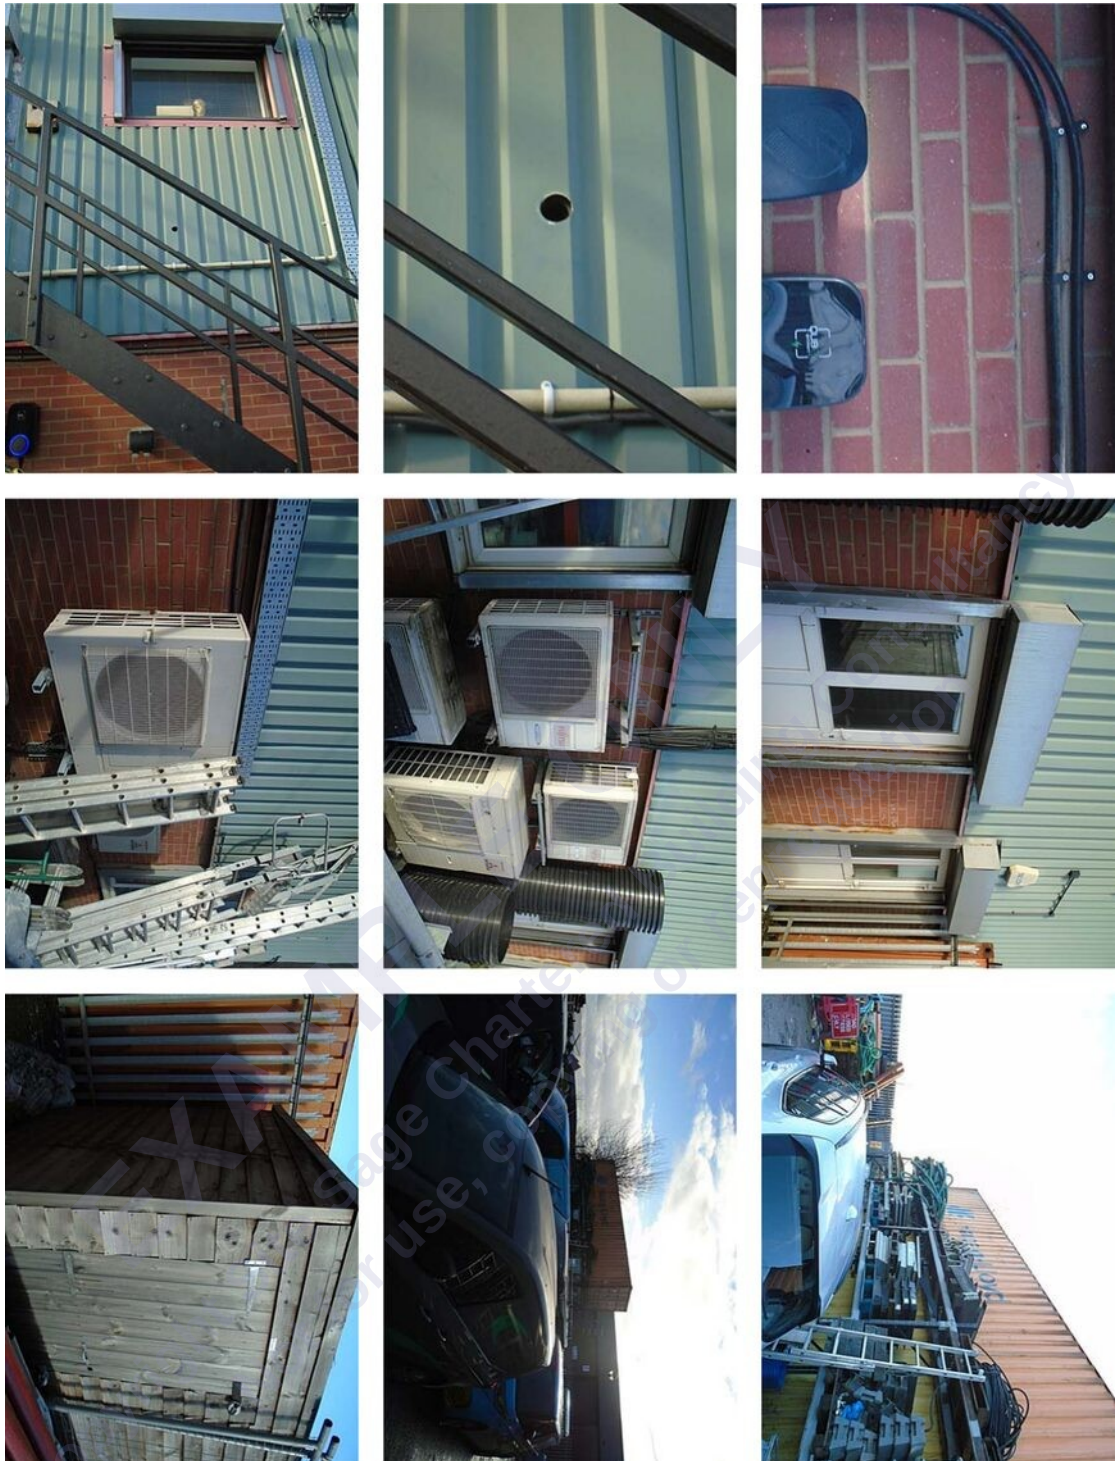
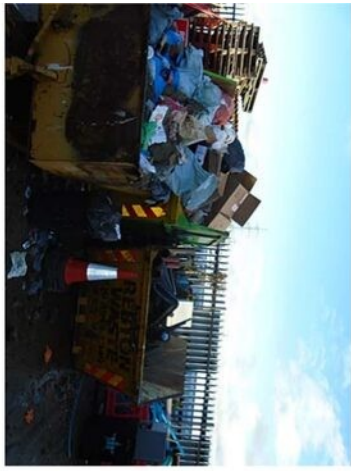
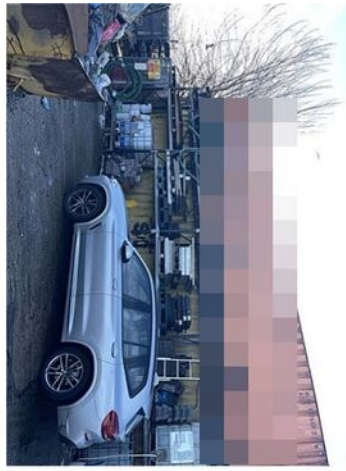
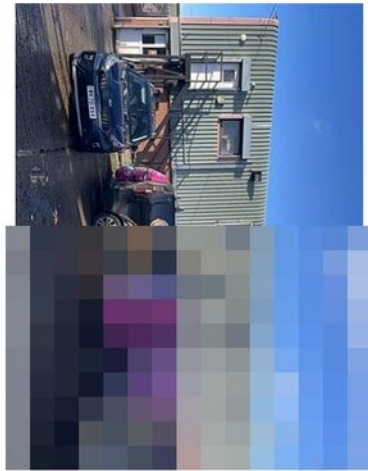
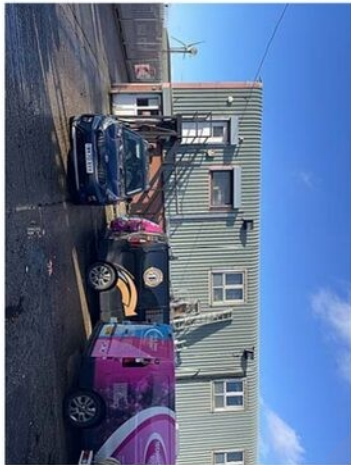
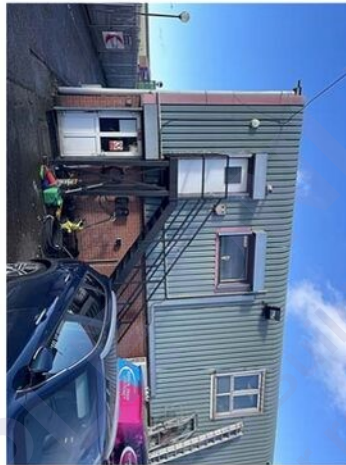
## Appendix D – External Rear Elevation

Localised damage approximately 75mm wide beneath rear window adjacent to staircase.

External metal staircase to first floor. Appeared secure and serviceable.

Photographs showing rear elevation including brickwork, metal cladding, external staircase, staff-only rear access doors, lighting, and rear yard.

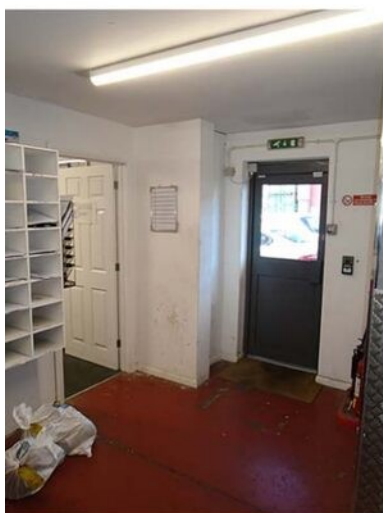
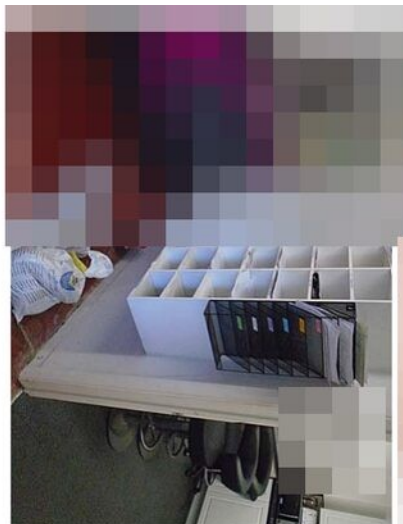
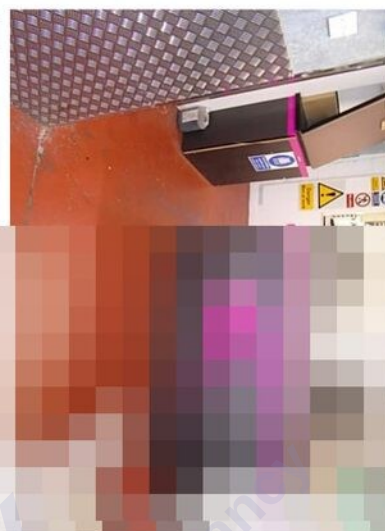
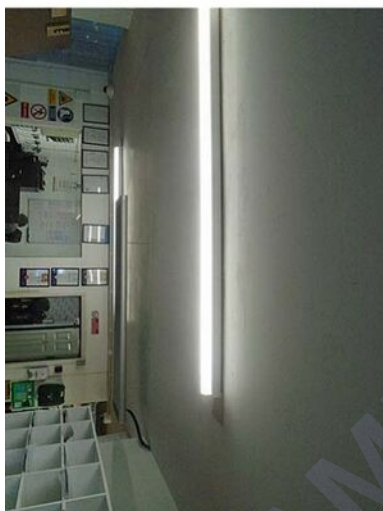
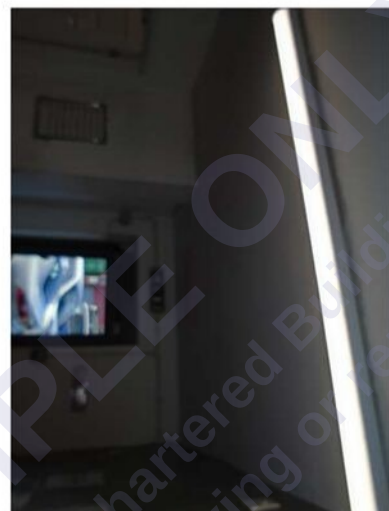
## Appendix E – Reception Area

Plastered and painted with evidence of historic water staining and flaking paint.

Heavily marked and stained. Structurally sound.

Painted concrete floor with areas of paint loss and wear.

Wear and chipping to front edge.

Photographs showing reception area finishes, ceiling condition, floor wear, and reception desk.

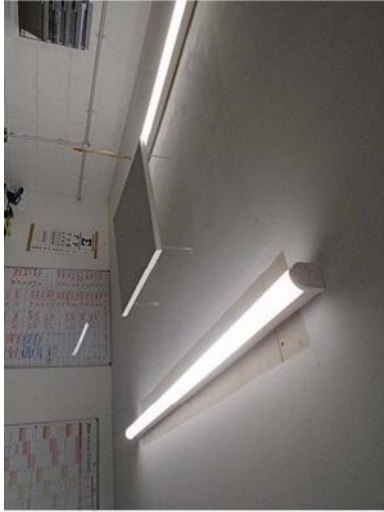
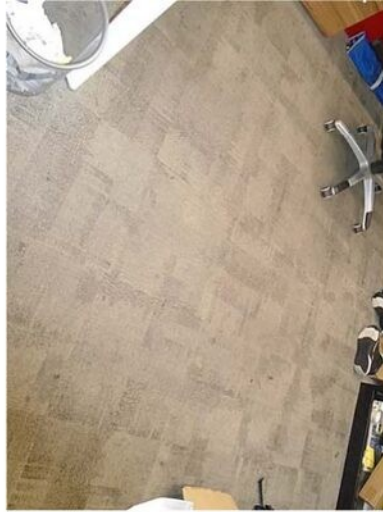
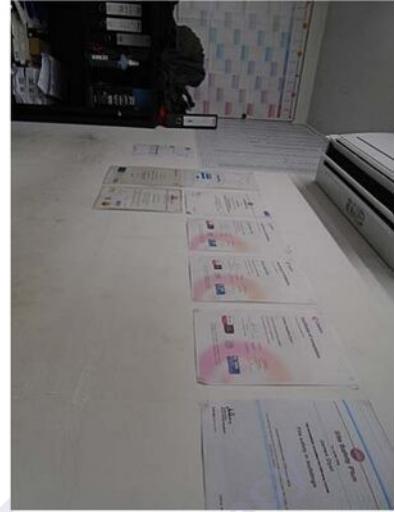
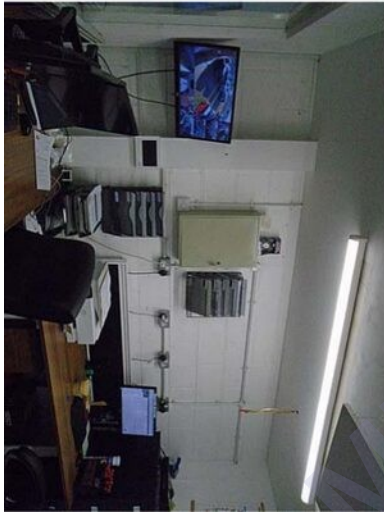
## Appendix F – Office Behind Reception Area

Poor decorative finish with patching from previous fittings.

Numerous marks and heavy wear.

Carpet tiles heavily stained and worn.

Glazed panels and door to front elevation. No obvious defects noted.

Photographs showing carpet tiles, wall finishes, ceiling condition, and glazed panels.

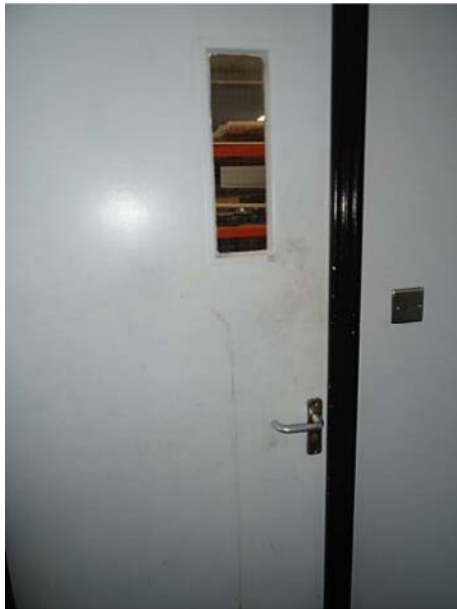
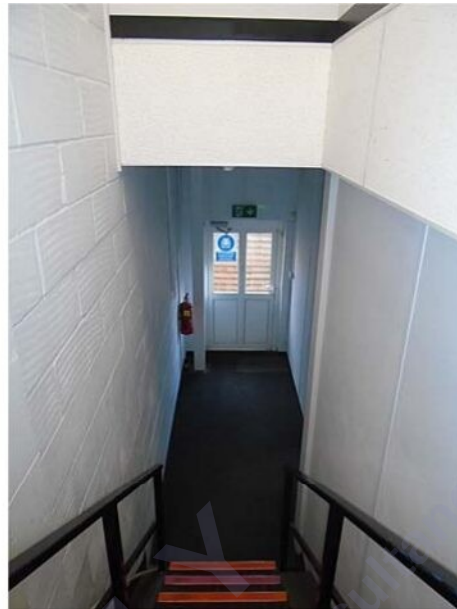
## Appendix G – Stair Base / Ground Floor Access Area

Suspended ceiling in generally good condition.

Painted blockwork forming party wall.

Door to warehouse shows wear and missing cover plate to handle.

Photographs showing stair base, suspended ceiling, walls, and access doors.

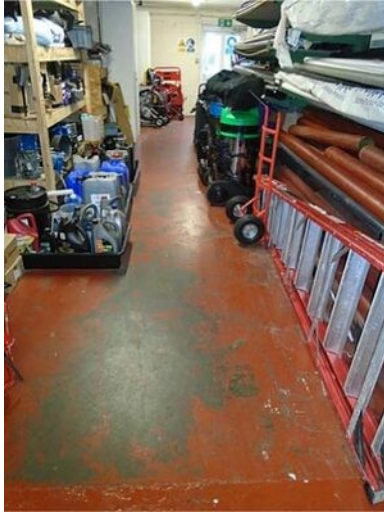
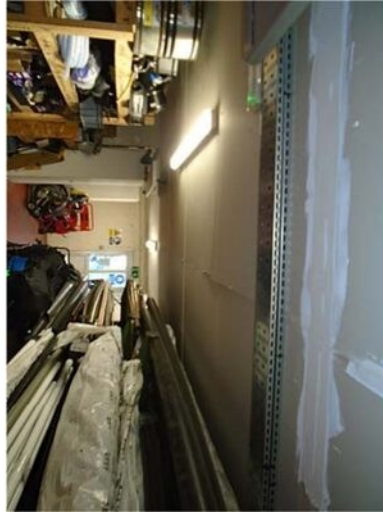
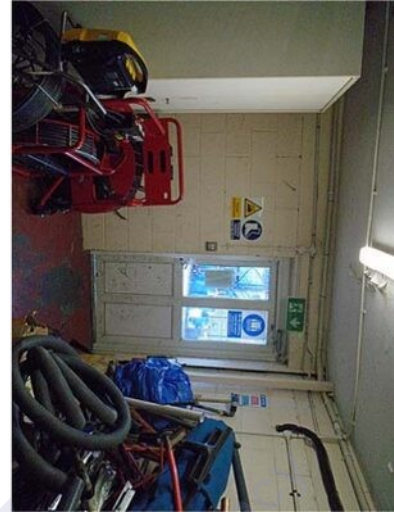
## Appendix H – Ground Floor Lobby / Storage Area (Between Office and Rear Exit Door)

Painted red concrete floor showing heavy wear.

Painted surfaces with scuffing consistent with storage use.

Plasterboard ceiling with unfinished decorative finish and wear.

Photographs showing red painted concrete floor with heavy wear, storage racking, unfinished ceiling, and rear staff exit door.

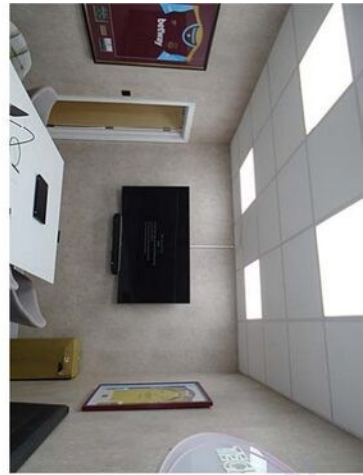
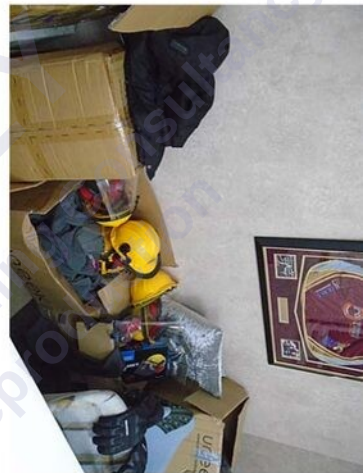
## Appendix I – Boardroom / Conference Room (Ground Floor)

Suspended ceiling with air-conditioning unit. One water-stained tile noted.

Stone-effect cladding. Good condition.

Carpet tiles with staining and wear.

Photographs showing ceiling condition, wall finishes, floor coverings, and fittings.

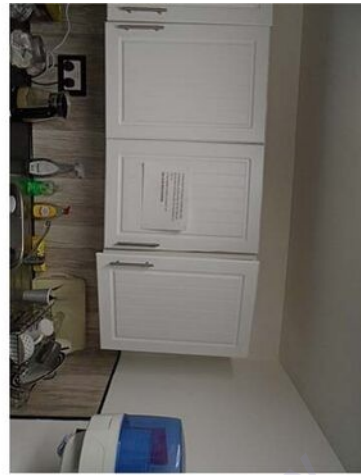
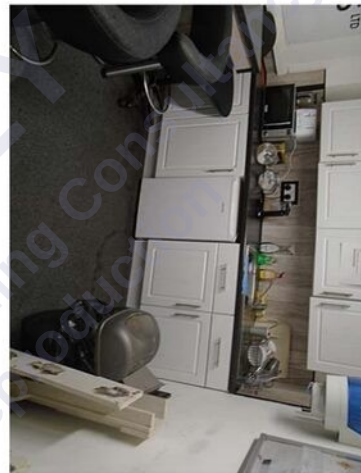
Wall-mounted unit to the right-hand side when viewed from the entrance door is coming away from the wall. Fixings appear loose or failed. **Health and safety hazard** with risk of detachment and injury.

Carpet tiles heavily stained.

Plastered and painted with localised flaking.

Photographs showing fitted kitchen units, floor finishes, ceiling condition, and unsafe wall-mounted unit.

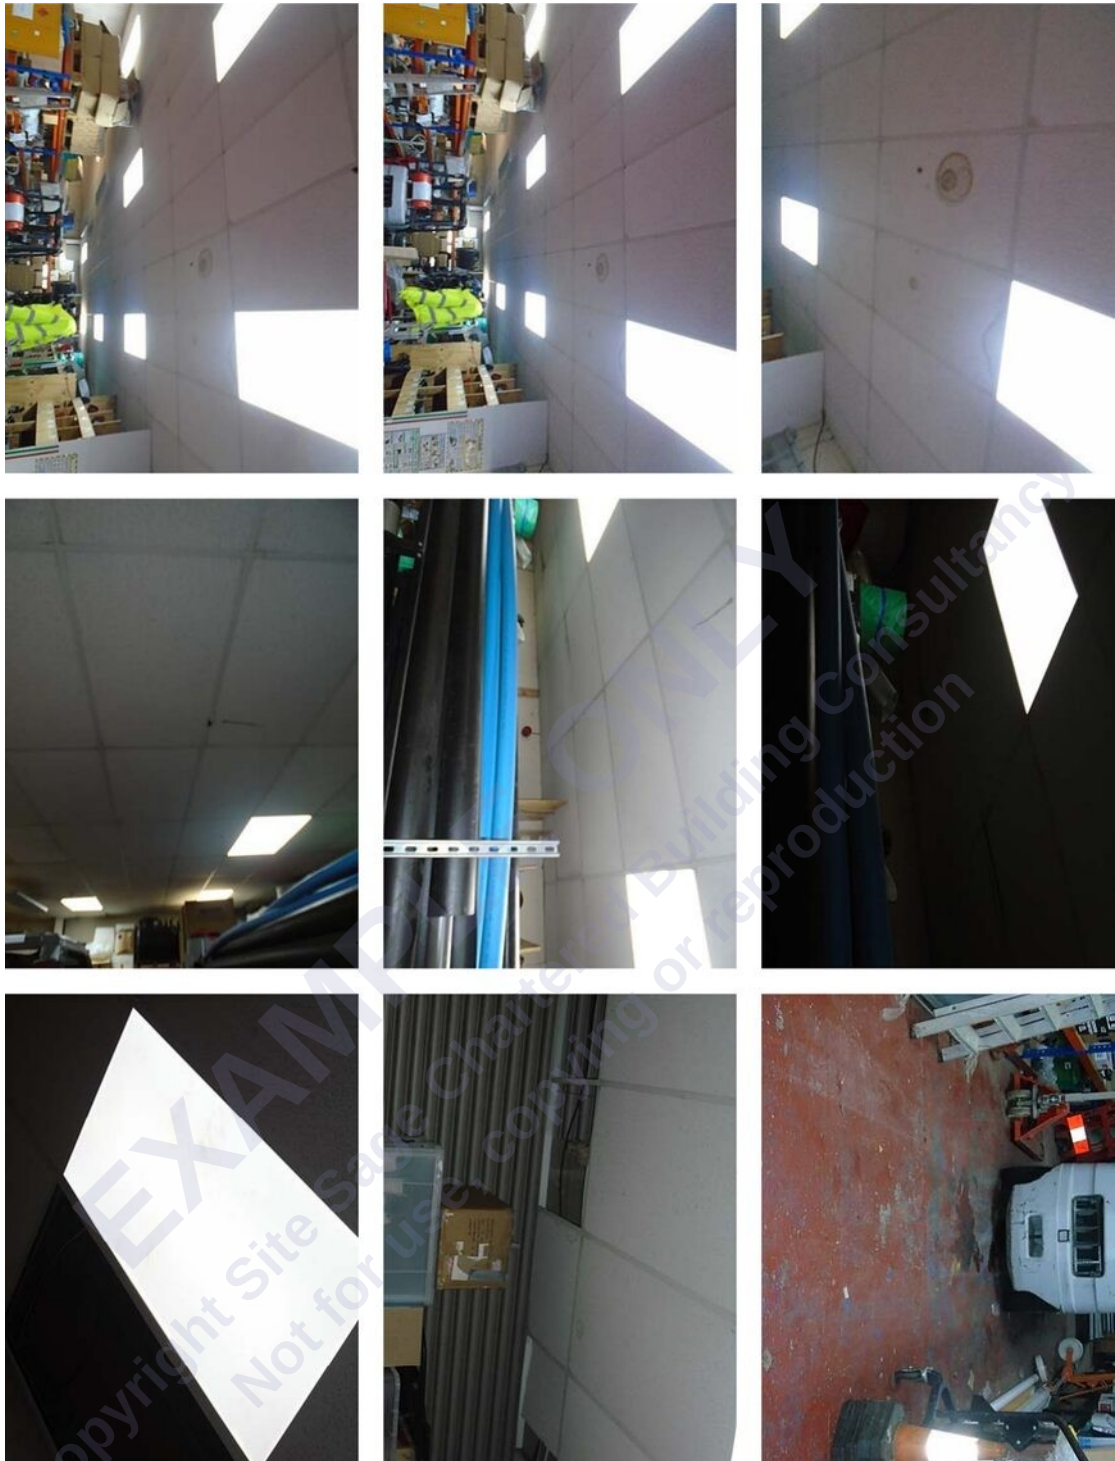
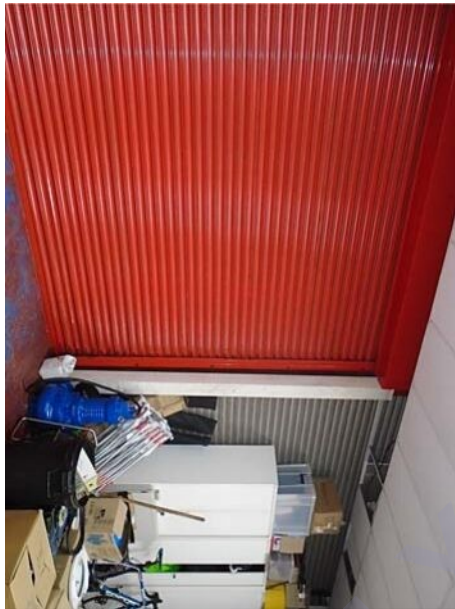
## Appendix O – Open-Plan Warehouse

Photographs showing warehouse space including ceiling tiles, blockwork walls, roller shutter doors, and worn painted concrete floor.
