## SCHEDULE OF DILAPIDATIONS

**GROUND FLOOR PREMISES**

**1 SAMPLE ROAD**

DATED: 9 NOVEMBER 2016

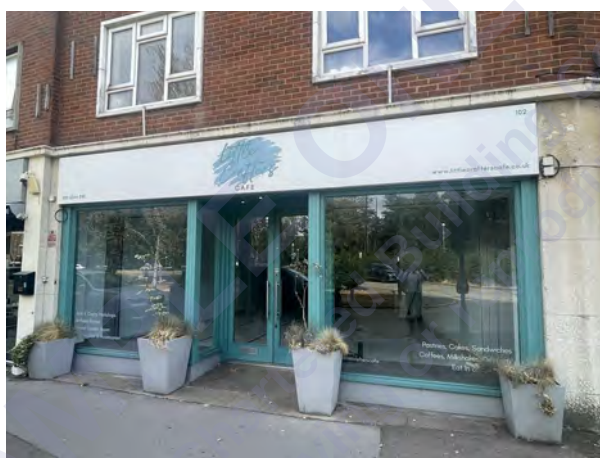
The front elevation and shop front to Sample Road

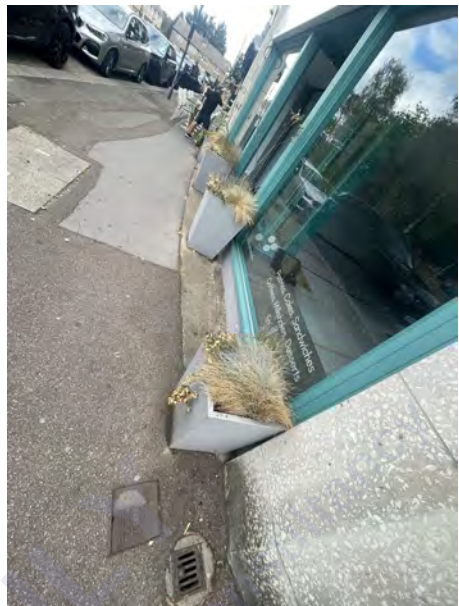
**Plate A6**  
Two of the planters standing against the shop front glazing, with dead and dying planting.

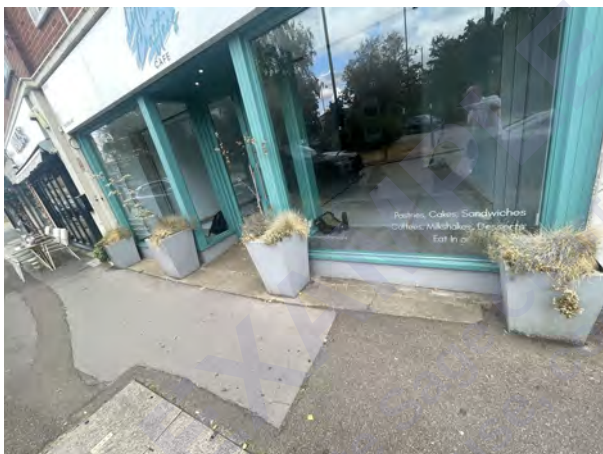
**Plate A7**  
Low oblique view along the frontage showing four planters standing on the footway in front of the unit.

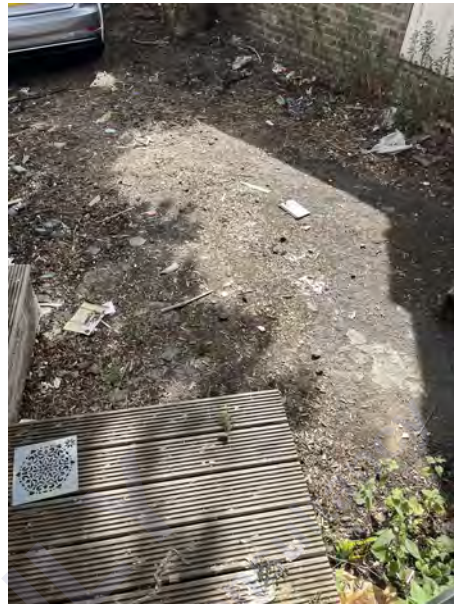
**Plate B2**

| <b>Yard surface</b> | The Yard surface is of bare compacted earth and hardcore with patches of degraded concrete. There is no evidence that it was ever laid with a made surface. No sum is claimed for providing a surface, which would be an improvement and not a want of repair. The item scheduled is confined to clearance. |

The Yard surface — bare compacted earth and hardcore with patches of degraded concrete, litter and debris throughout.

| Item No. | Location / Element | Description of breach of covenant | Remedial works required | Clause / Costing |
|---|---|---|---|---|
| 5.02.1 | Yard — clearance | The Yard is not clean and tidy. There are widespread accumulations of litter, paper, plastic, timber fragments and organic debris across the whole of its surface. A loose timber decking panel, a decorative screen panel and a loose concrete block or kerb section lie on the ground. Self-seeded vegetation is growing continuously along the base of the boundary wall and the flank wall. Clause 25.1 requires the Tenant to keep the Property, which includes the Yard, clean and tidy. | Clear the whole of the Yard of litter, debris, loose materials and rubbish and remove from site to a licensed facility. Cut back and remove the self-seeded vegetation growing at the base of the walls. Leave the Yard clean and tidy. | 25.1, 30.1, 30.3<br><br><b>£340.00</b> |

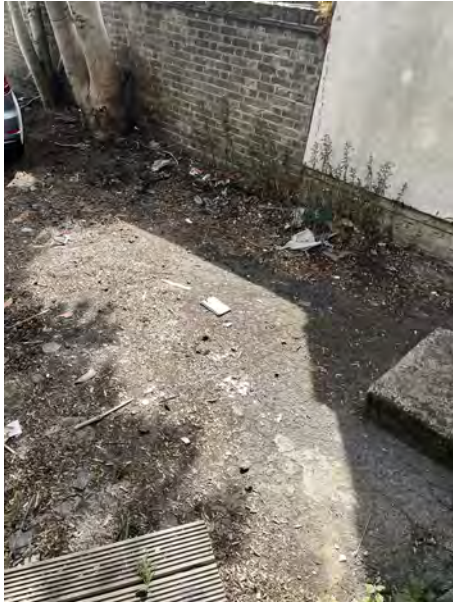
**Plate B5**

| <b>Boundary walls and trees</b> | Mature trees are growing hard against the brick boundary wall to the Yard. The condition of that wall, and any effect of the trees upon it, is not a tenant repairing item under this lease and is excluded. It is drawn to the Landlord's attention for his own purposes. |

The same corner. Mature trees growing hard against the brick boundary wall.

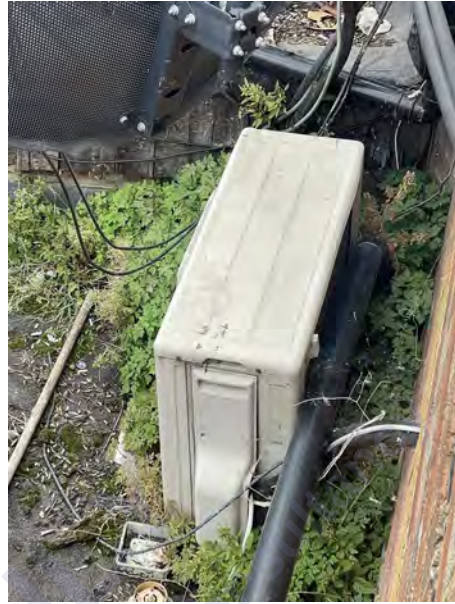
**Plate B6**

The redundant condensing unit on the main rear flat roof, with associated pipework and cabling. Not the Tenant's equipment — excluded from this Schedule.

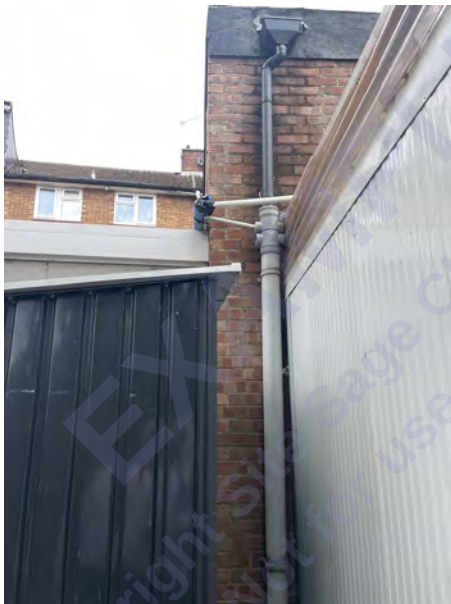
**Plate C3**

The narrow gap between the structure and the main building. The sheeting is built hard against the brick pier and its rainwater pipe.

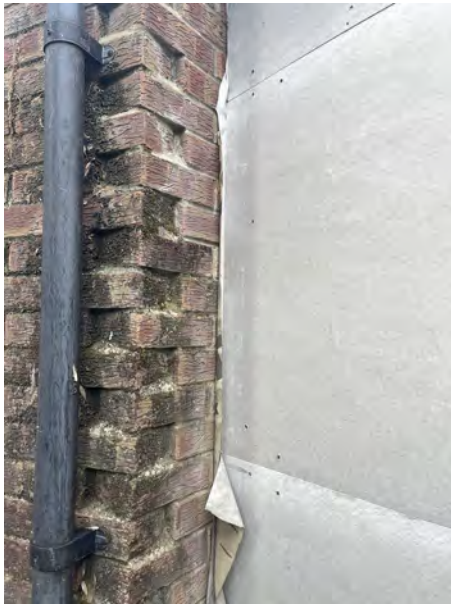
**Plate C5**

The junction of the cladding with the existing brickwork. The abutment is open and unsealed and the breather membrane is exposed and torn.

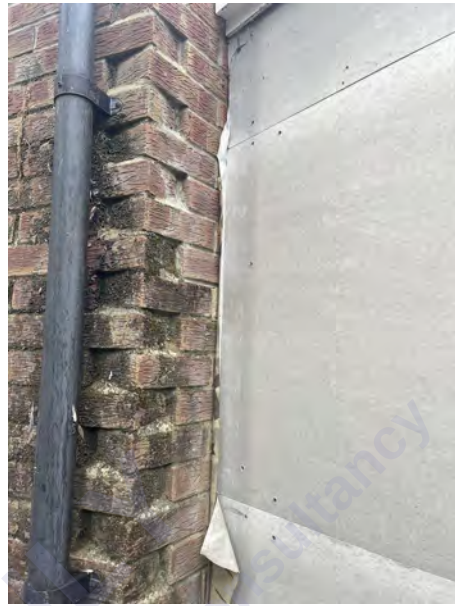
**Plate C6**

The same junction from further back, showing the full height of the open abutment and eroded brick faces.

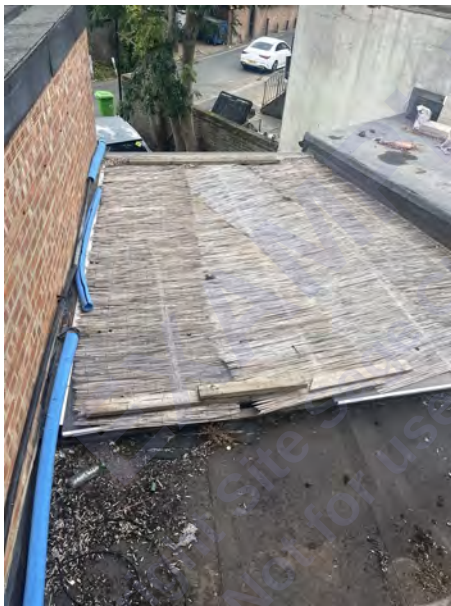
**Plate C7**

The roof of the structure from above, overlaid throughout with rolled reed screening held down only by loose timber battens.

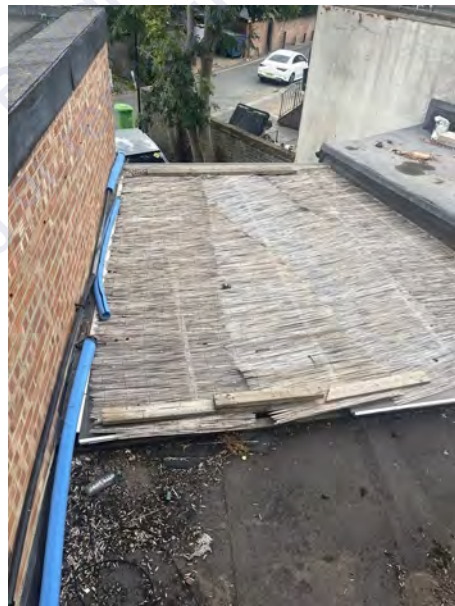
**Plate C8**

The roof from a second position. The screening is bleached and split, with open joints between the rolls.

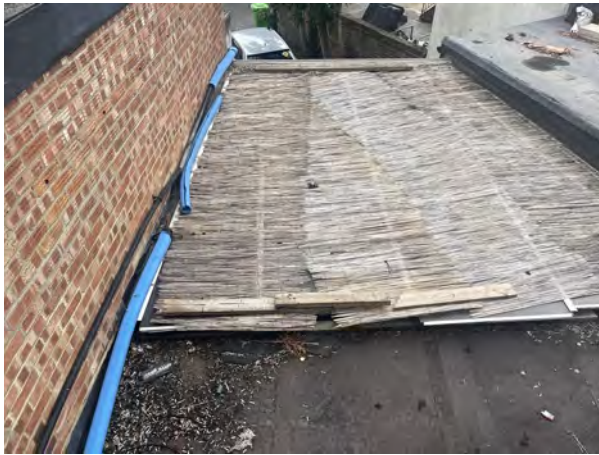
**Plate C9**

Detail of the roof. At the near edge the screening has pulled back to expose the corrugated plastic sheet beneath.

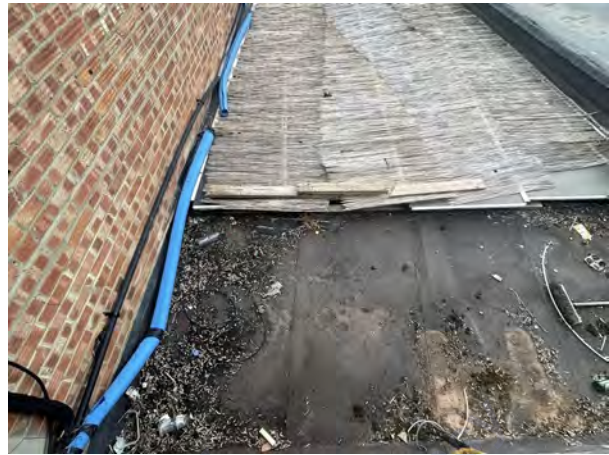
**Plate C10**

The edge of the roof where it meets the adjoining flat roof. The cut edge of the plastic sheet is visible below the screening.

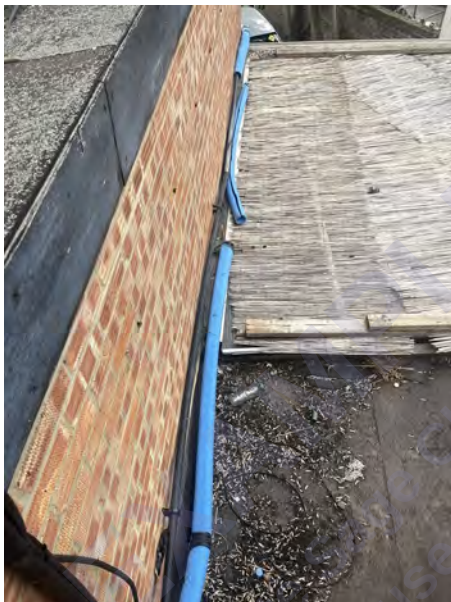
**Plate C11**

The junction of the roof with the brick wall of the main building. No flashing, upstand or seal, and services laid loose along the joint.

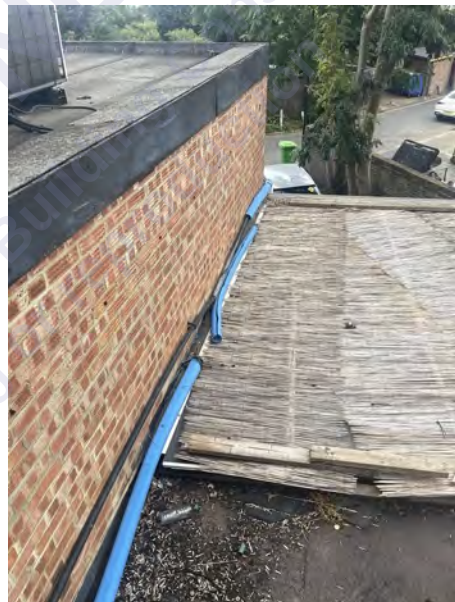
**Plate C12**

| Item No. | Location / Element | Description of breach of covenant | Remedial works required | Clause / Costing |
|---|---|---|---|---|
| 5.05.2 | Structure — services within it | Lighting, socket outlets and further accessories have been installed within the structure and are fed from within the demise. A lagged service pipe and a cable run loose along the junction of the roof with the wall of the Building. The route and status of the supply were not established. Clause 28.3 prohibits the installation of Service Media without the consent of the Landlord. | Before any demolition, isolate the supplies serving the structure and disconnect them safely by a competent person. Trace, disconnect and remove all cabling and pipework serving the structure back to its point of origin within the demise, and cap off and make good at that point. Identify, and divert or protect, the service pipe and cable running along the roof junction. Provide certification of the electrical isolation. | 28.3, 25.1<br>32.1, 32.2<br><br><b>£140.00</b> |

The roof looking down along the brick flank wall, with the service pipe and cable running down the brickwork.

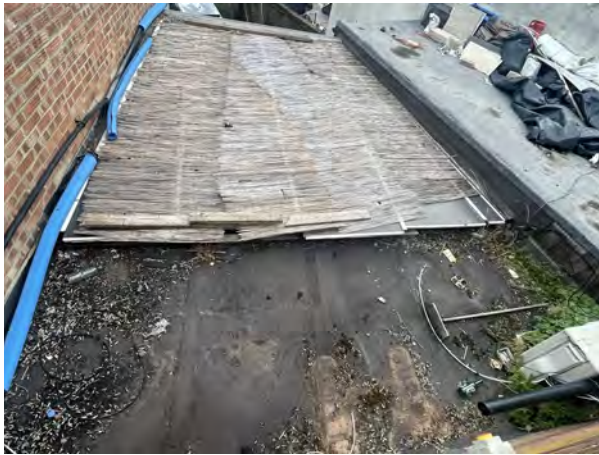
**Plate C13**

The structure roof and the adjoining flat roof, showing accumulated rubbish, moss and standing water staining.

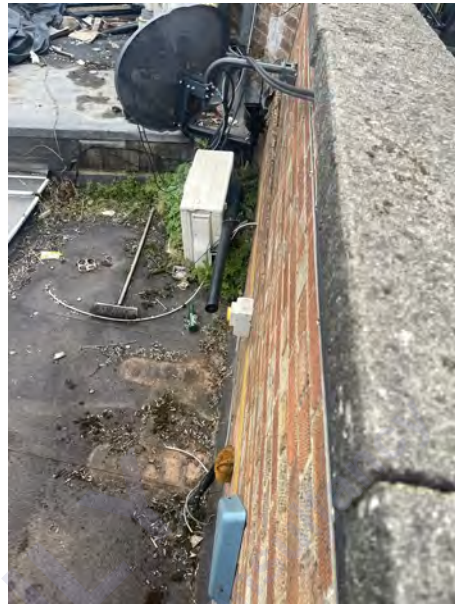
**Plate C14**

The adjoining flat roof with a discarded air conditioning unit, satellite dish, loose cabling and general refuse.

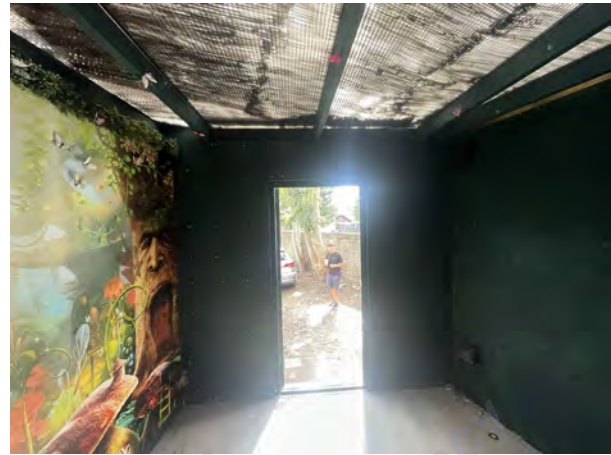
**Plate C18**

The interior looking towards the external doorway, with numerous filled and unfilled fixing points to the lining.

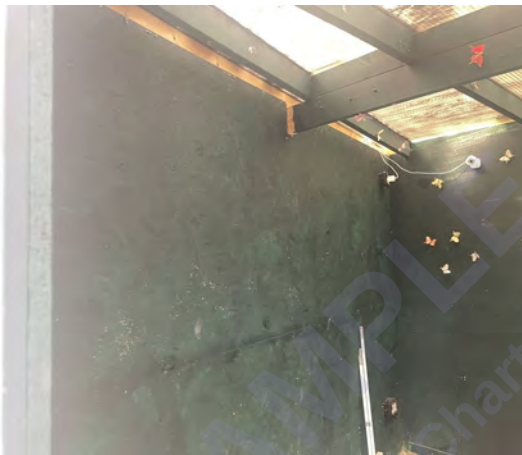
**Plate C19**

The head of the wall internally. Timber beams bearing on a wall plate, with surface run cable and lampholders at high level.

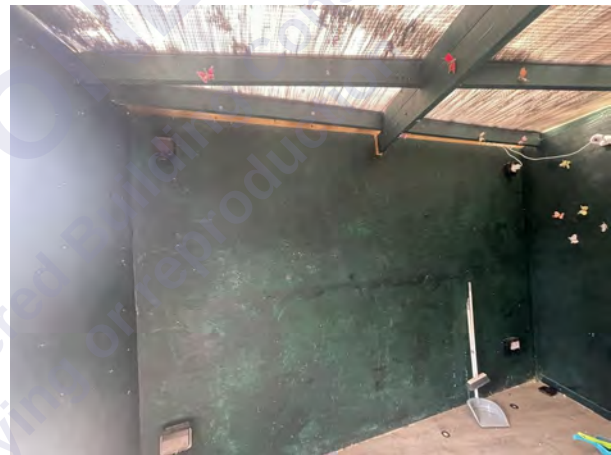
**Plate C20**

The same corner. Accessory plates at low level, and staining and moss visible through the translucent roof sheets.

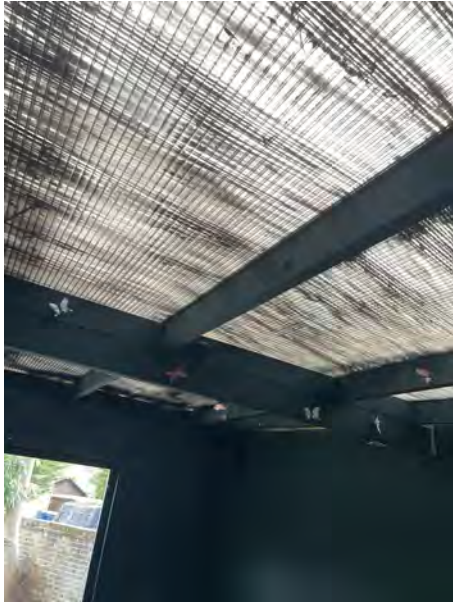
**Plate C21**

The roof from beneath. Extensive dark staining and organic growth on and above the translucent sheeting.

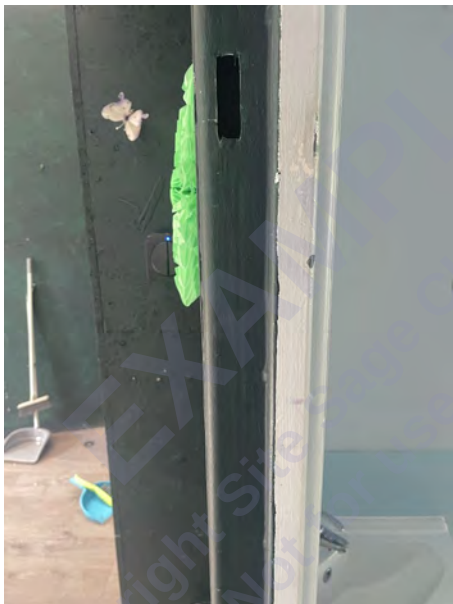
**Plate C23**

The external door and its lining. Paint to the lining is flaking and lifting with the substrate exposed.

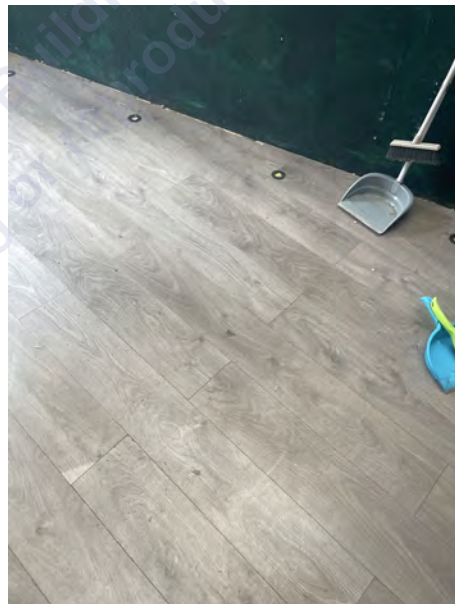
**Plate C24**

The floor of the structure. Laminate plank finish perforated at intervals by fixing sockets for equipment since removed.

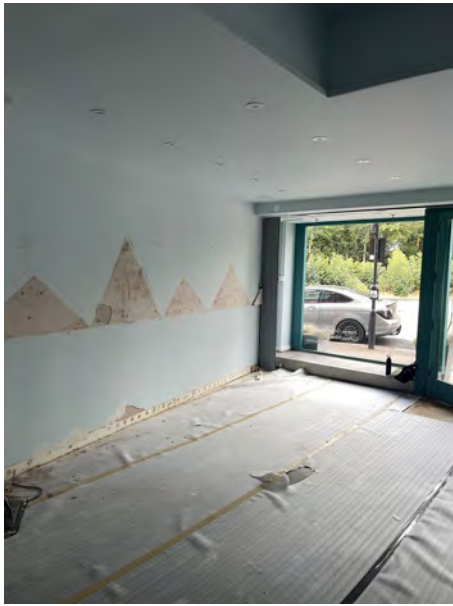
**Plate D1**

| Item No. | Location / Element | Description of breach of covenant | Remedial works required | Clause / Costing |
|---|---|---|---|---|
| 5.03.2 | Front trading area — walls, fixings and applied finishes | The wall finishes have been damaged by the removal of the Tenant's fittings and applied decorations. There are numerous fixing holes and remaining wall plugs across the walls, in scattered groups and in regular grids marking removed runs of shelving and wall units. A broken horizontal line of blown and torn plaster runs the length of one wall where a continuously fixed run has been taken off. On the opposite wall a band of applied decorative finish and four large shaped panels have been pulled away, taking paint, plasterboard paper and backing plaster with them. Skirting has been removed in places, leaving the plaster broken away at the base. | Remove all remaining fixings and wall plugs. Cut out, fill and patch plaster all damaged areas to the walls, approximately 25 m2, and rub down to a true and even surface. Reinstate skirting to match the existing where removed, approximately 12 m. Prepare and redecorate the whole of the wall surfaces of the front trading area, approximately 92 m2, in two coats of emulsion. | 25.1, 27.1, 27.2<br>30.1, 30.2 [L]<br><br><b>£1,480.00</b> |

The front trading area looking towards the shop front. Applied decorative finishes have been stripped from the left hand wall, taking paint, paper and plaster with them.

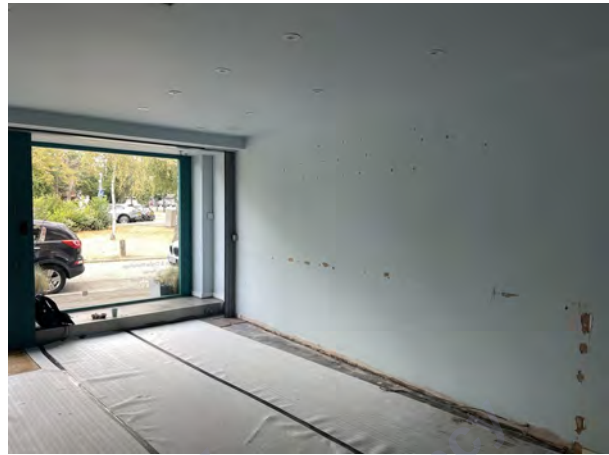
**Plate D2**

The opposite wall of the front trading area. Numerous fixing holes and remaining plugs, with a horizontal line of blown plaster where a fixed run has been removed.

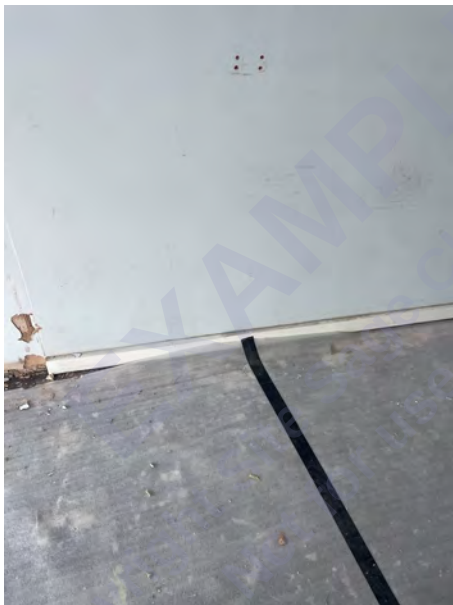
**Plate D3**

Detail of a removed wall fitting. Four screw fixings with plugs remaining, and skirting removed below with the plaster broken away.

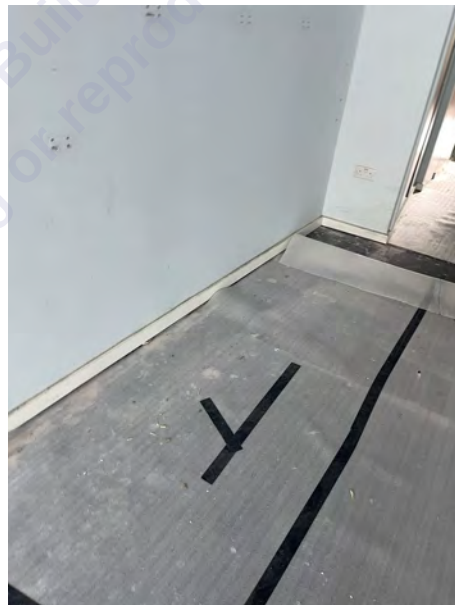
**Plate D4**

Internal corner and doorway to the rear. Scattered fixing holes; skirting remains in place on this run.

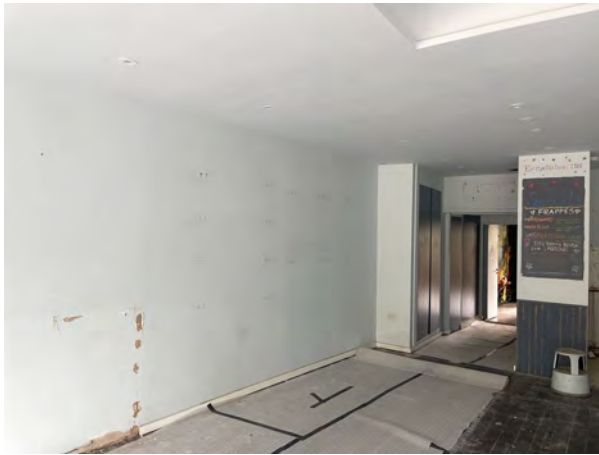
**Plate D5**

Looking towards the rear of the trading area. A regular grid of fixing points marks a removed run of shelving or wall units.

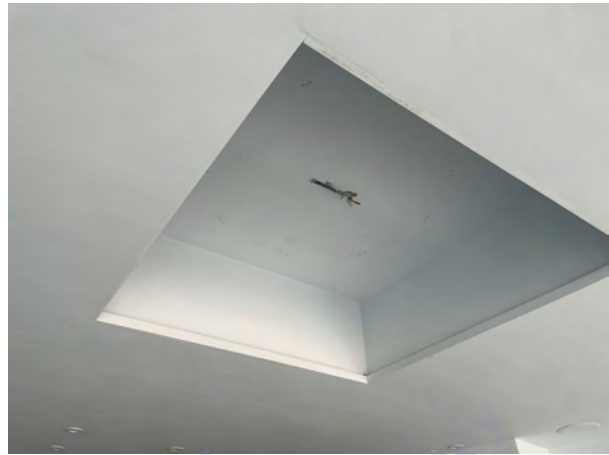
**Plate D6**

The recess formed in the ceiling at the rear of the trading area, with a cable and connector block left hanging from the centre.

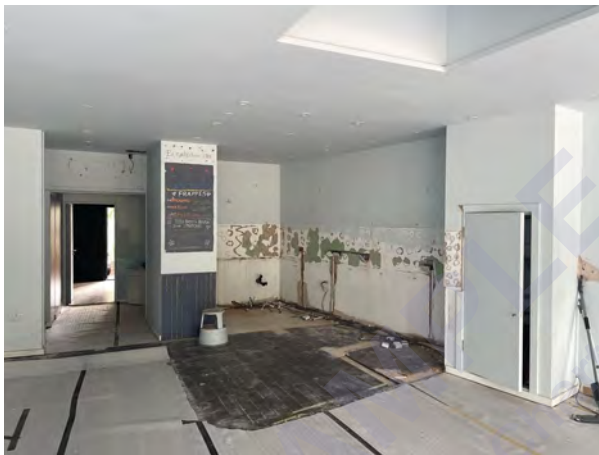
**Plate D7**

The rear wall at the former servery. Wall tiling stripped over the lower part, leaving adhesive, torn paper and exposed plaster, with services left in place.

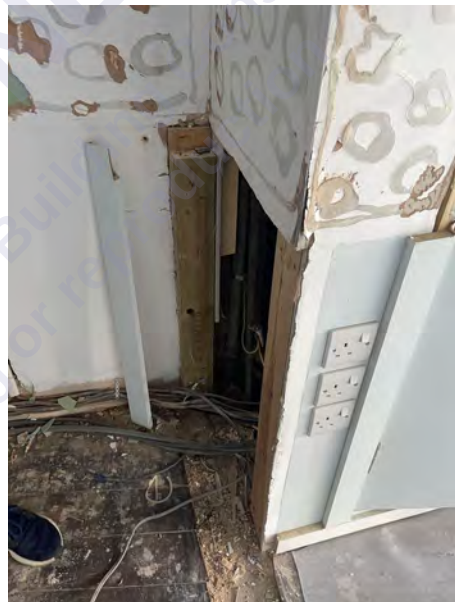
**Plate D8**

The wall lining opened up at the rear corner, exposing the stud and the services within, with socket outlets left live on the adjoining face.

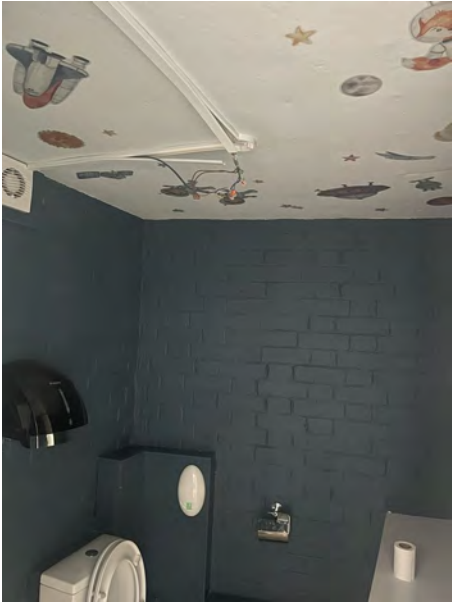
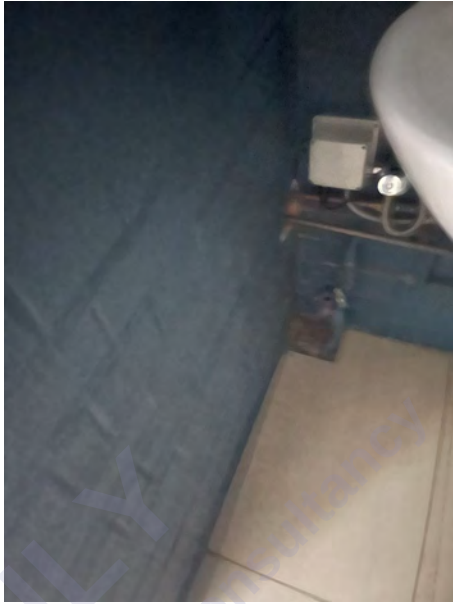
| <p><b>Plate E1</b></p> <p>The WC. Decorative stickers applied across the whole of the textured ceiling, and a connector block left hanging where a light fitting has been removed.</p> | <p><b>Plate E2</b></p> <p>Beneath the wash basin, showing the trap, supply connections and isolating valve.</p> |

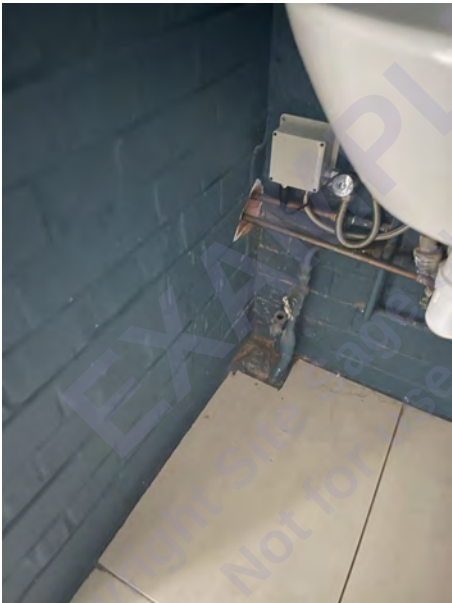
| Item No. | Location / Element | Description of breach of covenant | Remedial works required | Clause / Costing |
|---|---|---|---|---|
| 5.03.6 | WC — evidence of leakage at the wash basin | At the corner beneath the wash basin there is rust coloured staining and paint loss to the painted brickwork at the junction of wall and floor, a corroded fixing, and green staining to the joints of the unlagged copper pipe run. This is consistent with past or continuing leakage. The cause was not established, no opening up having been carried out. Clause 25.1 requires Service Media within and exclusively serving the Property to be kept in good working order. | Investigate the cause of the leakage, carry out such repair to the pipework or fittings as is found to be necessary, and make good the decoration and finishes to the wall and floor affected. A provisional sum is included. | 25.1, 30.1<br><br><b>Provisional<br/>£120.00</b> |

Item 5.03.6 is a provisional sum. The cause of the leakage was not established and the sum will require adjustment once it is. If the cause proves to be a defect in a part of the Building which the Landlord repairs under clause 26.1, or damage by an insured risk, the item falls out of this Schedule altogether.

| <p><b>Plate E3</b></p> <p>The corner below the basin. Staining, paint loss and corrosion at the wall and floor junction, with verdigris to the copper pipe run.</p> | |

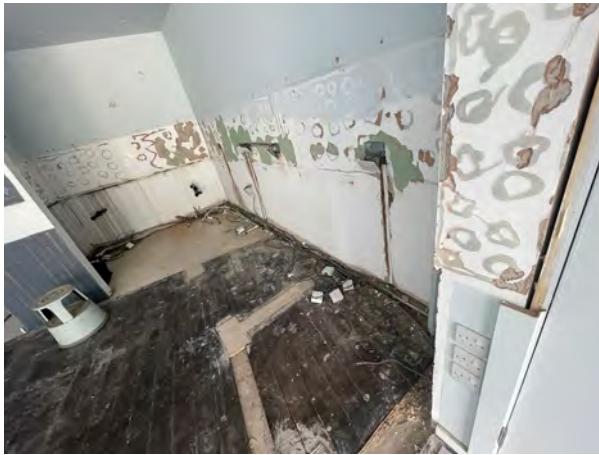
**Plate F1**

The rear room. Floor covering lifted to expose stained timber boarding with plywood patches; wall tiling stripped over the lower part.

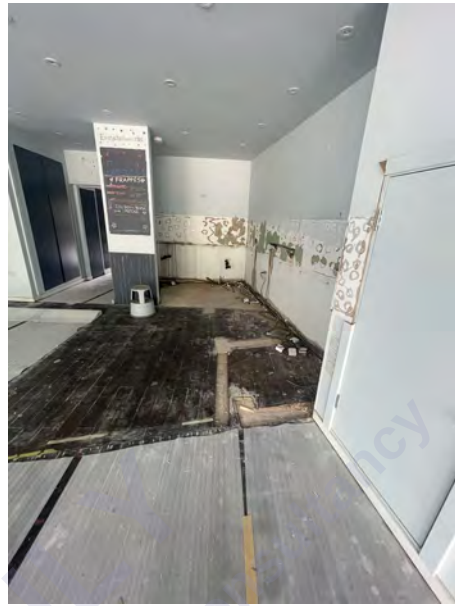
**Plate F2**

Looking from the trading area to the rear. Protective sheeting to the front floor; exposed boarding beyond, marked by the footprint of a removed fitting.

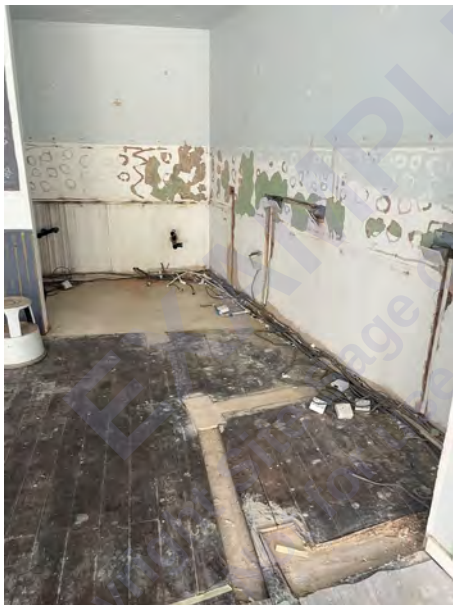
**Plate F3**

The rear room wall and floor. Chased service runs to former appliance positions and a waste pipe stub left projecting from the wall.

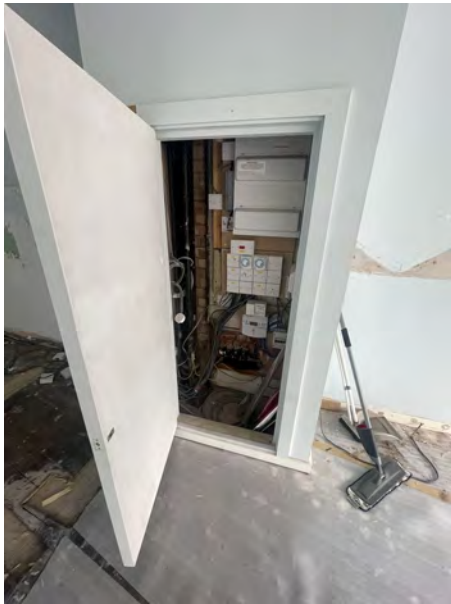
**Plate G1**

The service cupboard. Distribution board and meter position to the right; the boxing in to the left has been removed.

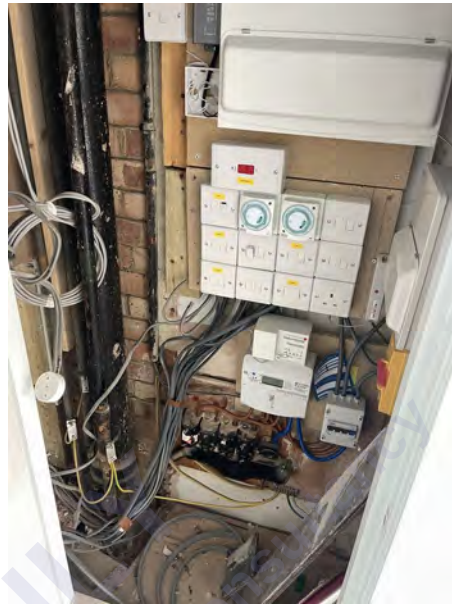
**Plate G2**

| Item No. | Location / Element | Description of breach of covenant | Remedial works required | Clause / Costing |
|---|---|---|---|---|
| 5.04.1 | Electrical installation — redundant wiring | Redundant cabling has been left throughout the Property. Within the void alongside the distribution board there is a quantity of twin and earth cable, coiled and hanging loose, with further lengths trailing across the floor of the void. In the main area an open steel back box has been left unenclosed in the wall, with cabling present, and loose pattress boxes lie on the floor. In the rear area two socket outlets have been detached and are lying loose on the floor, connected to lengths of flexible cable coiled across it. Clause 25.1 requires Service Media within and exclusively serving the Property to be kept in good working order. | Trace all cabling. Disconnect and remove all cabling proved redundant back to its point of origin. Make off, enclose and label all cabling that is to remain. Refix or remove the loose socket outlets and pattress boxes and make good the surfaces. Leave the installation safe. Provide a satisfactory Electrical Installation Condition Report, together with Electrical Installation Certificates or Minor Works Certificates for the works carried out. | 25.1, 30.1<br>32.1, 32.2<br><br><b>£520.00</b> |

The board, meter and cut-outs in detail, with the open void alongside containing loose cabling and the earth bonding clamps.

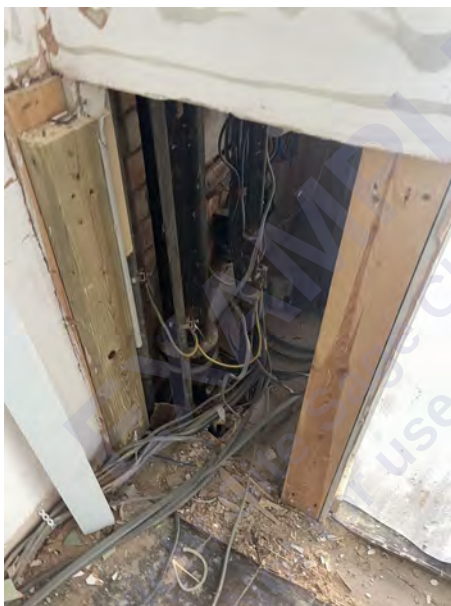
**Plate G3**

| Item No. | Location / Element | Description of breach of covenant | Remedial works required | Clause / Costing |
|---|---|---|---|---|
| 5.04.2 | Electrical installation — boxing in adjoining the distribution board | The boxing in to the left of the distribution board has been removed and has been left as a full height opening with ragged, unfinished cut edges to the plasterboard at the head and sides. The removal continues around the corner into the rear area, where a further panel has been cut away on a diagonal and left unfinished. A removed panel was standing loose against the wall. The opening exposes brickwork, timber studs, vertical pipework, cabling and the main protective bonding conductors and their clamps. | Reinstate the framing where disturbed and reinstate the boxing in on all faces, including the return into the rear area, in plasterboard to match. Tape, fill and skim to a true and even finish and redecorate to match the surrounding surfaces. Reinstate the trim and access panel. A means of access to the main protective bonding clamps within the void is to be retained. | 25.1, 28.2, 30.1<br>30.2 [L]<br><br><b>£380.00</b> |

The opening left by the removal of the boxing in. Ragged cut edges, exposed brickwork and studwork, and cabling trailing to the floor.

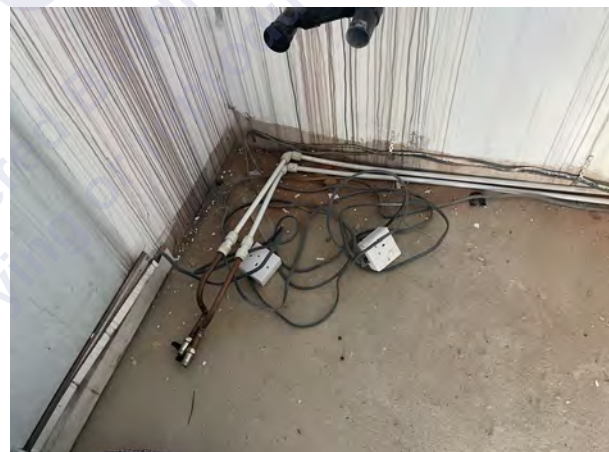
**Plate G4**

The rear room at floor level. Socket outlets detached and lying loose on the floor with trailing flexible cable.

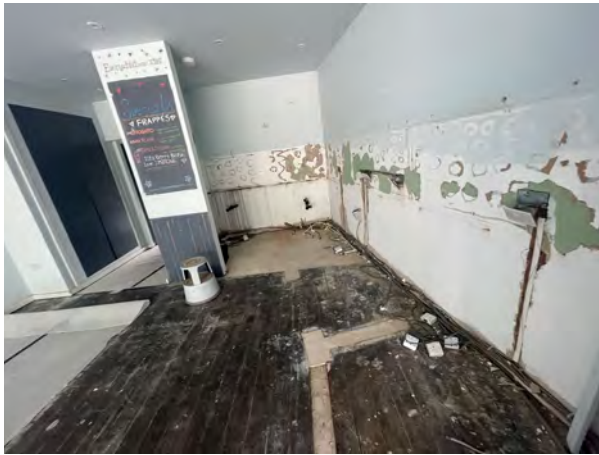
**Plate H1**

| Item No. | Location / Element | Description of breach of covenant | Remedial works required | Clause / Costing |
|---|---|---|---|---|
| 5.04.3 | Plumbing — redundant pipework at the former appliance positions | Redundant pipework remains at the former sink and appliance positions. In the main area two black plastic waste stubs project from the wall with copper supply pipes running down to floor level in made good chases, and a further waste stub is at low level on the side wall. In the rear area a waste branch passes through the wall and terminates in two open, uncapped ends, and supply pipework in plastic and copper has been cut and left lying loose across the floor, one end terminating at a lever valve and others open. | Disconnect and remove all redundant supply and waste pipework back to the point of connection with the retained services. Cap or blank the retained ends at that point. Make good the wall and floor penetrations and the chases, and make good all disturbed finishes. | 25.1, 28.3, 30.1<br><br><b>£280.00</b> |

The trading area looking to the rear, with waste stubs and capped supply pipes left at the former appliance positions.

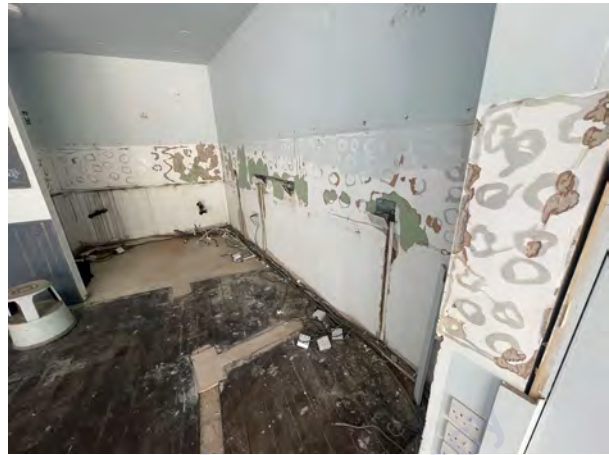
**Plate H2**

The same area from a second position. A removed plasterboard panel stands against the wall; socket outlets remain on the boxing beyond.

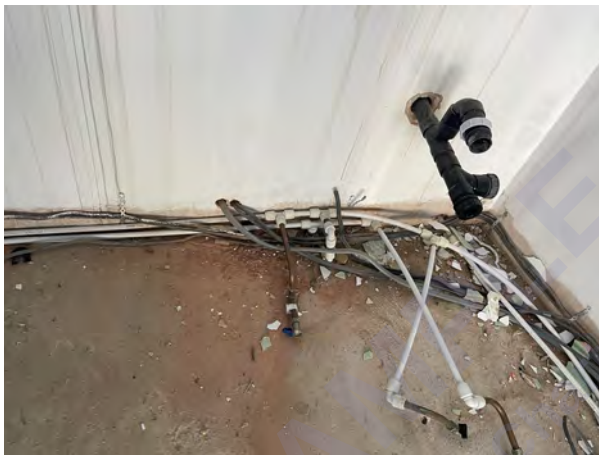
**Plate H3**

The rear room corner. Waste branch left with two open uncapped ends, and supply pipework cut and left loose across the floor.

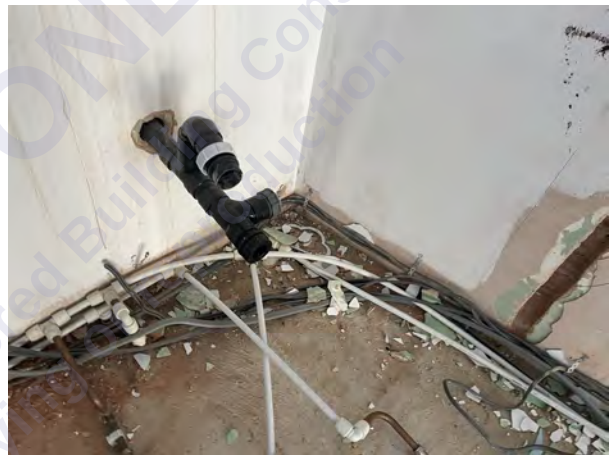
**Plate H4**

The same corner from the left, showing the extent of the disconnected pipework left lying on the floor.

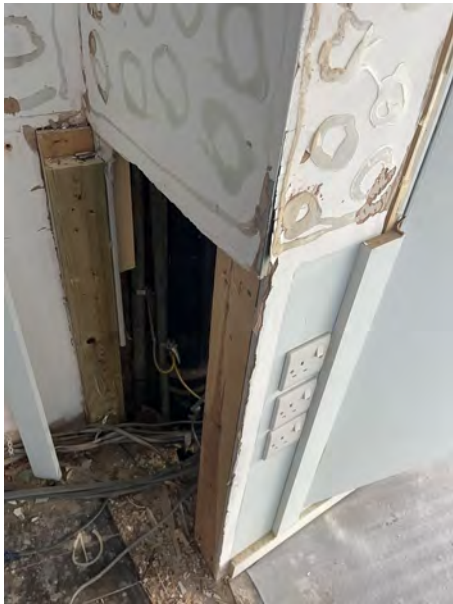
**Plate H5**  
The boxing in seen from the rear room, cut away on a diagonal and left unfinished, with services exposed within.

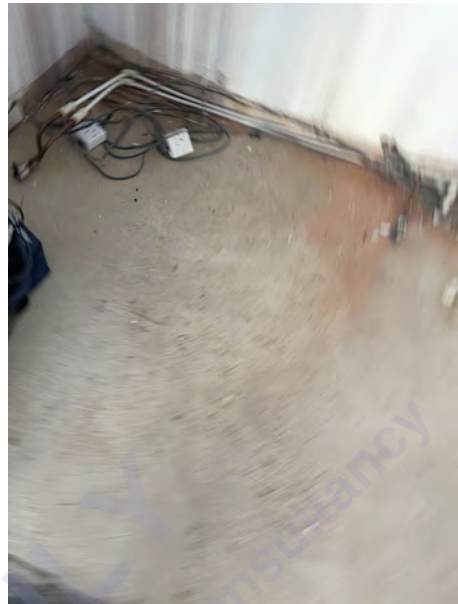
**Plate H6**  
The base of the rear room wall, with staining to the lining and discolouration to the floor at the corner.
