## EXPERT WITNESS REPORT

Flat 2, 10 Example Road, London, E1 0AA

| Report reference | SS/EW/EXAMPLE/2026 |
| Date of report | 24 August 2026 |

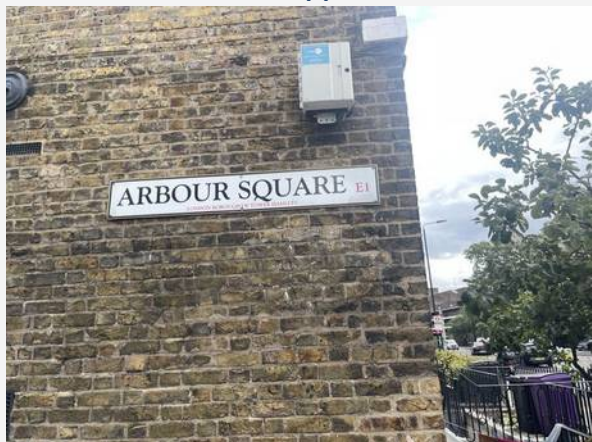
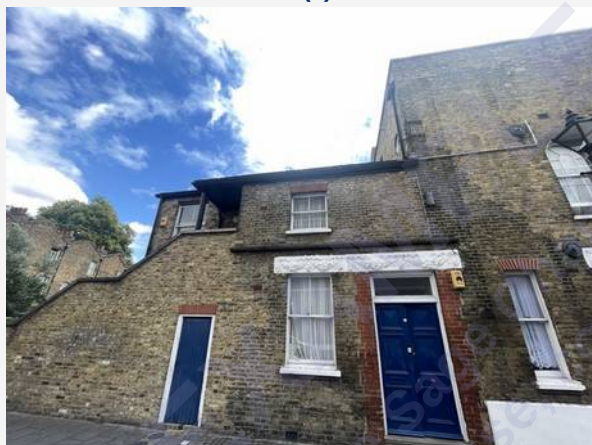
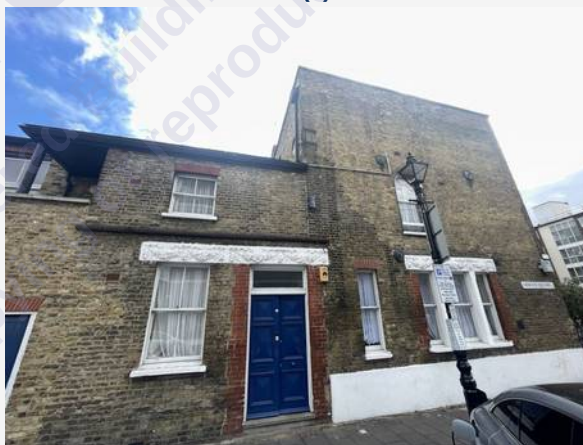
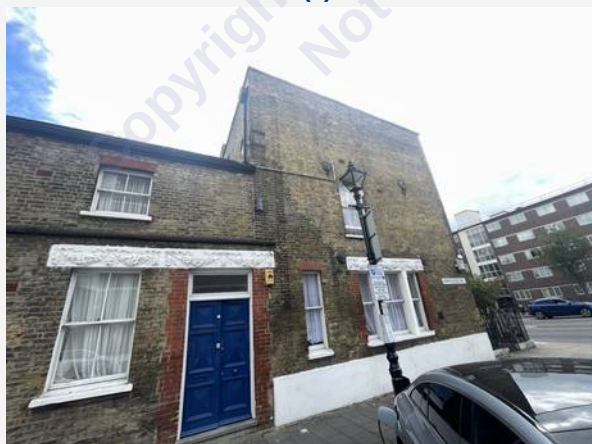
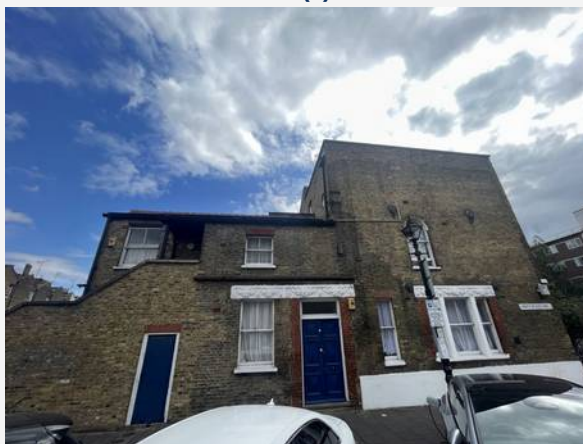
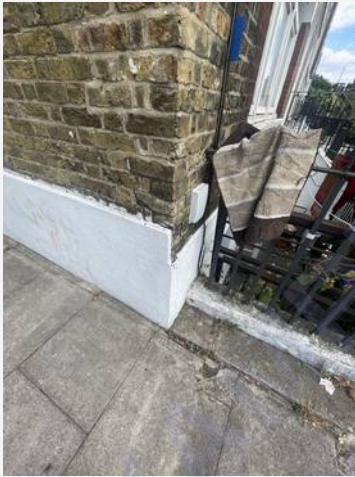
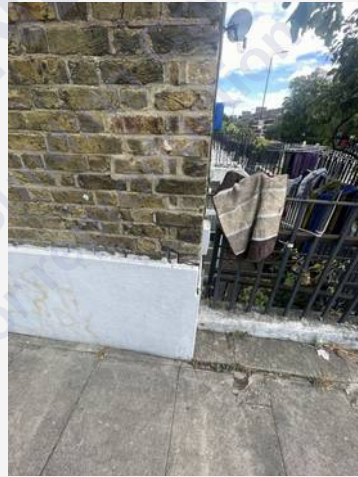
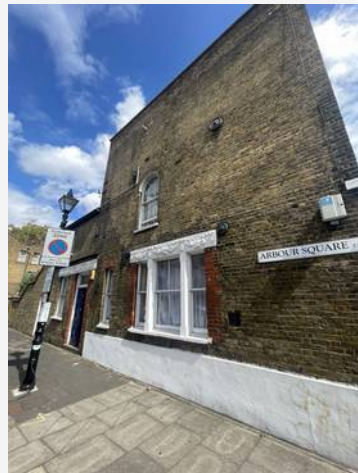
The external walls are of solid brickwork in London yellow stock brick. The brickwork is generally sound and stable. Pointing has weathered and is missing in isolated areas; the extent is not extensive and the condition is not, in my opinion, particularly bad for a building of this age. Localised repointing is appropriate as a maintenance item.

Cracking to the brickwork was observed at the right-hand corner of the property when viewed from the side elevation containing the entrance door, at the corner junction of Barbers Square and Example Road. The cracking is confined to the corner return. I saw no evidence of progressive or structural movement, no displacement of the brickwork, no distortion to openings and no associated internal cracking of a pattern that would indicate foundation movement. In my opinion this cracking is not structurally significant and is capable of repair by cutting out and repointing.

The external joinery requires attention. The putty to the ground floor windows has dried, shrunk and become loose, and has fallen away in places. The external paintwork to the windows is weathered and requires redecoration. These are cyclical maintenance items which, if left, will permit water to reach the timber and will in time cause decay to the sashes and frames. Their remedy is addressed at Section 12 below.

External elevation and surroundings. Photographs taken by the expert at inspection on 19 August 2026.

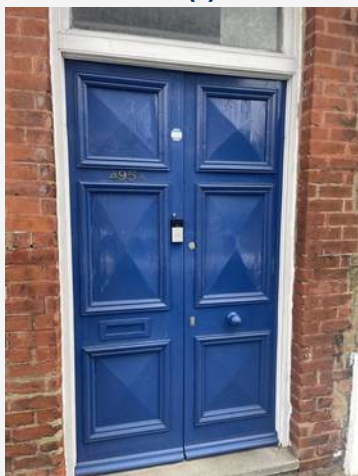
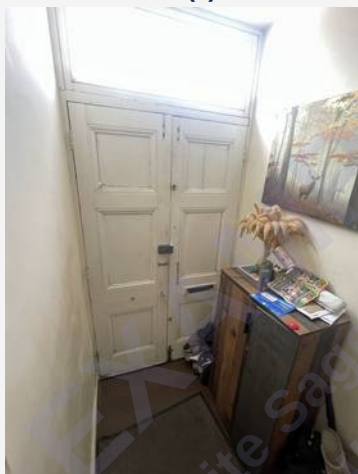
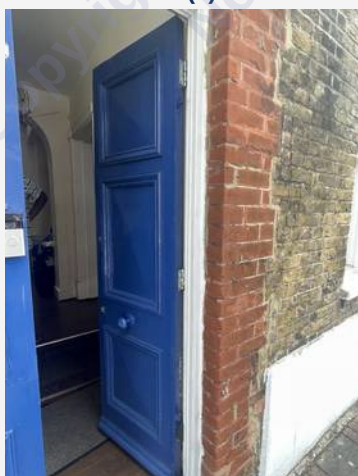
There are some cracks to certain of the timber panels, through which a small amount of daylight can be seen. These are shrinkage splits of the kind ordinarily found in a solid timber panelled door of this age, and they can properly be dealt with by filling when the doors are next prepared and redecorated as part of cyclical maintenance.

The decorative condition of the door is good. Timber doors of this construction exhibit a degree of differential movement between the seasons as the timber takes up and gives off moisture; that behaviour is normal, is not a defect, and is a characteristic of the material.

Entrance door, ironmongery and panels. Photographs taken by the expert at inspection on 19 August 2026.

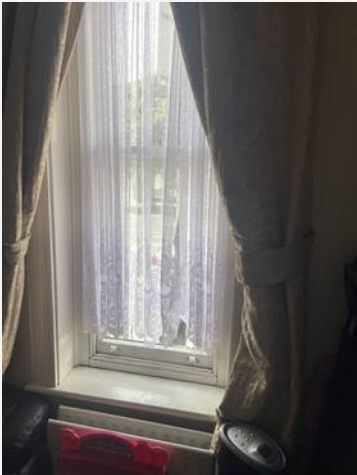
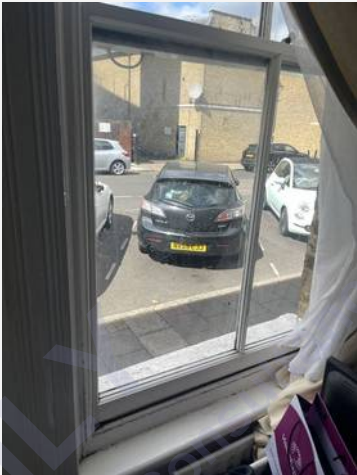
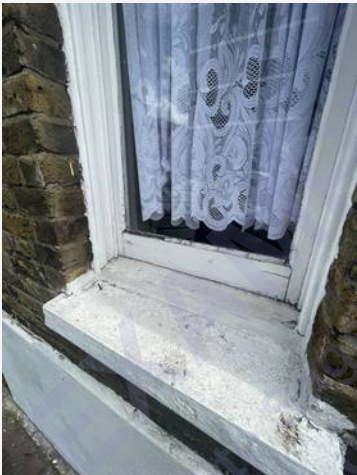
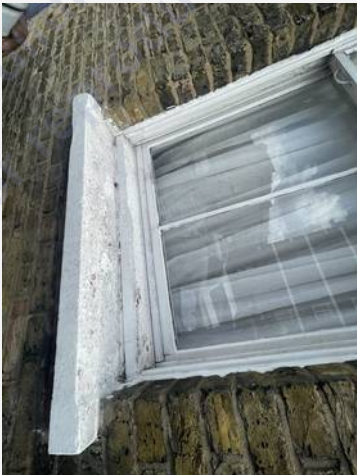
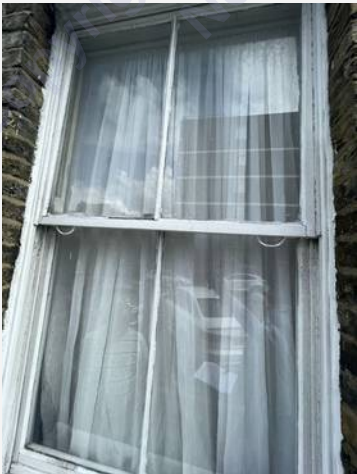
The windows to the living room are in satisfactory condition and are functional. They open, close and secure. Such movement as is present at the junctions of the frames is differential movement of the timber of the kind described at item 2 above and is not disrepair.

I took moisture readings at representative points to the walls and ceiling of the living room. All readings were within dry parameters. I identified no damp and no mould growth to the walls or ceiling of the living room. The pleaded allegation of damp and mould in this room is therefore not supported by the physical evidence at the time of my inspection.

Living room and windows. Photographs taken by the expert at inspection on 19 August 2026.

| <b>Remedial works</b> | Renew defective external putty and redecorate externally, as item 2. No works are required to remedy damp or mould in this room because none was found. |

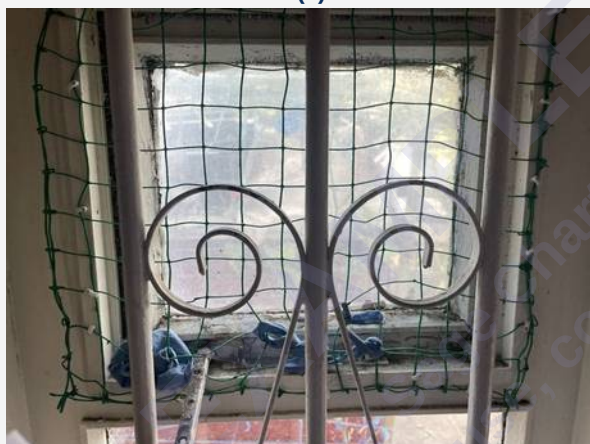
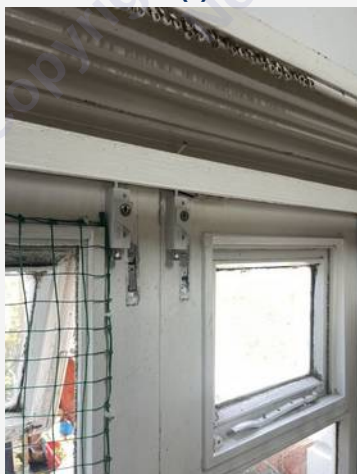
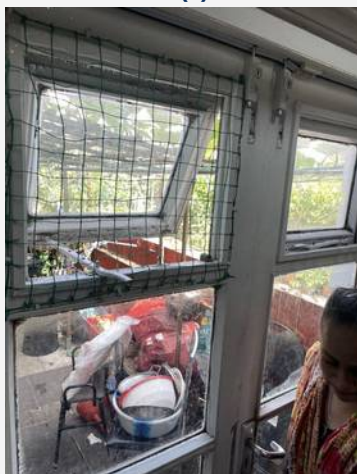
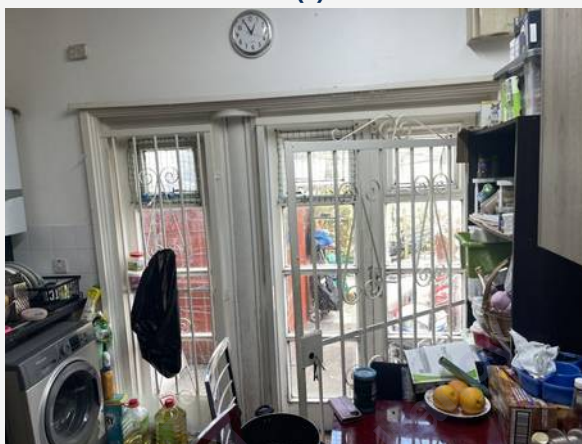
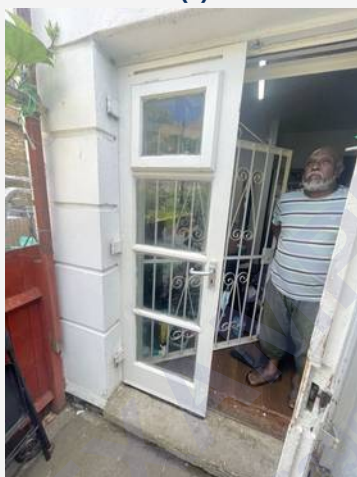
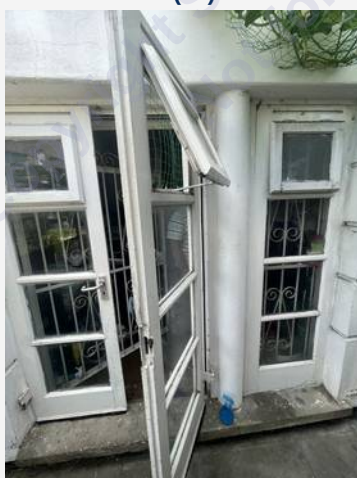
I examined the kitchen windows and doors. Everything is functional. The window frames are not broken. The doors show evidence of previous repairs having been carried out and all operate correctly.

I noted that the tenant has fitted net curtains internally, behind the security bars. The nets become caught in the window when it is closed, with the result that the window cannot be closed fully. That is a consequence of the tenant's own fitting of the nets and not of any defect in the window. It is capable of immediate remedy by the tenant.

I did not find the flooring to be raised or damaged by water ingress. Moisture readings to the kitchen were within dry parameters.

| <b>Remedial works</b> | Renew defective external putty and redecorate the external joinery. No renewal of window frames, patio lock or flooring is required. The tenant should release the net curtains from the window closure. |

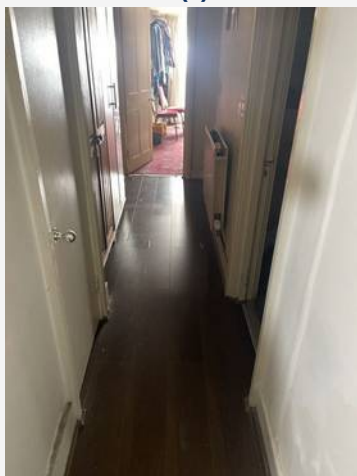
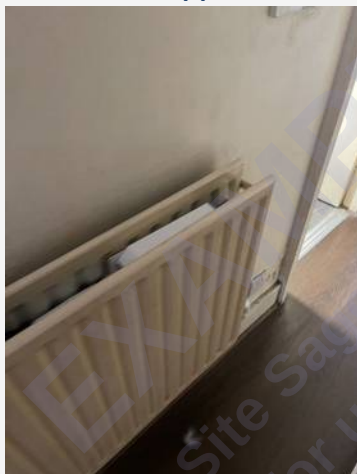
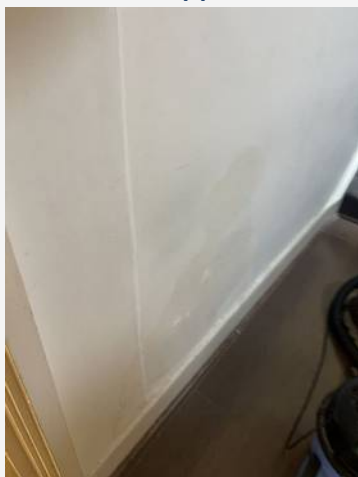
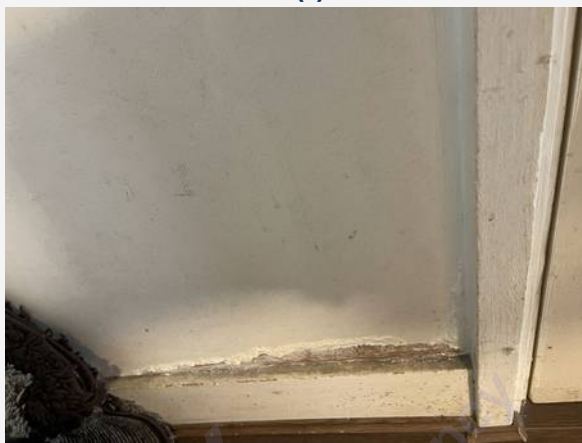
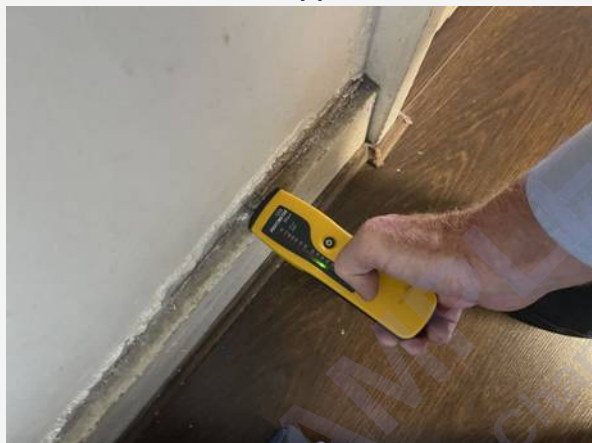
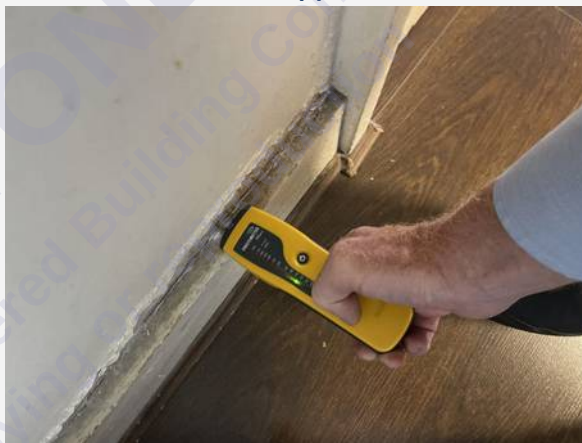
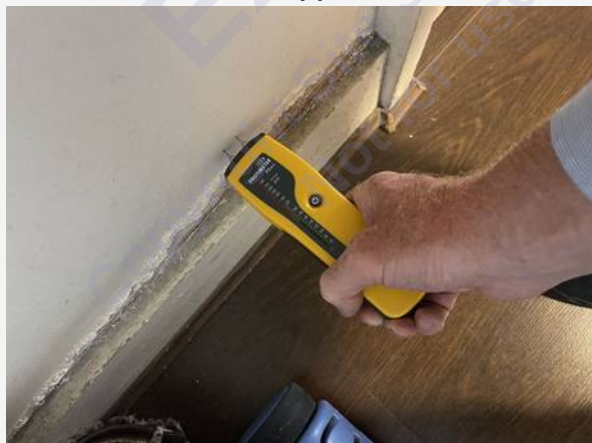
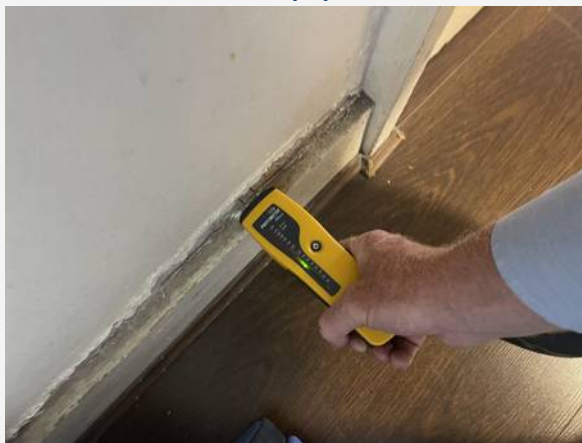
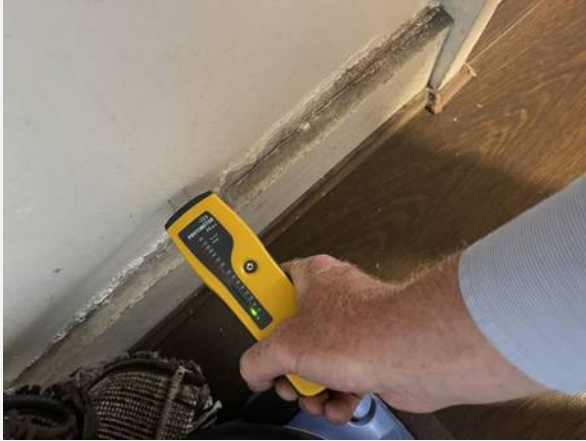
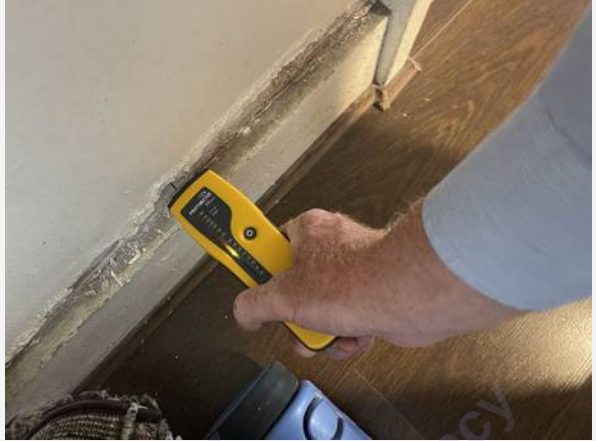
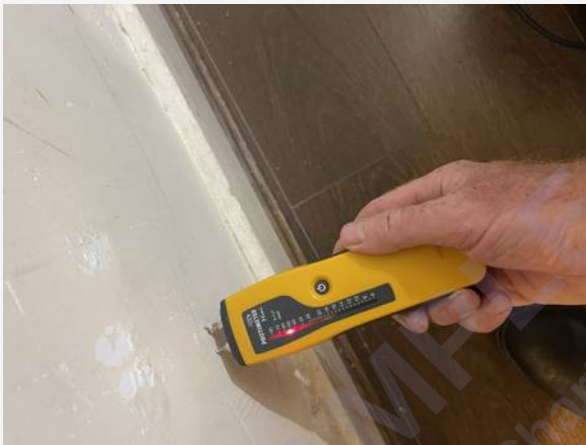
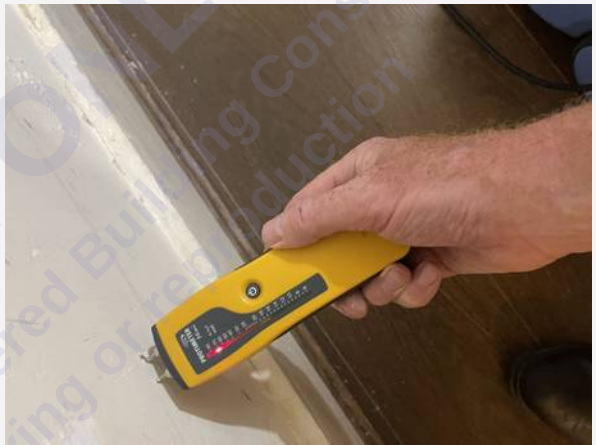
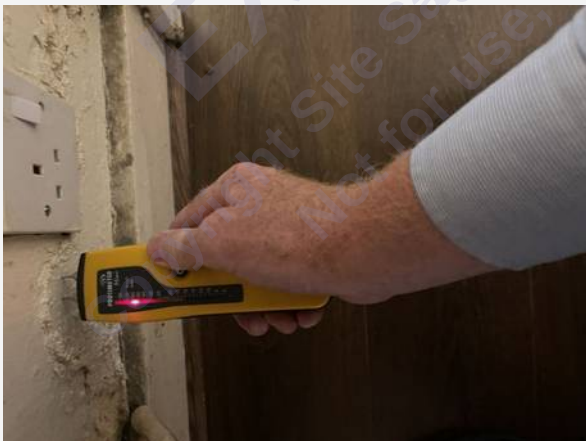
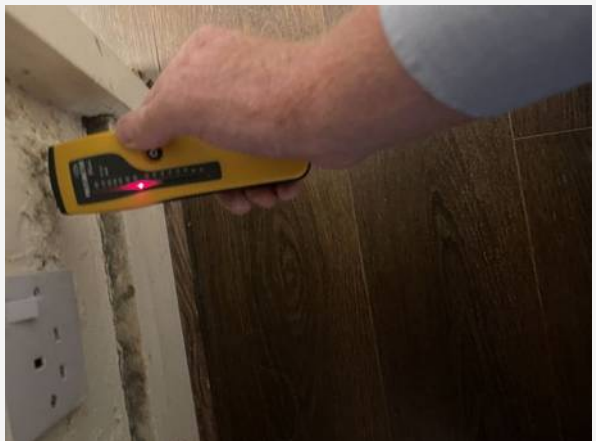
High moisture meter readings were recorded in that location. The affected zone extends to approximately the first one metre in height above floor level. The pattern of the dampness — confined to the base of the wall, extending upward to a broadly consistent height, and accompanied by disruption of the decorative finish — is characteristic of rising dampness rather than of a plumbing leak or of penetrating damp from above.

In my opinion, on the balance of probabilities, the cause is a defective or absent damp proof course to the basement wall. That is a defect to the structure of the dwelling.

Basement hallway — dampness to base of masonry wall. Photographs taken by the expert at inspection on 19 August 2026.

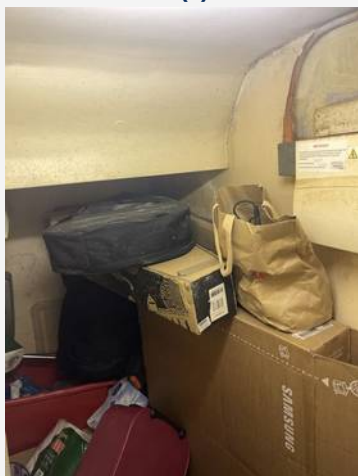
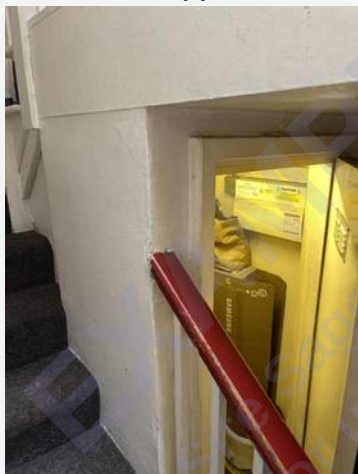
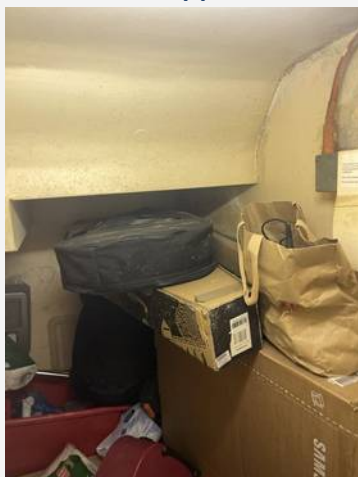
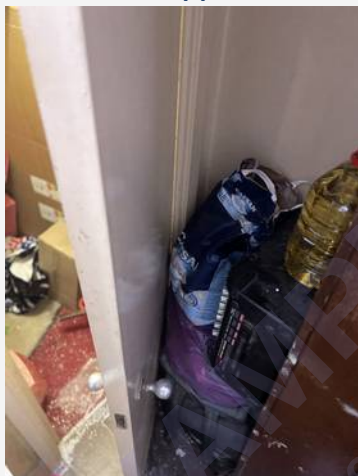
I was unable to enter the basement store, referred to in the Letter of Claim as the cellar. The door to that store would open only a short distance because the tenant's household possessions were stacked immediately behind it, and the clear gap between the door opening and the balustrade to the basement stairs was too narrow for me to pass through. I was able to photograph the interior of the store through the partly open door but I could not enter it, could not inspect the wall and floor surfaces concealed behind the stored goods, and could not take any moisture readings within that space.

Basement store — access restricted by stored contents. Photographs taken by the expert at inspection on 19 August 2026.

My findings in respect of pleaded item 7 are therefore confined to what was visible and perceptible from the doorway. I recommend that the tenant clears the stored contents and that a further inspection of that space is carried out if the matter remains in issue between the parties. I reserve the right to review my opinion on that item following any such re-inspection.

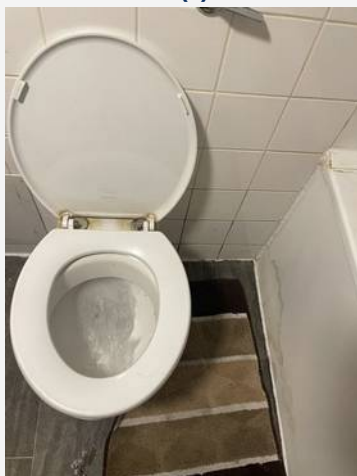
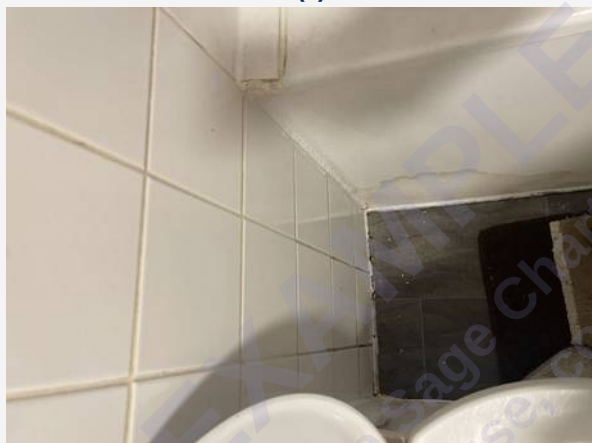
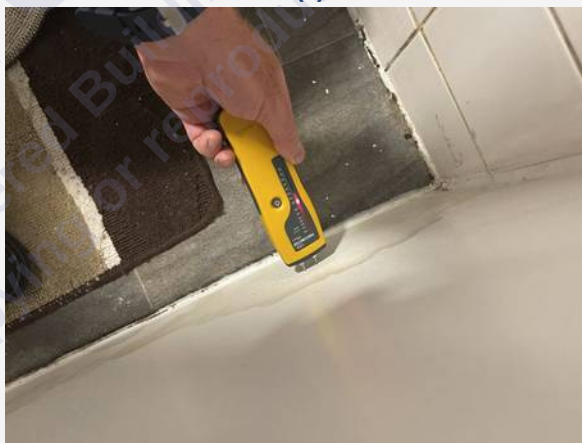
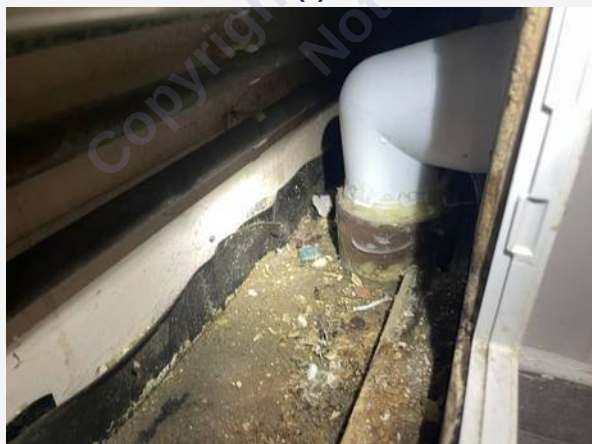
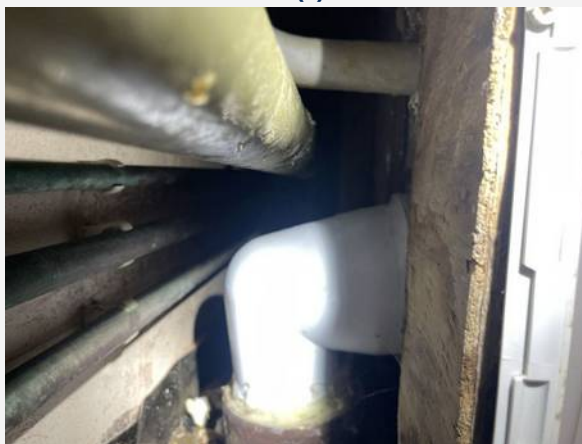
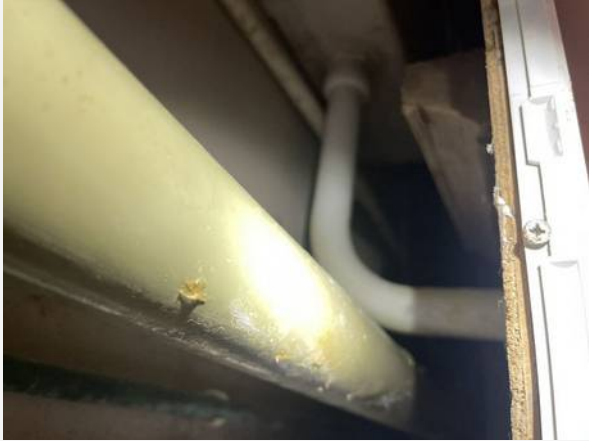
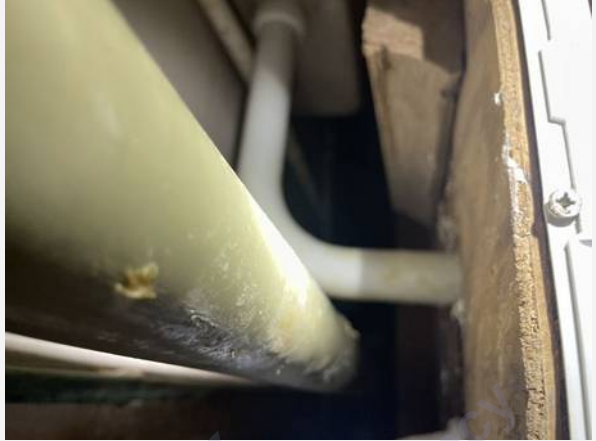
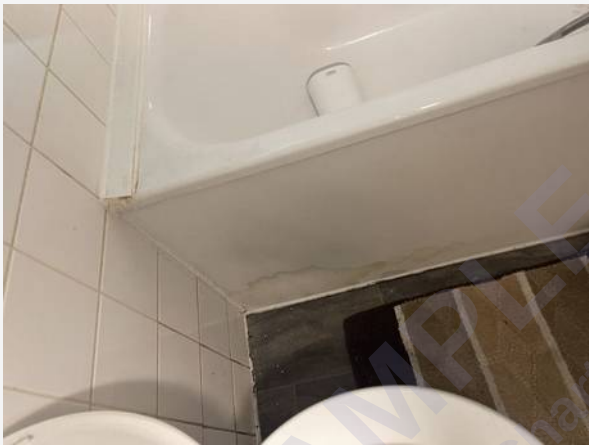
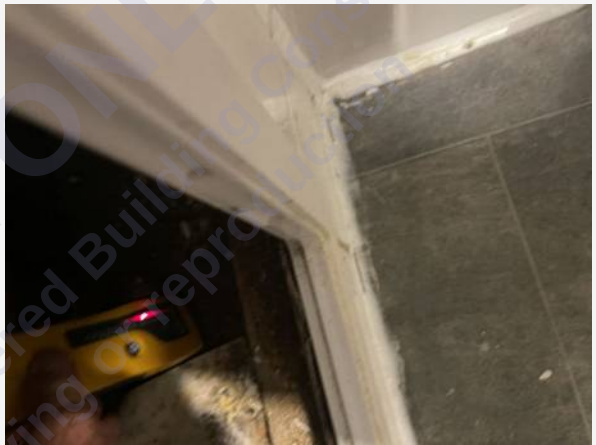
| Location | Reading | Comment |
|---|---|---|
| Bathroom, area of the bath and WC pan | Very high — saturated | Consistent with an active leak |

Bathroom — leak behind WC pan and bath. Photographs taken by the expert at inspection on 19 August 2026.

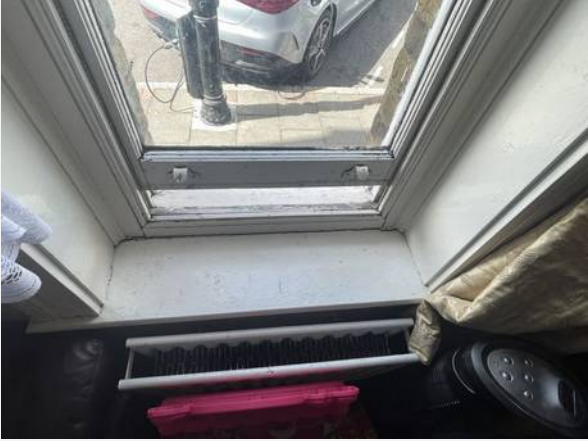
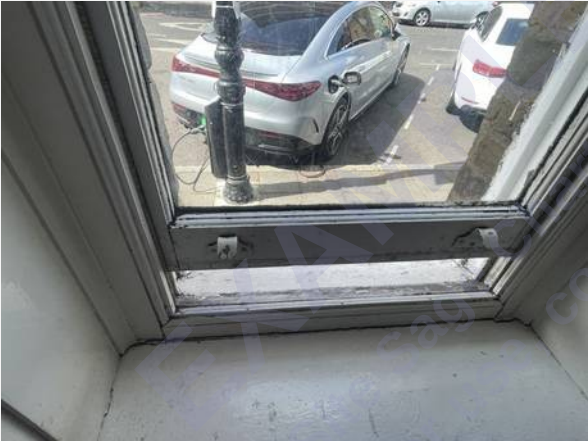
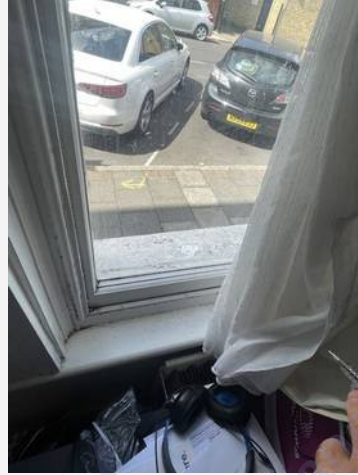
The front bedroom window presents a particular condition which I deal with here because it is repeated in the pleaded items relating to the individual bedrooms. The sash weights to that window are too heavy for the sash, with the result that the sash is lifted slightly away from its seal. The window can be pushed down and locked in position and it remains functional. This is a matter of adjustment, not of disrepair to the structure.

Son’s bedroom — front bedroom sash window. Photographs taken by the expert at inspection on 19 August 2026.
