## BUILDING SURVEY

### 14 Example Avenue

Anytown, Epping, Essex, CM16 0AA

Date of inspection: 9th September 2026

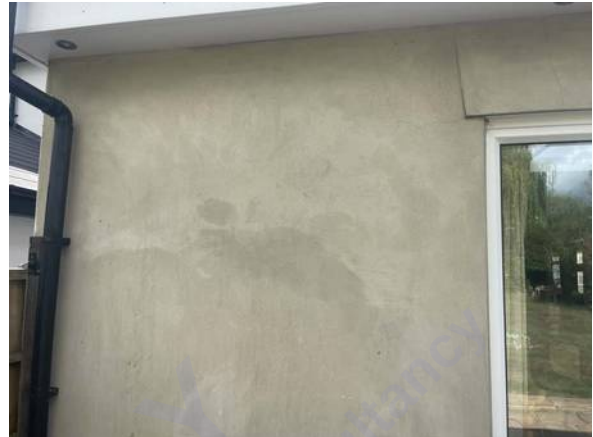
8241

A stained area was noted to the render adjoining the rear door. Structural openings formed at ground floor level are dealt with at Section 34.

A stained area was noted to the external render adjoining the rear door, illustrated at IMG\_8241. This is external and is cross referenced to Section 22.
