## COMMERCIAL BUILDING SURVEY

1 & 2 Sample Parade  
Sampleton  
Sampletown  
Essex  
XX1 1XX

Prepared by  
Dennis Brett MCIOB FFPWS LCGI MPTS  
Site Sage Chartered Building Consultancy

Inspection Date  
5 March 2026

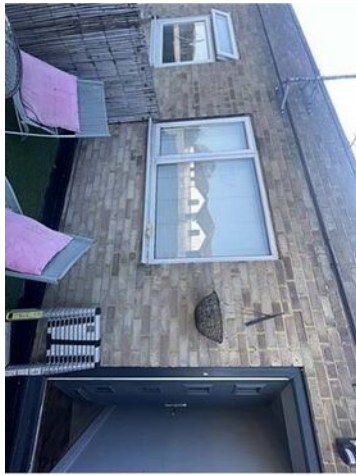
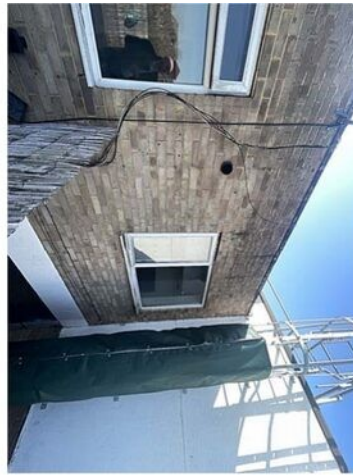
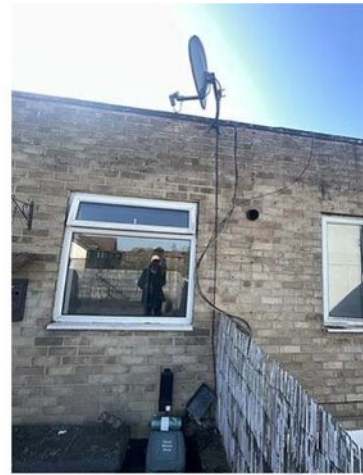
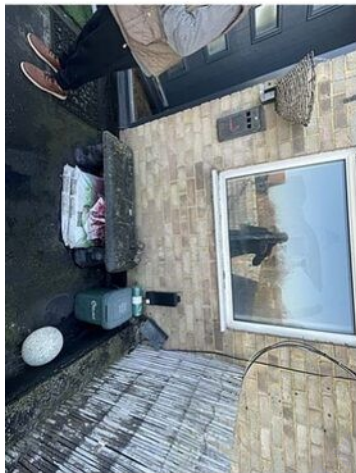
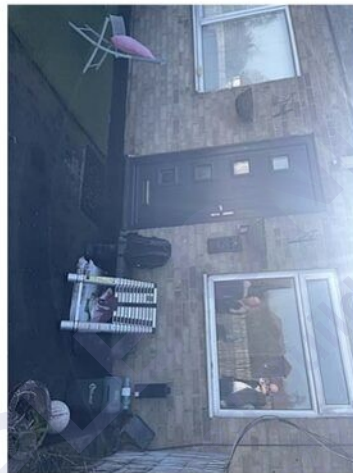
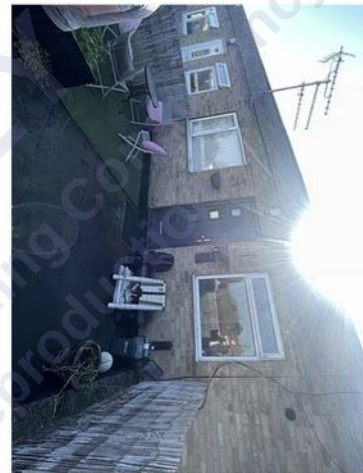
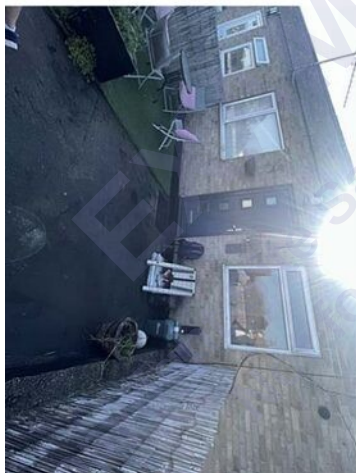
# Appendix I – Rear Flat Roof Covering Ground Floor Rear Hall and Pathway

The asphalt pathway providing access to the HMO also forms a **roof structure below and is leaking**, cross-referenced with Section 19.

Water ingress was observed to the hallway ceiling caused by the defective roof covering above.

This appendix contains photographs showing the flat roof covering located over the rear ground floor hall and access pathway leading to the residential accommodation above.
