## SCHEDULE OF CONDITION

**Sample Industrial Estate**  
**Units 2F, 2G & 2H**  
**1 Sample Way, Sampleton, Essex XX1 1XX**

**Client:** Sample Trading Limited (Mr A Sample)  
**Surveyor:** Dennis Brett MCIQB FFPWS LCGI MPTS  
**Date of Inspection:** 16 January 2026  
**Time:** 10:30am

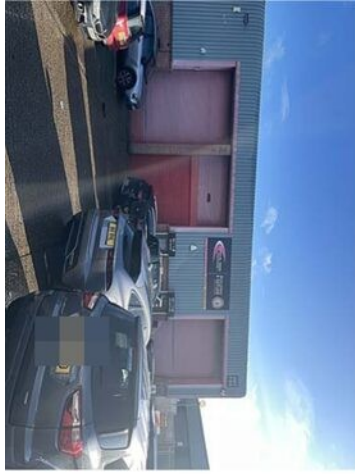
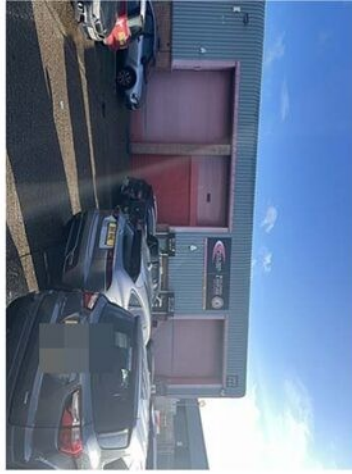
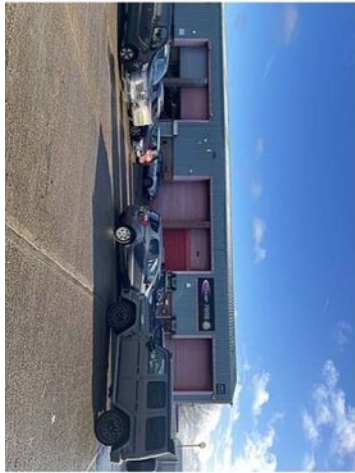
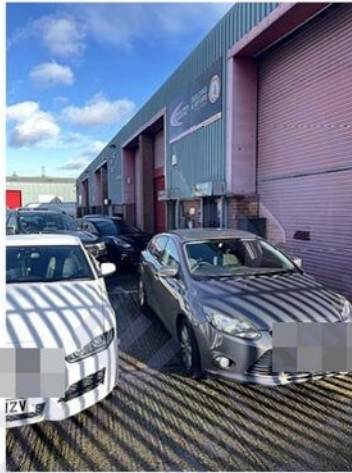
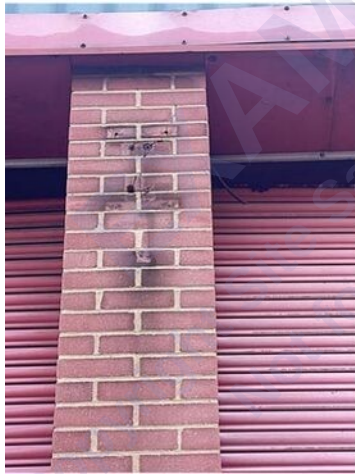
## Appendix B – External Front Elevation

Photographs showing front elevation including brickwork, metal cladding, roller shutter doors, signage, and forecourt parking.

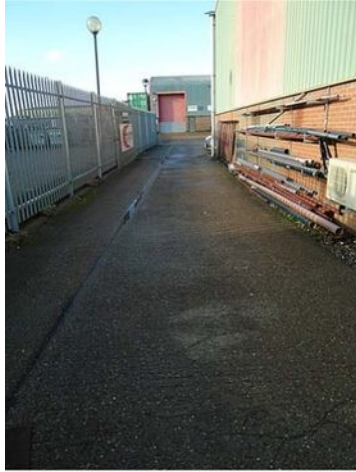
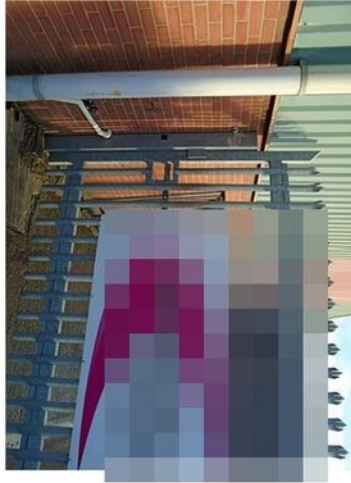
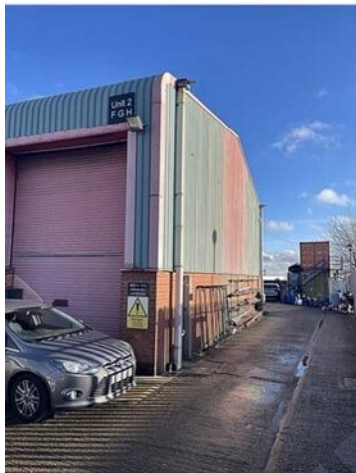
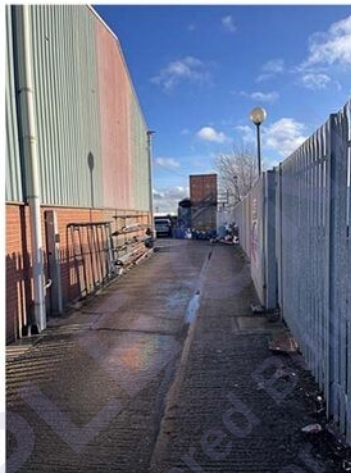
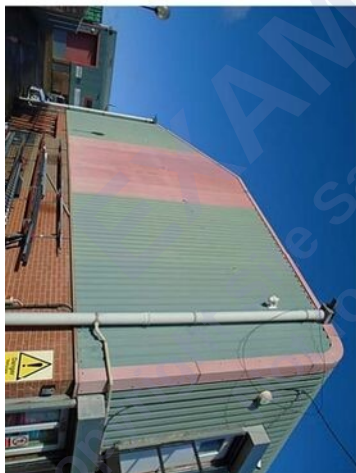
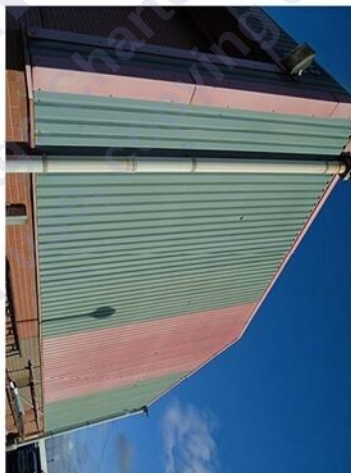
## Appendix C – External Side Elevation

Photographs showing side elevation including metal cladding, vehicle access gate, concrete hardstanding, and external services.

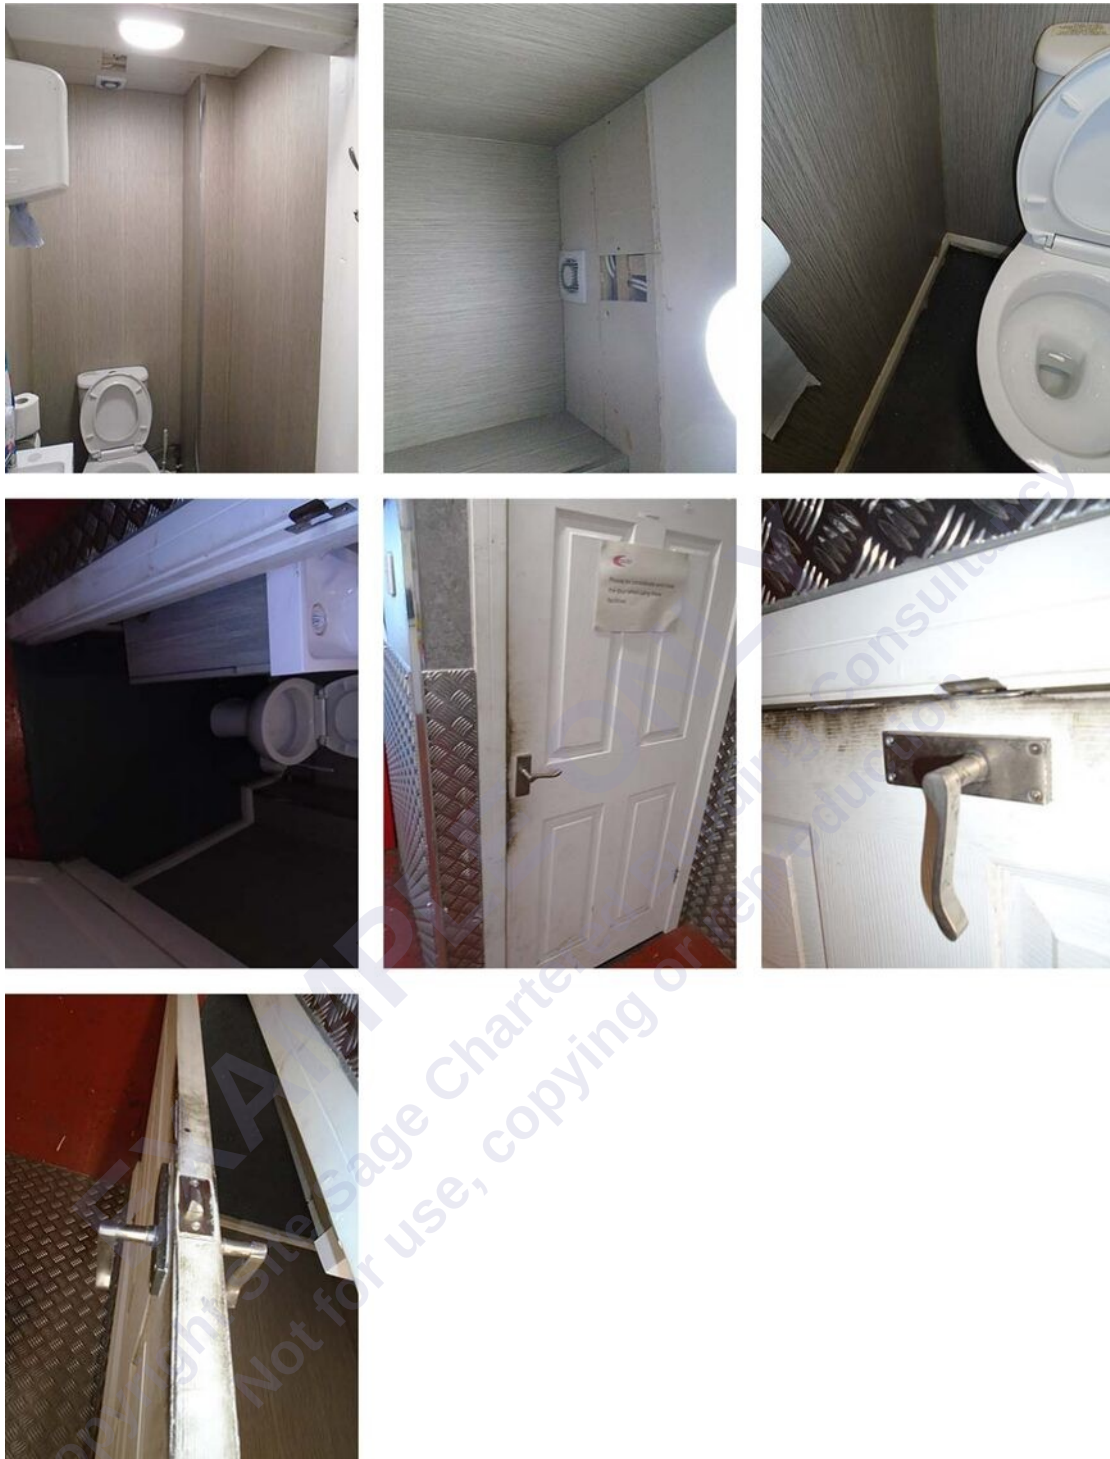
## Appendix J – Male WC – Ground Floor (Reception Area)

Photographs showing sanitary fittings, wall finishes, flooring, and door condition.

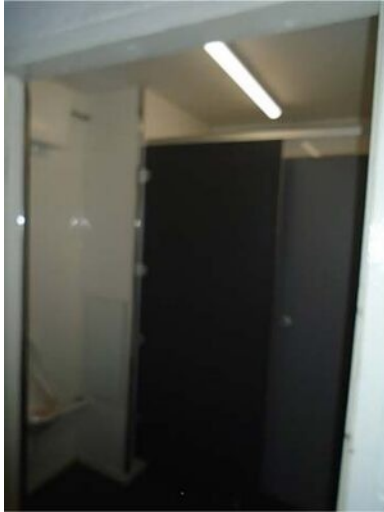
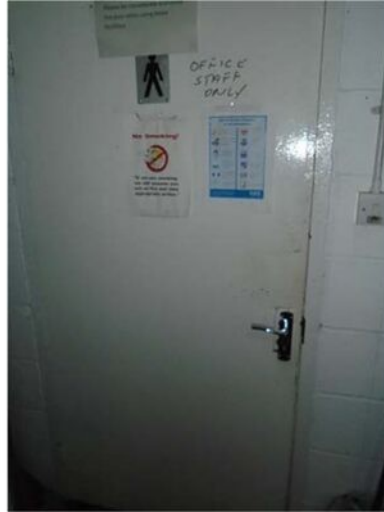
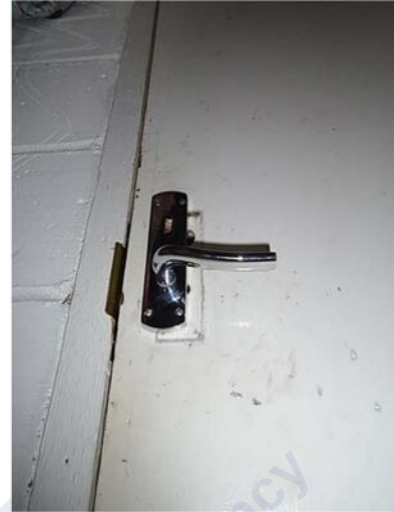
## Appendix K – Male WC – Ground Floor (Adjacent to Boardroom)

Photographs showing sanitary fittings, wall finishes, flooring, and door condition.

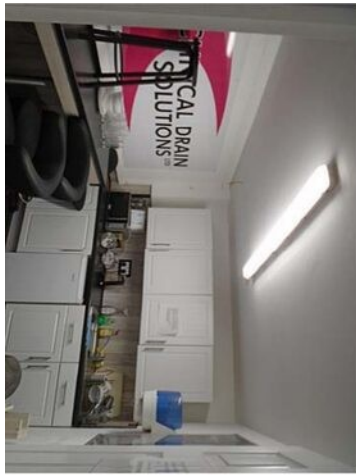
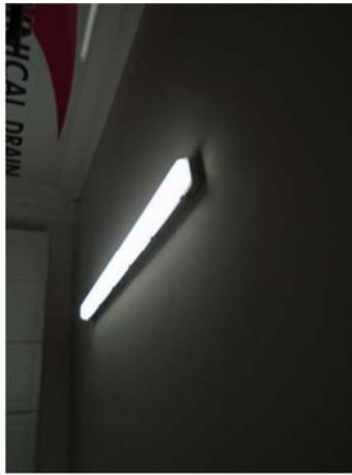
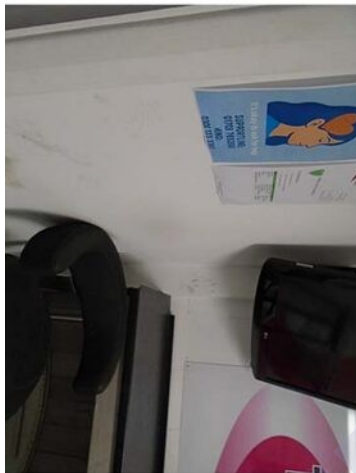
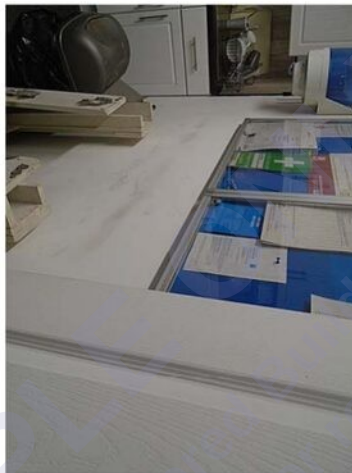
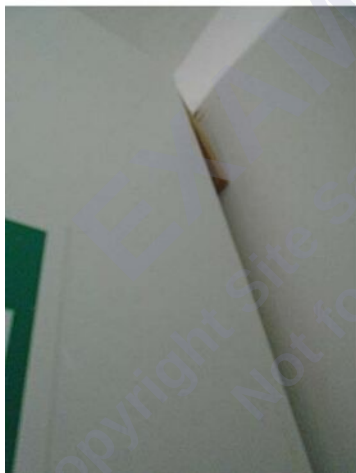
Wall-mounted unit to the right-hand side when viewed from the entrance door is coming away from the wall. Fixings appear loose or failed. **Health and safety hazard** with risk of detachment and injury.

Photographs showing fitted kitchen units, floor finishes, ceiling condition, and unsafe wall-mounted unit.

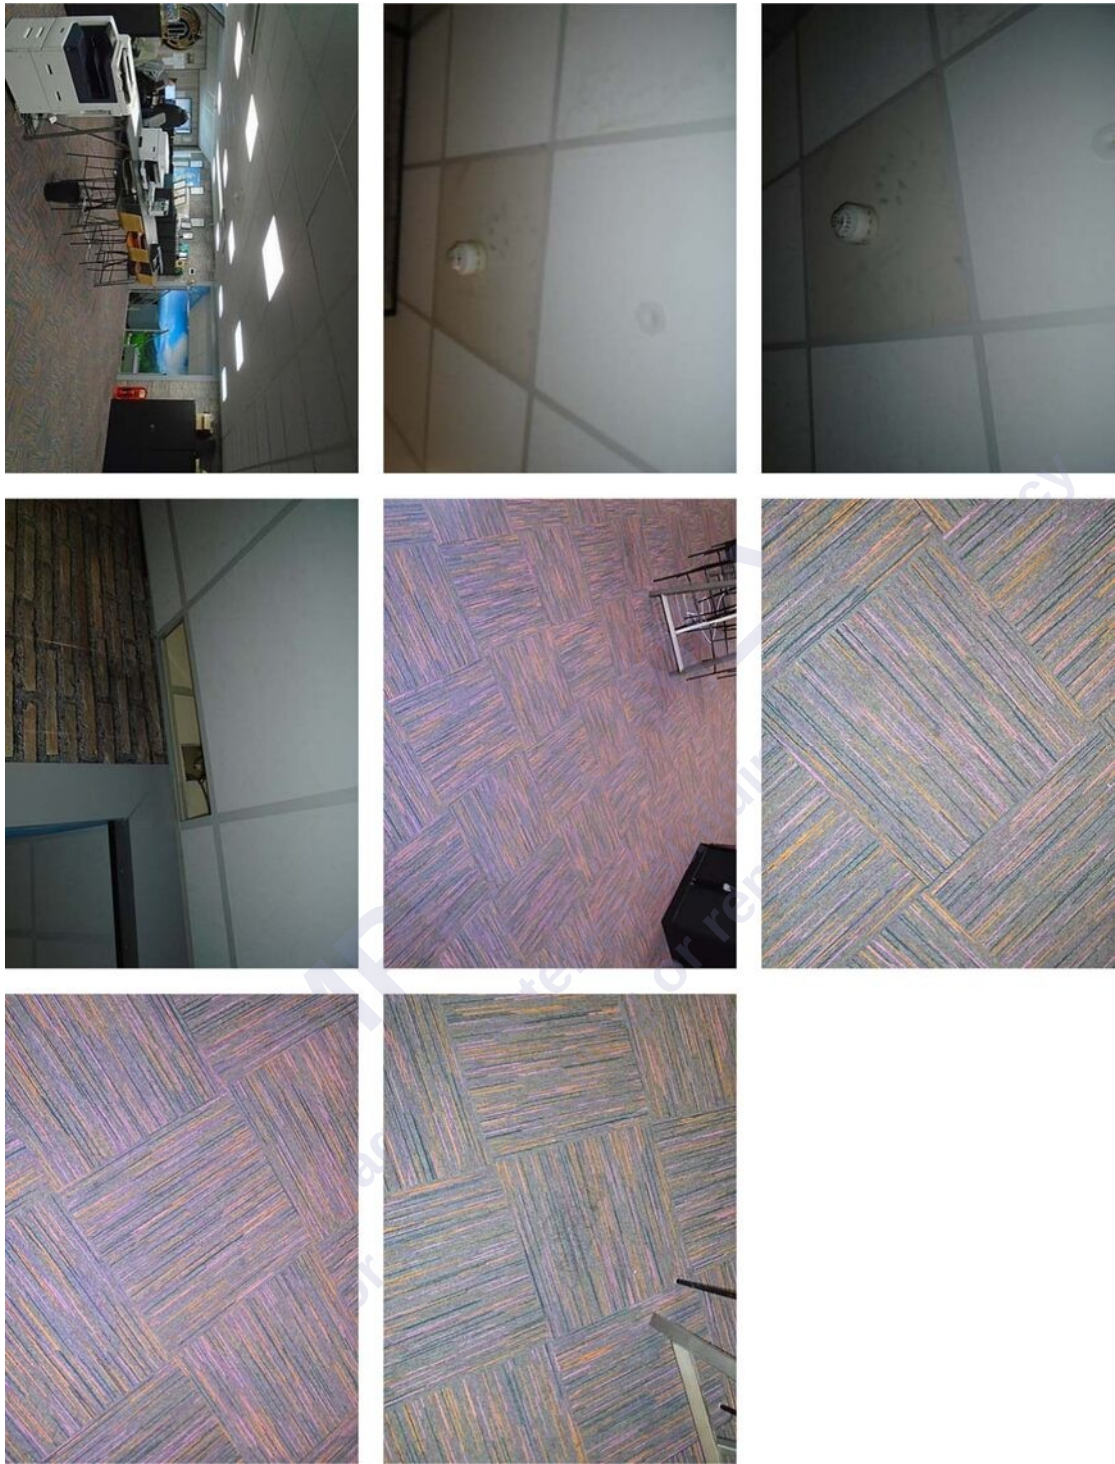
## Appendix T – Office 1 (Glazed Front Office)

Photographs showing glazing, door fittings, ceiling tiles, and internal finishes.

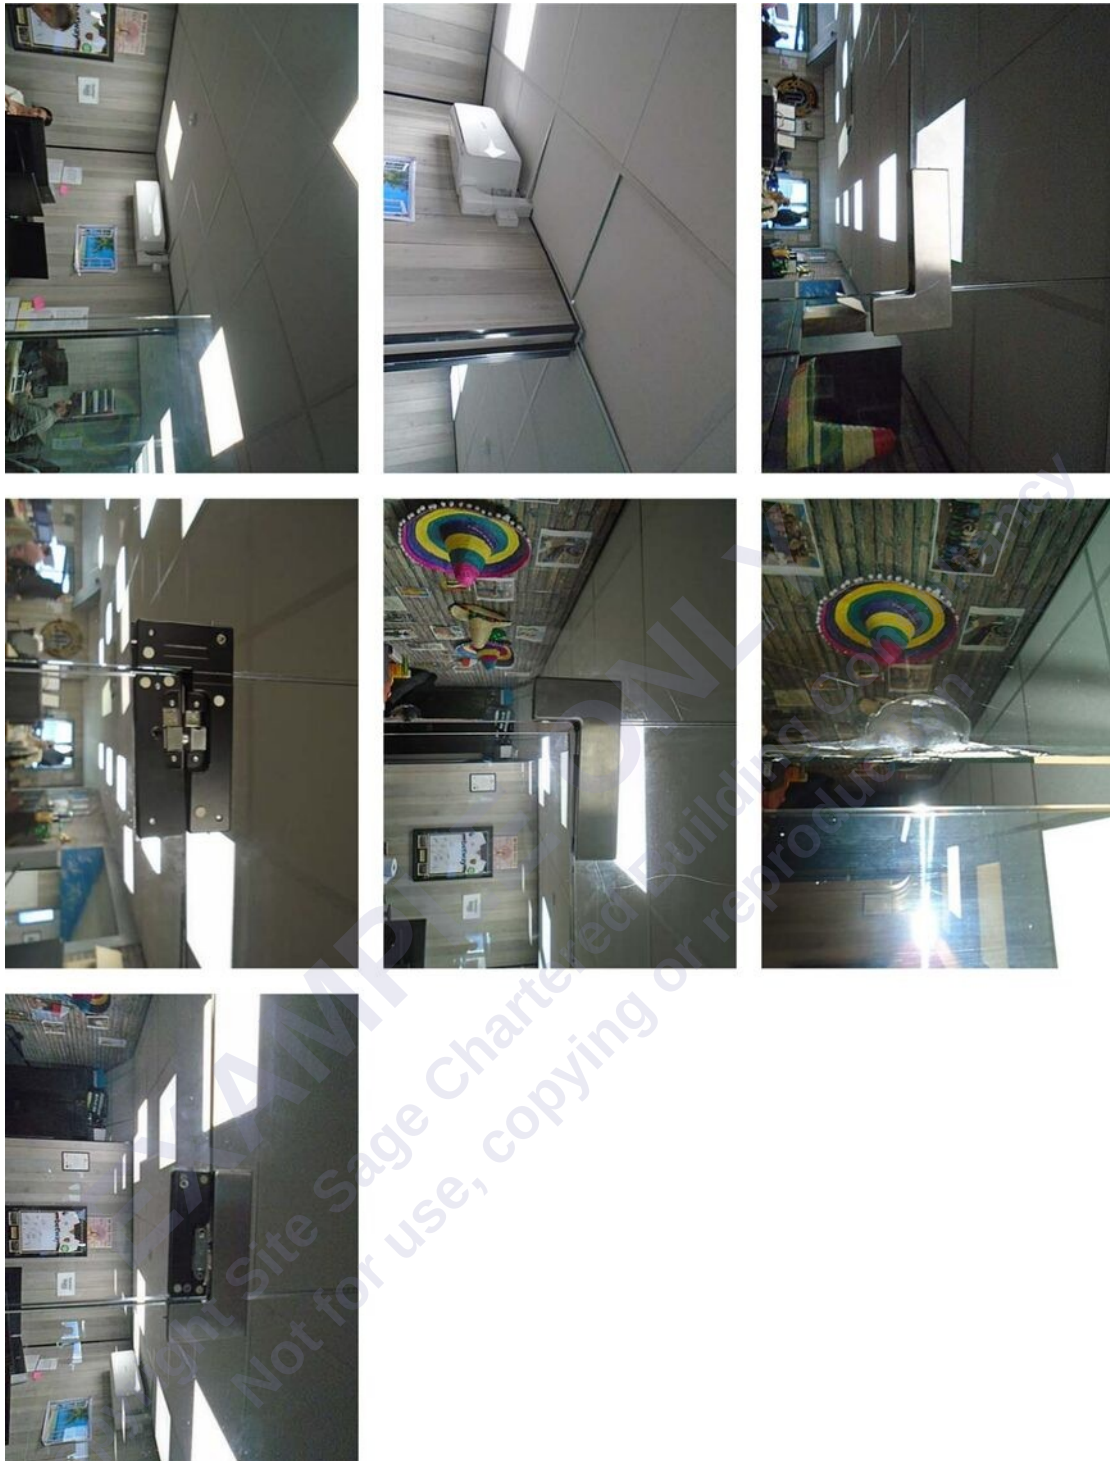
## Appendix U – Office 2 (Glazed Front Office)

Photographs showing glazing panels, internal finishes, and minor defects.

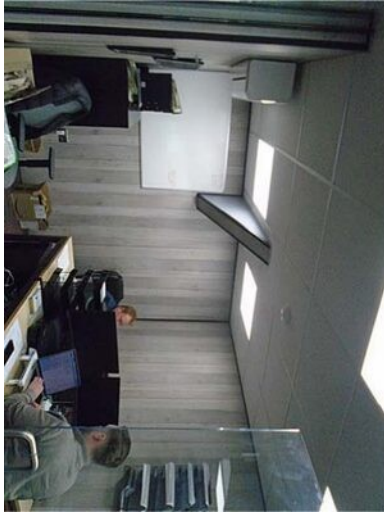
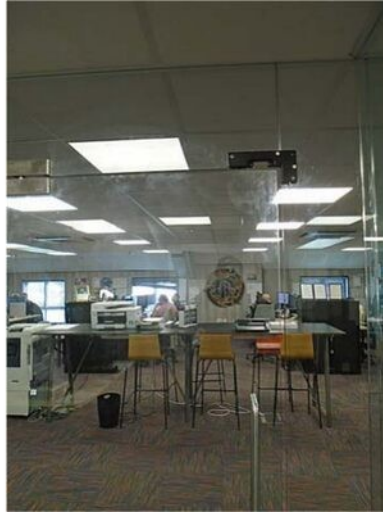
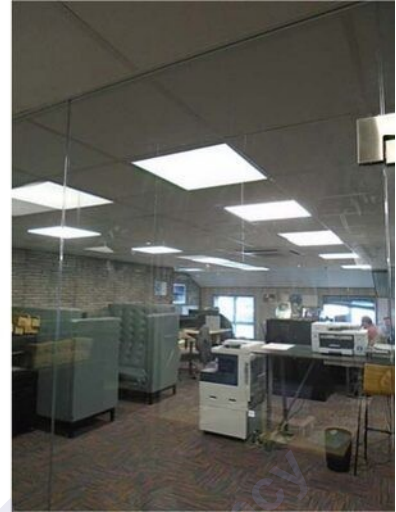
Photographs showing ceiling tiles, glazing, and general condition.

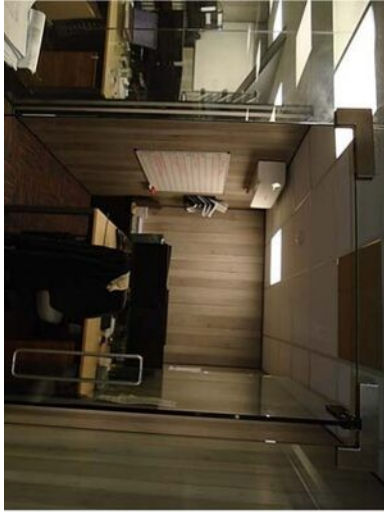
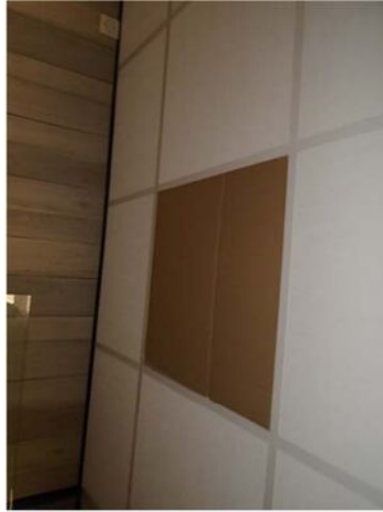
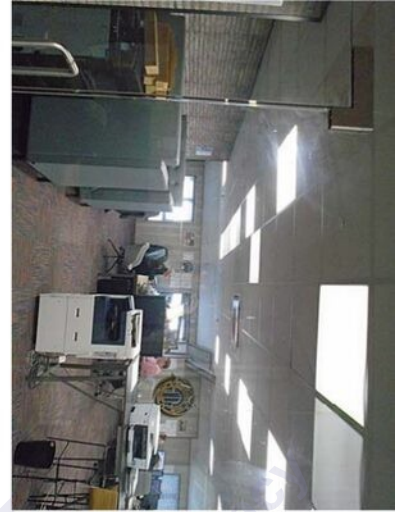
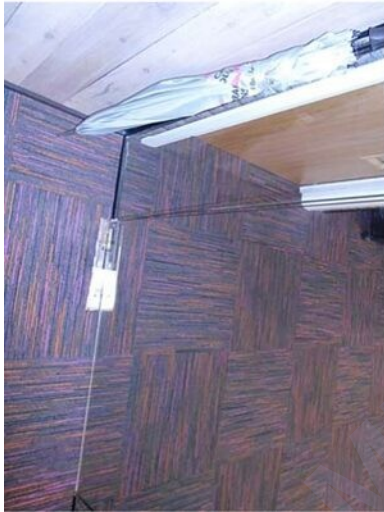
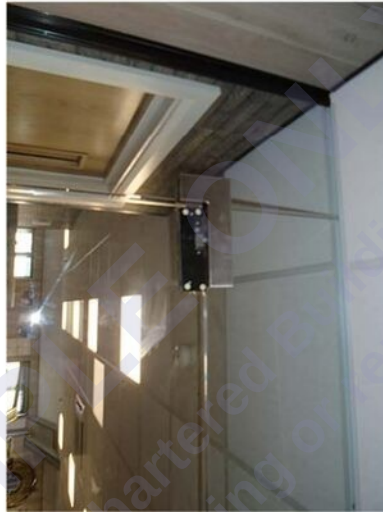
Photographs showing incomplete ceiling, exposed services, wall finishes, floor condition, and door clearance.

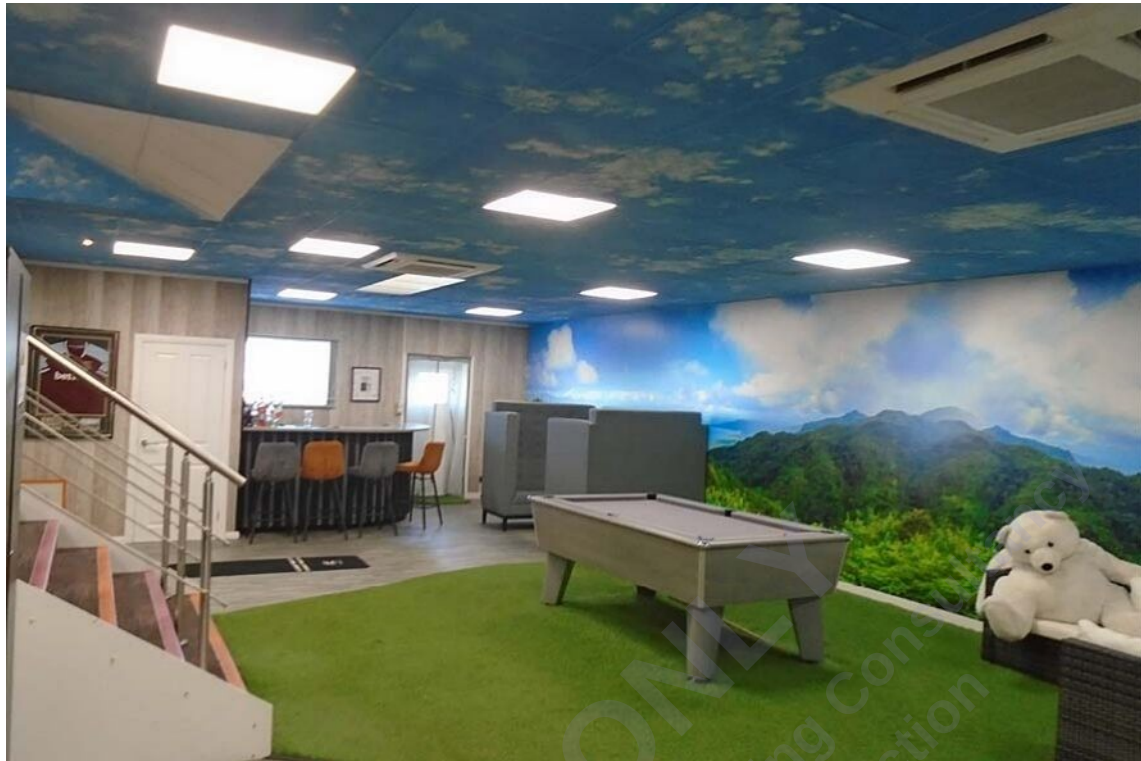
## Appendix X – Rest / Break Area / Tea Point (First Floor)

Photographs showing rest and break area forming part of the open-plan first floor accommodation, including laminate flooring, artificial grass feature flooring, decorative wall finishes, suspended ceiling, and tea point facilities. Photographic coverage is limited; description reflects the condition observed at the time of inspection.
