## SCHEDULE OF DILAPIDATIONS

**GROUND FLOOR PREMISES**

**1 SAMPLE ROAD**

DATED: 9 NOVEMBER 2016

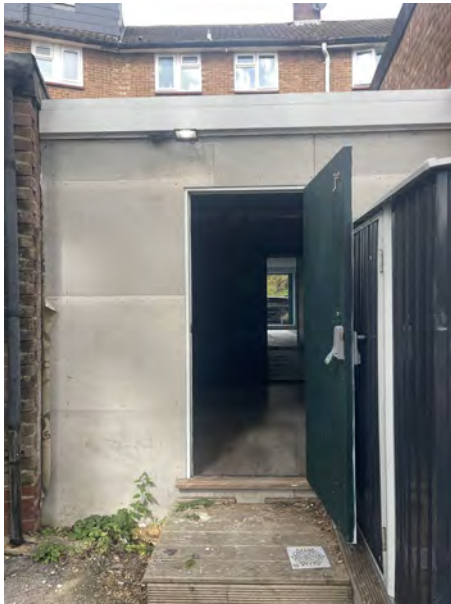
**Plate B1**

The rear of the premises. Rendered wall, flat roof over, and the rear door giving on to the Yard.

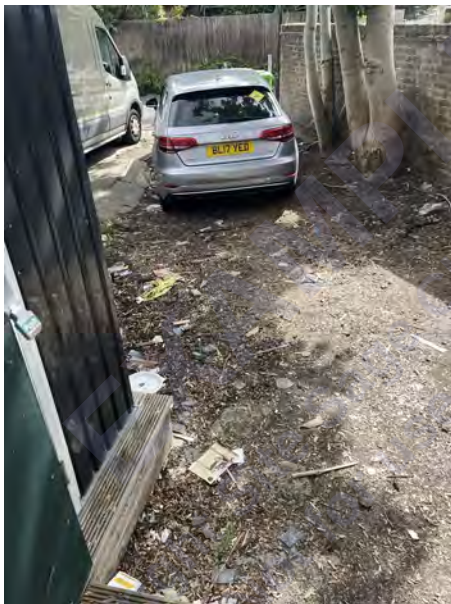
**Plate B3**

View out across the Yard from the rear doorway. Brick boundary wall to the right, close boarded fence beyond.

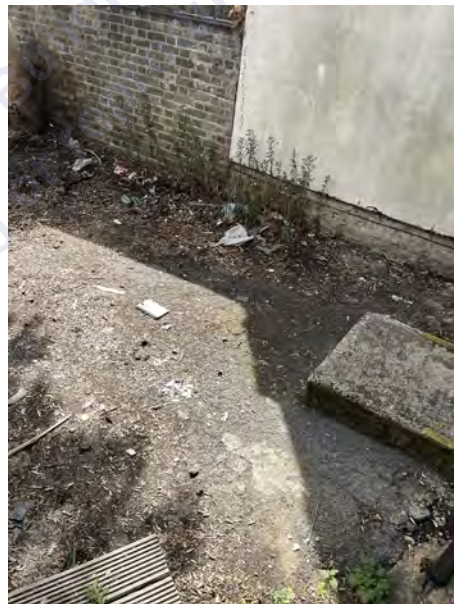
**Plate B4**

Corner of the Yard. Weathered brick boundary wall meeting the rendered flank wall, with weed growth along the base of both.

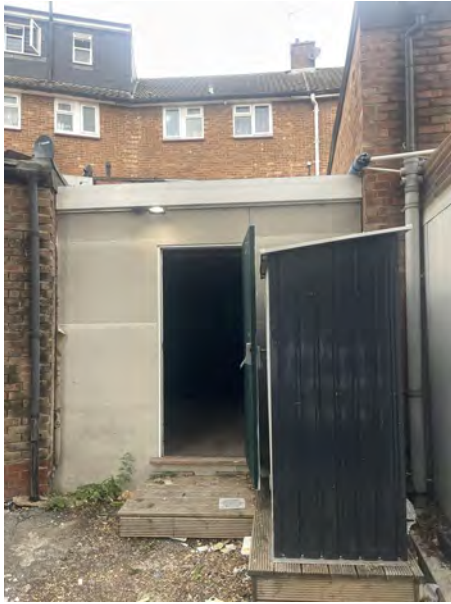
**Plate C1**

The structure viewed from the Yard. Grey sheet cladding on the yard elevation, pale fascia at roof level, doorway centrally.

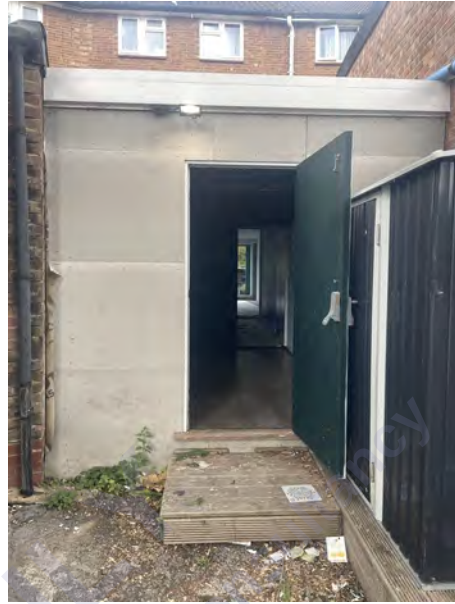
**Plate C2**

The yard elevation with the door standing open. The route through the structure into the shop is visible beyond.

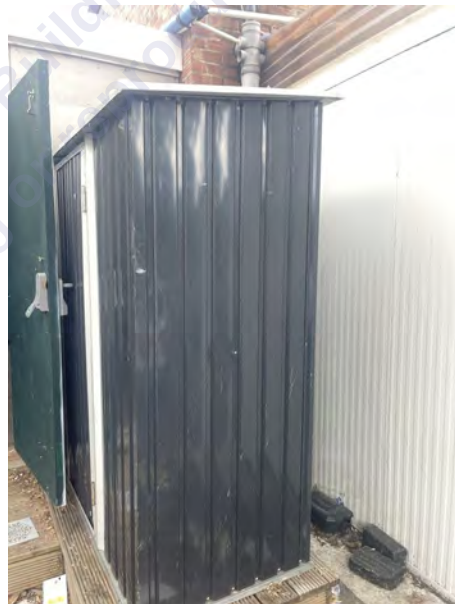
**Plate C4**

The separate profiled metal store standing on timber decking beside the structure. Not part of the Tenant's works — excluded from this Schedule.

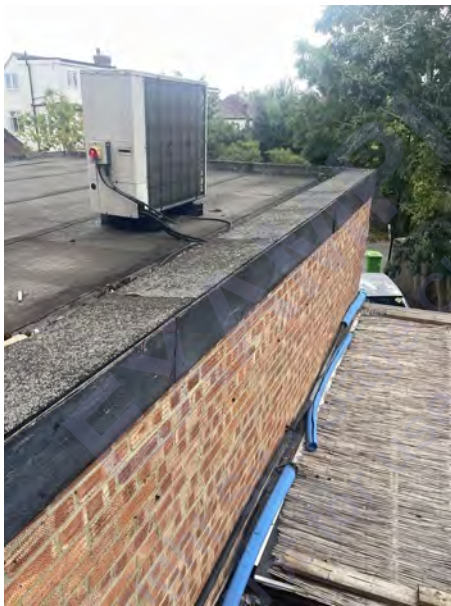
**Plate C15**

A condensing unit standing on the adjoining flat roof, at a level above the structure.

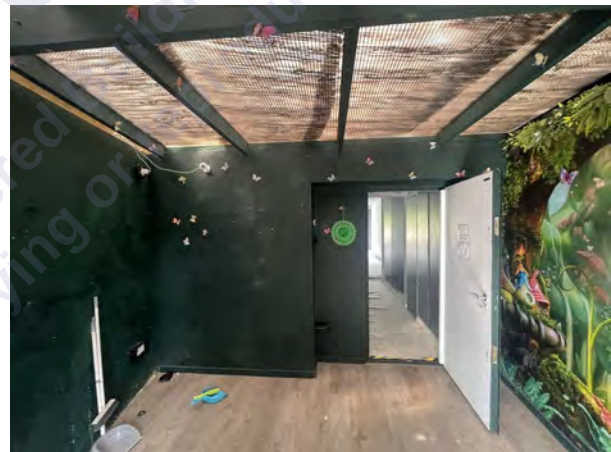
**Plate C16**

The interior of the structure looking towards the shop. Board lining painted dark green, timber beams over, translucent roof above.

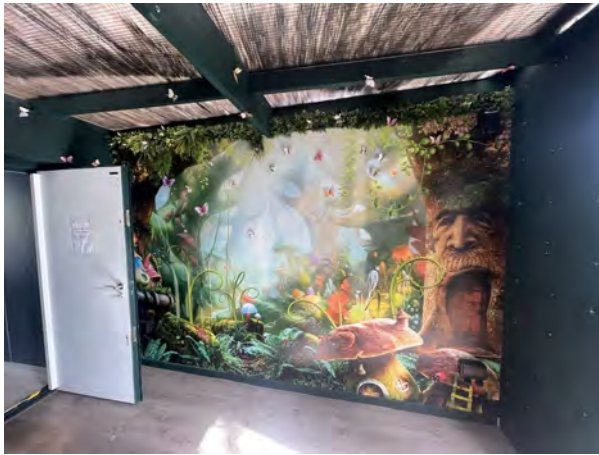
**Plate C17**

The interior. Printed woodland mural applied to the full height of one wall with artificial foliage to its head.

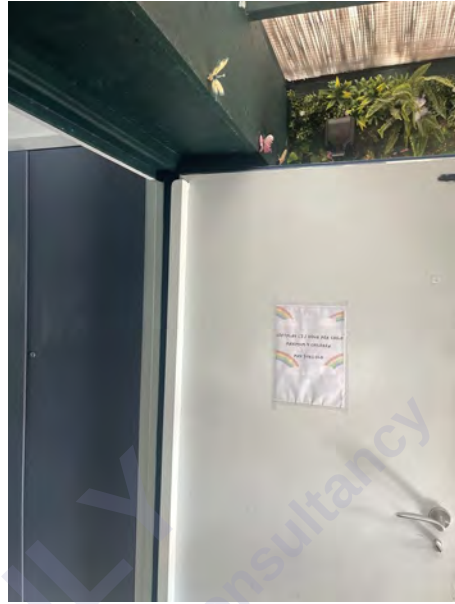
**Plate C22**

The door from the structure directly into the shop, with the Tenant's notice recording the soft play use.
